# Geological-Geotechnical Characterization of the village of Monsanto and evaluation of the stability conditions

**Ricardo Dias dos Prazeres**

Instituto Superior Técnico

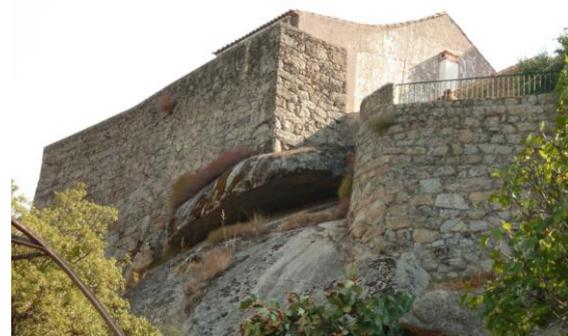
Point 4 is a place where a stone wall is built with the base on a rock block. This block is bounded by two large subhorizontal joints (Figure 12: Local 4 watching by the street, showing the block and the subhorizontal joints.). The site is on private land, making it difficult to properly visual inspection. The existence of the construction on the block prevents the observation of possible subvertical joints parallel to the slope. The joints parallel to the slope would cause the block to fall.

Figure 12: Local 4 watching by the street, showing the block and the subhorizontal joints.

In this case there is no proposal for a solution, as it was not possible to observe the site in a more detailed way. However, it is proposed that an inspection be carried out at the place to confirm the existence of the family of subvertical joints parallel to the slope.

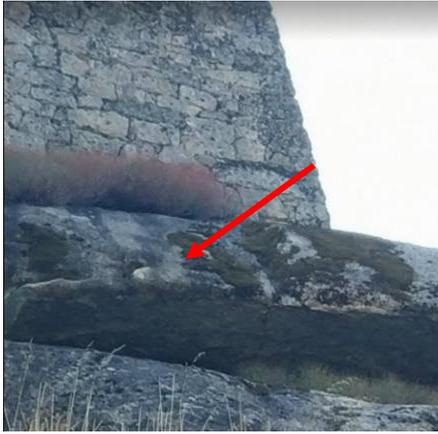
However, the existence of subvertical joints perpendicular to the face of the block and also to the slope has been verified (Figure 13)).

Figure 13: Subvertical joint perpendicular to the face of the block (arrow)

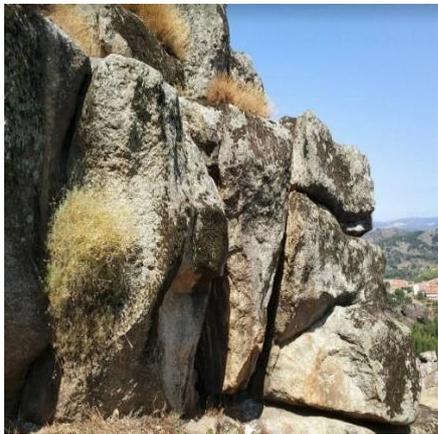
However, in nearby slopes and to the north of point 4 it was possible to visualize the family N°20; 90°, parallel to the slope and which can, in turn, be parallel to a possible fracture in the block (Figure 14).

Figure 14: Joints on the slopes north of point 4

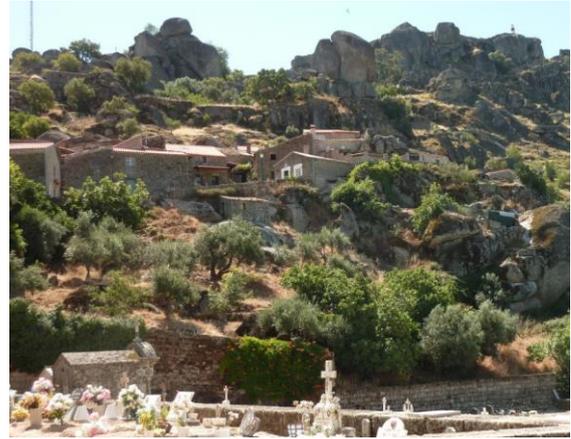
Point 6 consists of a tourist spot, the "Penedo do Pé Calvo", located at the top of the slope, above the graveyard, as shown in Figure 15, which is quite visited by tourists.

Figure 15: View from the graveyard

It consists of two large blocks, separated by a subvertical joint but with irregular layout, that rest on another granitic block limited by subhorizontal joint. In this block sub-vertical or vertical cracks are observed indicating that the rock's compressive strength has already been exceeded (Figure 16). Thus, the two blocks may fall along the slope due to the rupture of the block at the base.

The solution proposed for this local is the injection of cement or epoxy resin into the contact between the unstable blocks and the foundation block and in this to seal the fractures, in order to prevent the advance of the degradation. Steel cables may also be used to prevent movement of the block, provided a location for anchorage to a stable bulk is found. After the intervention it is necessary to have a monitoring of the fractures in order to verify the possible variation of the opening. Another relevant point about the proposed solution is that it fits the landscape, with a reduced visual impact.

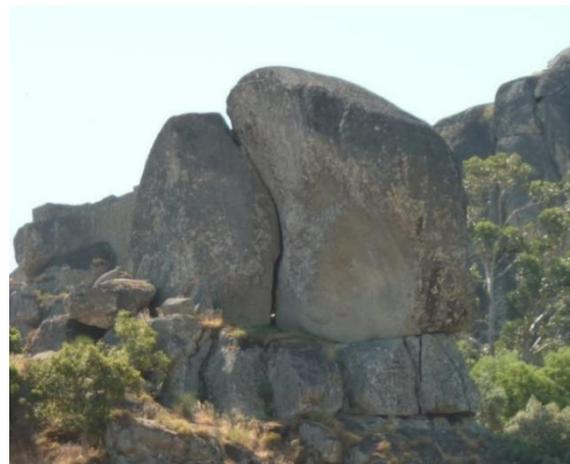
Figure 16: Vertical fractures due to compression

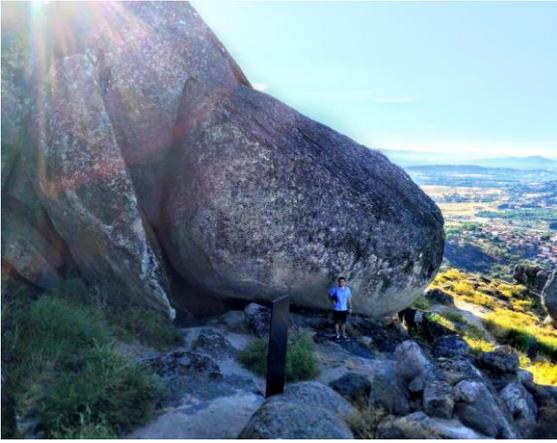
Point 14 is a tourist spot known as Penedos Juntos (Figure 17). At the base of this slope is the School and the GNR building. The presence of these buildings makes this place a priority for an intervention.

Figure 17: Penedos Juntos, person for scale

The solution proposed for this local is the cleaning of the foundations, so that the degradation in the foundation can be better verified. Subsequently, the construction of a support wall should be carried out to prevent the degradation from evolving. This construction should be done in a phased way to avoid the total destabilization of the block. The support wall will replace the supports that present cracking and a drainage system should be created to prevent the percolation of the rain from further erosion.

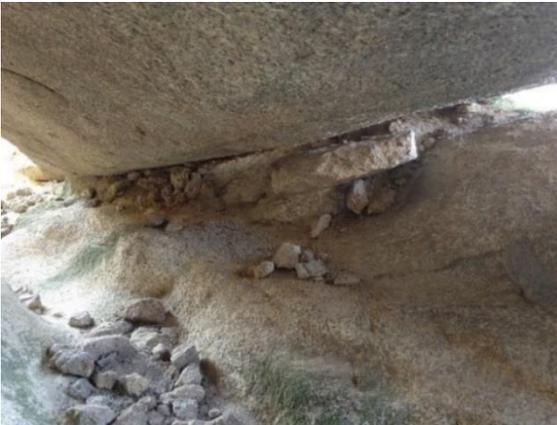
At the local the erosion caused by the passage of water in the foundations of the block is very visible in Figure 18. At the base of the block there are only 2 points of support on the ground, constituted on the spot by a large granite block. Between the two blocks of granite there is a small thickness of granite very altered that presents/displays subvertical cracks, indicating that the resistance to the compression has already been exceeded. The meteorization at this location is facilitated by the existence of cracks and by being in an inclined zone, as seen in Figure 19. It will be seen that the lower block has a very clear and clean surface, with the quartz crystals in relief, because of the surface runoff of the rainwater which seems to have a preferential path here.

Figure 18: Erosion make by the water of the rain

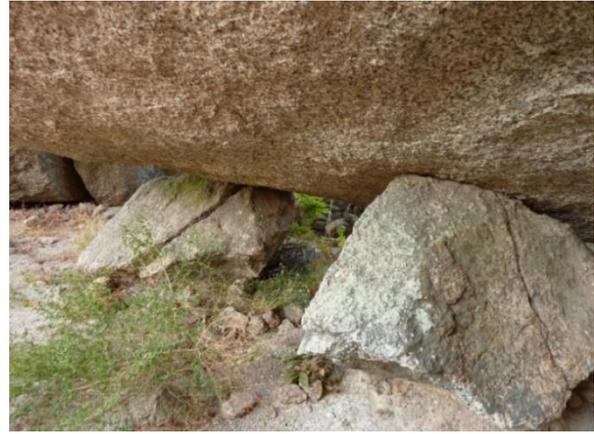
Figure 19: Granite fragments on which the block is supported, showing compression fractures
