## **Green roofs in Mediterranean climate**

Proposal of a maintenance plan

**Extended abstract**

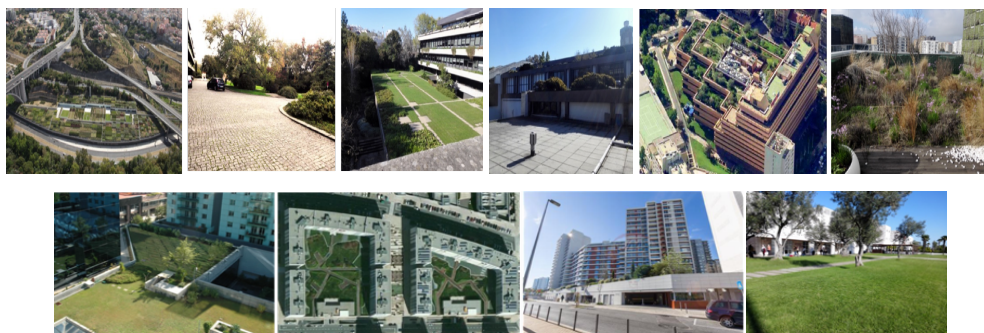
Figure 2. Green roofs of the inspected case studies I, II, III, IV, V, VI, VII, VIII, IX and X (from left to right).
