STABILIZATION OF SÃO PEDRO DE ALCANTARA'S VIEWPOINT WITH MINIMIZATION OF EARTHWORKS

From the project to the execution

April 2018

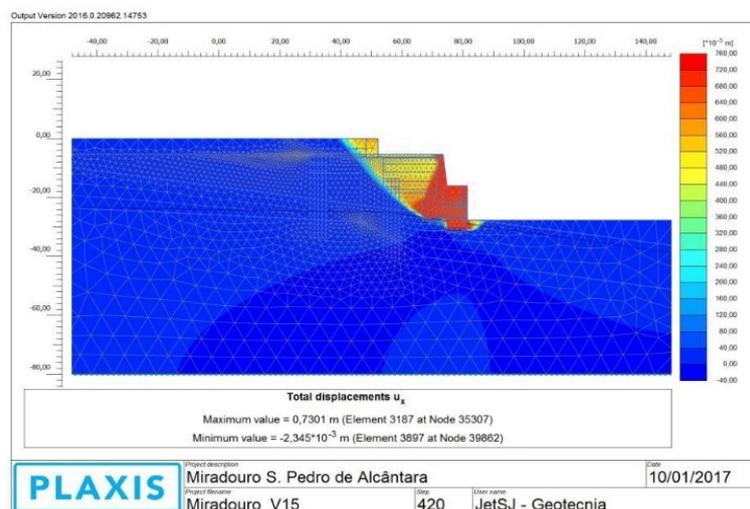
Figure 3: Horizontal displacements

- Characterization of the ground that supports the equipment and its framing in three different geotechnical zones (see fig. 2);
- Displacement of the lower support wall (see fig. 3);
- Possible sliding surface at depths of around 30 meters (see fig. 3).

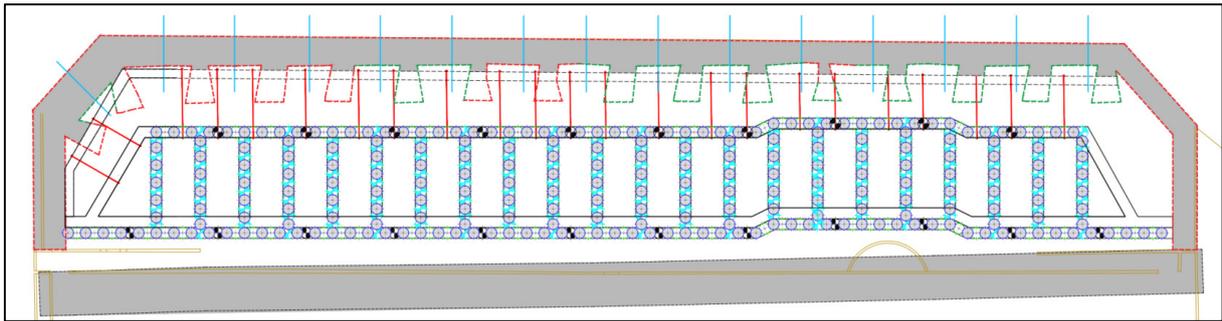
Figure 4: Stabilizing structure to be performed on the lower platform

The project designed for the stabilization of S. Pedro de Alcântara's viewpoint consisted in the implantation of two secant bored pile walls in the lower platform, locked and connected by a set of buttresses secant bored pile walls (see figure 4). Adding to the above-mentioned "superstructure" of concrete, a set of drainage and waterproofing devices for the ground were also planned, such as the use of a landfills of lightweight aggregate, geotextiles and geomembranes to be placed over the ground and the beams.

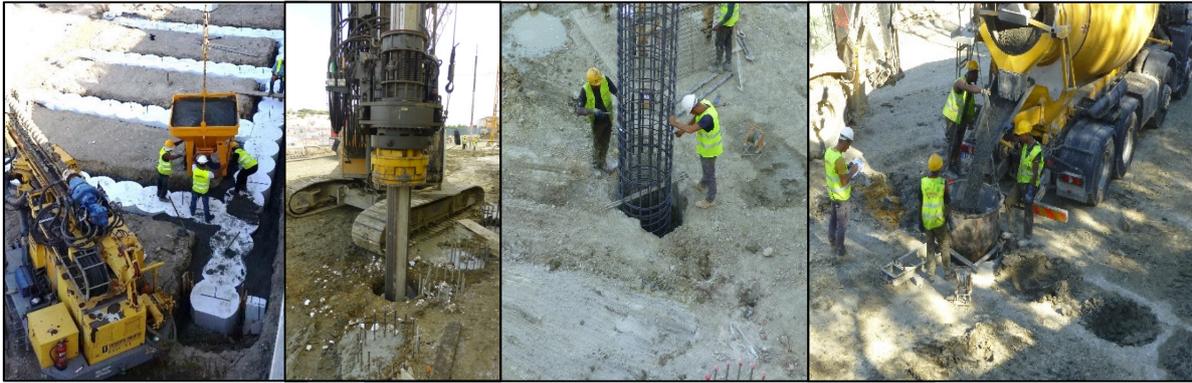
Figure 7: Execution of the piles

The first work to be carried out regarding the construction of stabilizing structure was the insertion of the guide walls in the ground (see figure 7 first image). The next process was the execution of the piles, and this can be split into the following steps: First the drilling, and then the insertion of the steel reinforcement bars into borehole finalized by concrete pouring through the tremie pipe. The construction process of piles can be seen in figure 7.

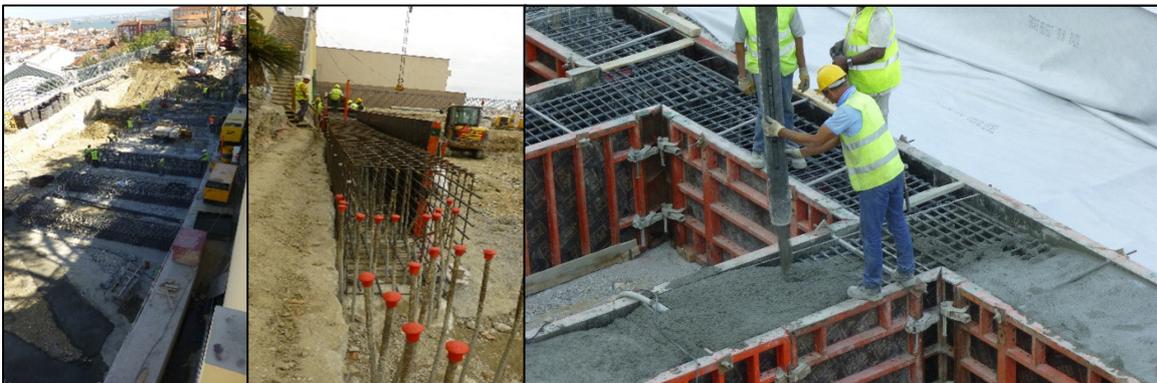
Figure 8: Execution of the capping beams.

The execution of the beams was divided into three parts: 1) Production and placement of the steel reinforcement cages according to the design; 2) Preparation and placement of formwork with lateral shoring; 3) Concrete pouring. The three images of figure 8 represent each one of those steps.

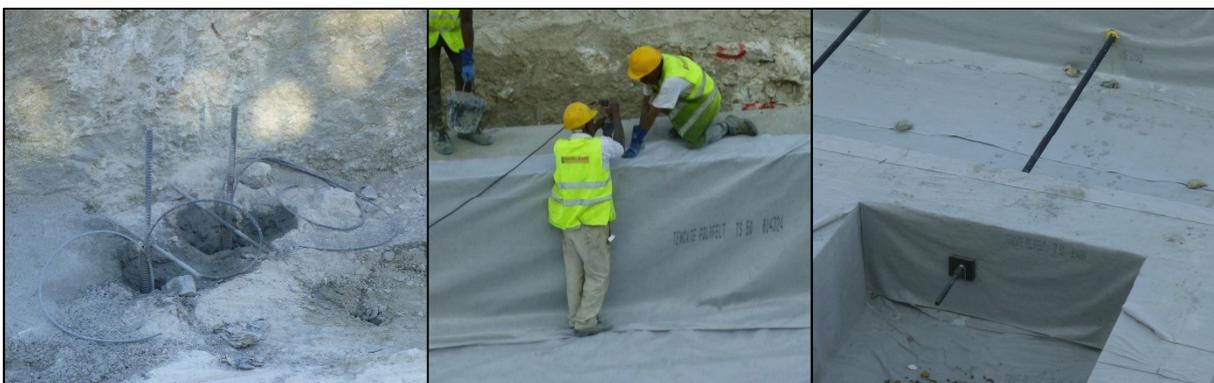
Figure 9: Application of gewi rods and geotextile fixation

To control the displacements of the support wall of the lower platform a beam was installed over the nailed buttresses and connected to the stabilizing structure with pre-strengthened tie rods. Figure 9 shows the application of these two elements in the construction site.

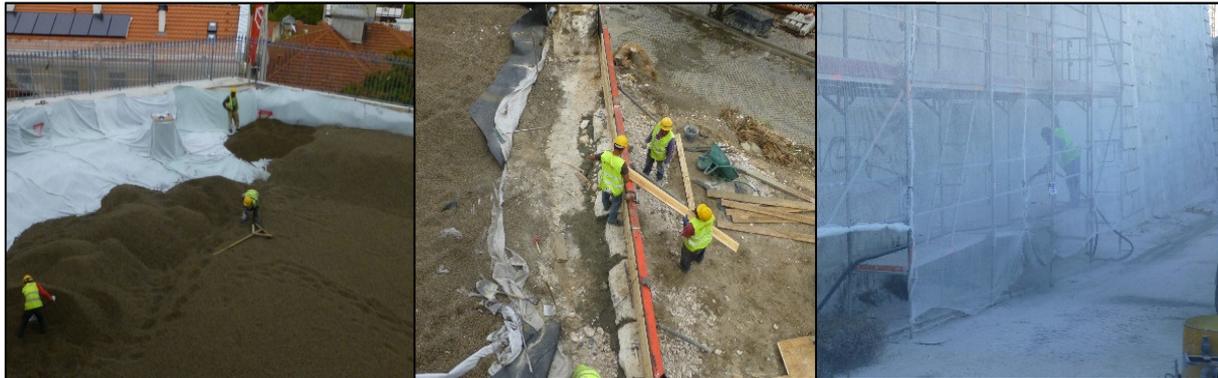
Figure 10: Execution of landfills with lightweight aggregates and reconstructions and rehabilitation of the lower support wall

The last developed works in this project were the reconstruction of the lower wall in the south zone and the rehabilitation and cleaning of the support wall of the lower platform. These actions can be seen in the last two images of the figure 10.

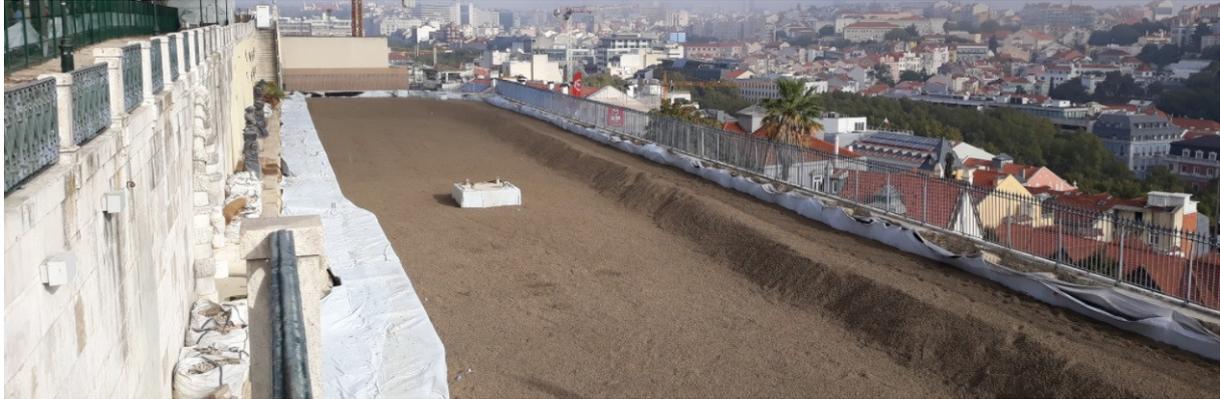
Figure 12: View of the lower platform after the work has been completed.

- The accomplishment of the work (see figure 12) allowed the preservation of the historical element and created conditions for the reestablishment of the landscape characteristics of the equipment.
