**Rehabilitation Techniques and Repair of Cambambe  
Fortress**

Extended Abstract

**Master in Civil Engineering**

**September 2016**

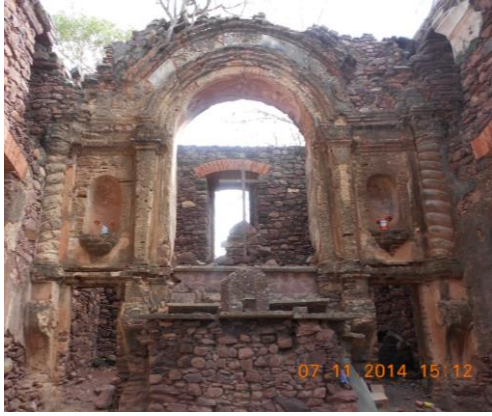
Figure 1 – Altar wall.

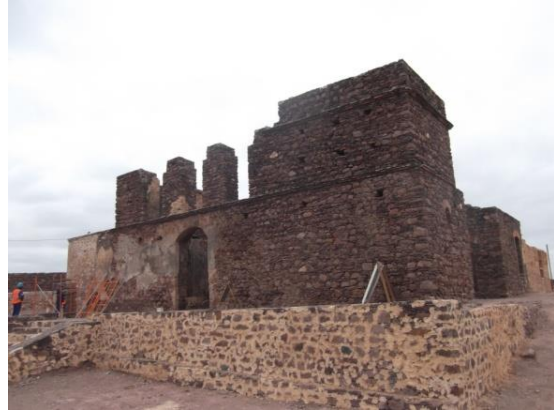
Figure 2 – Main facade walls.

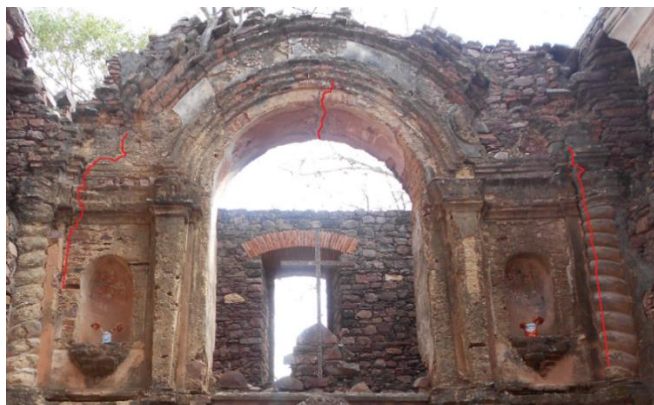
Those cracks develop along much of the butress height, with 6 meters in total, approximately. The opening of the cracks is variable, it may reach about 5 centimeters on the top of the wall. Another place where cracking is visible is the connections between altar wall and lateral walls. In this case cracks are in the top of the wall, with 2 to 3 meters of extension (Figure 3). The cause of this anomaly is related mainly to the disconnection of the walls for lack of connecting elements and to the deformation of the altar wall. These slots are the most relevant, but there may be other lesser extent and lesser severity along the remaining walls.

The cracking observed in the connection between altar wall and lateral walls indicate a deformation associated with the collapse of this wall and its consequent disconnection of the remaining walls (Figure 3). The most likely causes are:

- High slenderness of the wall;
- Lack of reinforcement elements of connections with orthogonal walls;
- Lack locking perpendicular to the wall plane;
- Horizontal loadings (for exemple: the wind).

Figure 3 – Cracking and deformation of the altar wall.

Have been considered two solutions to the wall of the altar. The first would be the dismantling and reconstruction, which in addition to being a rather lengthy process, would mean the loss of the equity value and original architectural value of that wall. The second solution is about straightening and repair of that wall, which seems to be more reasonable. The straightening can be accomplished using tensioned steel cables which introduce a horizontal force corresponding to the required displacement to check the verticality of the wall. The steel cables are attached to horizontal lever hoists, which can be fixed to the ground by nailing. The cables must be an even number (minimum 2) to not create eccentricities when application of forces. The cables pass through the wall in the region of the arch. In the posterior face of the wall must be a metal plate or wooden plank, supported by a temporary structure, which allows homogeneous distribution of forces on the wall. The process should be carefully monitored through direct observation and possibly also using topographical equipment. If there is any anomaly in the wall the process should be stopped immediately. To the altar wall is also suggested the execution of adherent nails with rebars of steel protected against corrosion inserted into holes previously open to various height, in the wall connections with the side walls. Nails must be later sealed with an appropriate grout composed by natural hydraulic lime (NHL). It also suggests restoring the front side of the wall to recover its ornamentation.

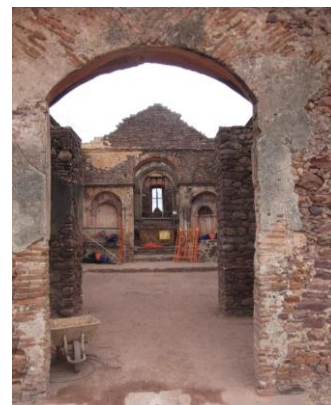
Is a non-structuran anomaly that affects mostly entire walls and is defined by the loss of particles to the minimum mechanical stress. The main agent is water, which begins to infiltrate the wall, where it forms voids and pathways that lead to the formation of weak areas. The masonry laying mortar, which in some areas may even never have existed, is currently very scarce and may have significantly lost its agglutinative capacity, which contributes to the structural strength deficit of the walls (Figure 4) [9] [10].

Figure 4 - Disaggregation of masonry.

For the current walls (all walls excepting the ornamented sides of altar wall and ante-chamber wall) it is proposed the application of reinforced render technique to repair and consolidate the masonry. This technique should also be applied to areas to build. The application of this technique allows the final painting with white color, as in other churches of the same era (Muxima and Massangano) (Figure 6). Finally, it is recommended to apply wooden doors and windows with protection wood shutters.

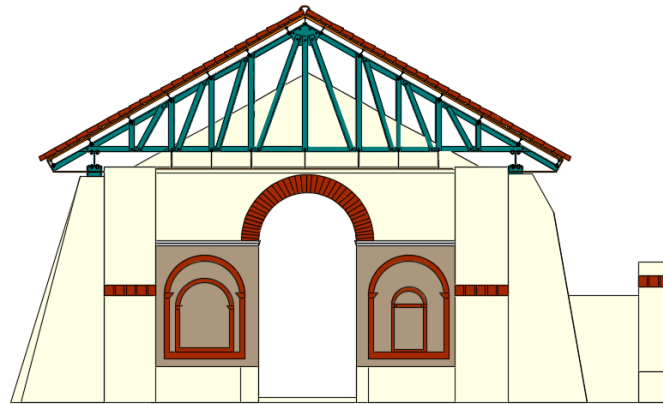
Figure 5 - Current roof support structure section.

The roof is supported by a steel structure consisting of: roof beams, trusses, beams, columns and foundations. The roof beams are IPE 160 metallic profiles, whose spacing is determined by the maximum permissible span of sandwich panels (1.25 meters). The trusses are composed of LNP 150 16 metal profiles type (Figure 5). Steel was chosen because wood requires more skilled labor and is more difficult to obtain good quality elements. The LNP profiles have the advantage of allowing the assembly of trusses simply by screwing of their flaps. Trusses are supported by HEB 400 steel beams and columns of the same type. Columns are strategically located in the corners, allowing them to be coated with masonry. In any metal structure should be provided a protection scheme against corrosion and against fire. Foundations are footings made of reinforced concrete,

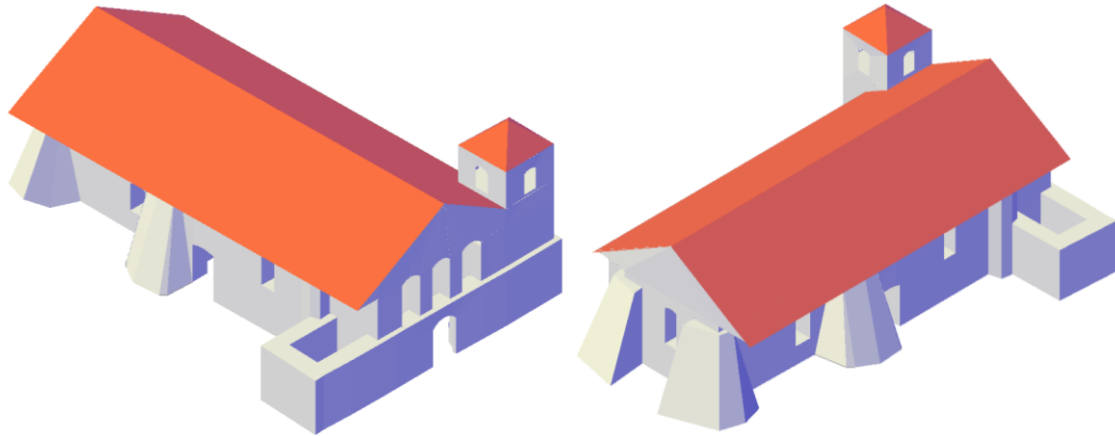
Figure 6 - General rehabilitation aspect (two perspectives).

It is proposed the reconstruction of the belfry tower 4 meters above its current height, using a masonry similar to existing masonry, with natural hydraulic lime mortar. The walls of belfry tower overlaps the metal structure in this área. In the belfry tower there are four openings materialized by discharge arches in masonry. It is also proposed the reconstruction of the main and back side facades, with the same type of masonry and discharge arches in window áreas (Figure 6).
