Fault Analysis Methodology and Maintenance Improvement

Luís Pedro Martins Loureiro
luispedromartinsloureiro@tecnico.ulisboa.pt

Instituto Superior Técnico, Universidade de Lisboa, Portugal

January 2021

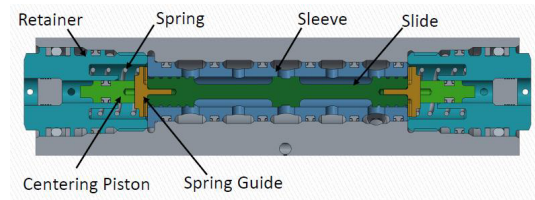
Figure 3: Control Valve Schematics and Spring Guide Location.

Out of the 31 different valves, 18 (58%) have a S/N of the form $8xy$. Out of these 18, 11 valves (61% of the $8xy$ series) were ultimately removed, no longer being in service. The remaining 7 valves (39%) are still in use, although being overhauled at least once. The data suggests an issue affecting specific serial numbers, with manufacturing errors or faulty batches being probable causes.

As no other information was known, the manufacturer was informed of the failures. Two malfunctions on the valves were later discovered as being the cause of the failures, as such:

- a bent spring guide internal to the control valve (*vd.* Figure 3);
- an incomplete drill depth on the supply pressure channel.

Replacement was required for the affected valves, corresponding to 79 different serial numbers. As such, a Service Bulletin was issued for that effect, occurring during the next maintenance opportunities.

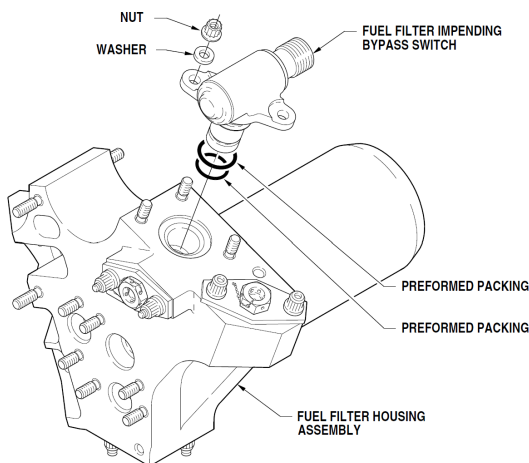
Figure 4: Latitude's FFIB Switch Schematics [9].

As no other information was known, the manufacturer was informed of the failures. At first, some preliminary conclusions were reached: there was a contamination on the switches' contacts, leading to two changes:

The test switches with the changes continued to fail. A new non-specified contamination was discovered, leading to a development of a fully new switch.

A Service Bulletin was then issued, requiring the replacement of all old P/N switches for the new P/N. Thus far, no failures have been reported regarding the new FFIB Switches.

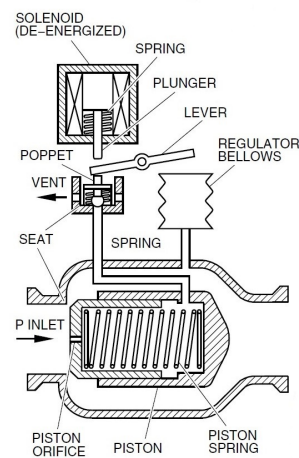
Figure 5: CH350's Anti-Ice Valve Cut Schematics [11].

No other information regarding the repairs or causes of failure was known, therefore the manufacturer was contacted. The investigation demonstrated problems with inner parts of the valve, namely with the bellows.

With the thermal expansion and contraction, the bellows material becomes brittle and damaged. This has an effect on the control section airflow, causing the valves to malfunction.

The manufacturer decided to create a new valve, with a new P/N. Whenever the new P/N is available, the valves will be replaced according to the manufacturers' guidelines.

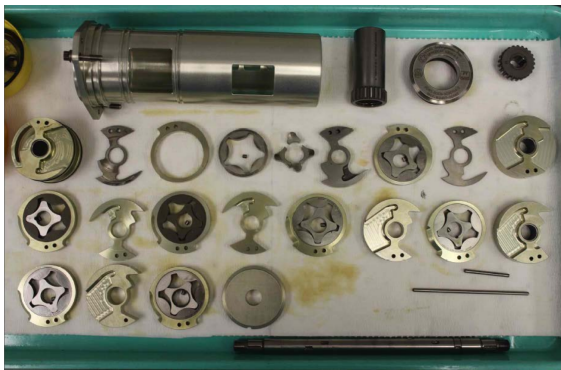
Figure 6: CH350's Oil Pump Component Breakdown.

The existence of two P/N demonstrates that an attempt was performed by the manufacturer to stop the failure events. The *P/N-5* had minor design changes compared to the *P/N-3*, namely an increased spring tension of the internal components. This kept the subparts closer together, thus reducing the gaps and clearances and, consequently, pressure variations.

As the *P/N-5* continued to fail, the manufacturer continued to seek possible manufacturing defects on both pumps *P/N-3* and *P/N-5*. There were contaminants discovered present on the pumps, rich in Silicon, Oxygen and Aluminum. These were consistent with two known factors:

Full fleet replacement of the pumps for the new *P/N-6* is undergoing. Thus far, and after a few inspections performed, those in service don't have any registered failures until September 2020.

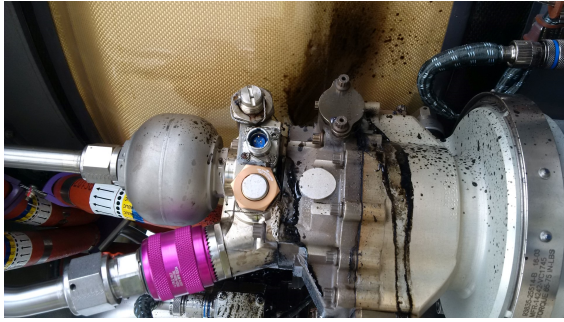
Figure 7: CH350's EDHP Leak.

Out of the 58 events that lead to the removal of EDHPs, the main reason for the failure events are leak events, with a total of 45 leakages. A real leak of the CH350's EDHP is shown on Figure 7.

Most failure events occurred in the interval 952 and 3658 Engine Flight Hours (EngFH), empirically implying that a possible preventive maintenance task should take place in this interval. As such, an EO was prepared.

To select the maintenance task, information regarding the EDHP's assembly is necessary. The EDHP is closed, therefore only a General Visual Inspection (GVI) can be performed. If failure is found, a Detailed Inspection shall be carried out to determine if the item is safe for operation; if unsafe, a replacement of the EDHP is mandatory.
