Analysis of the potential conditioning factors for pipe sticking in well drilling through active faults.

Wire-line boreholes FAM-1 and FAMSISIGN, Alhama Fault, Murcia, Spain.

J. M. Moratalla

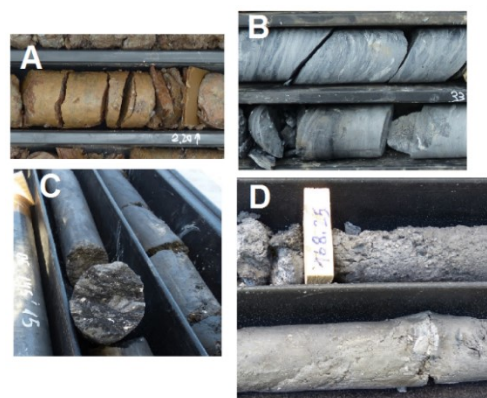
Graphitic quartz schists with fine-medium grain sizes, there are continuous alternations with levels of phyllites along all the borehole. (Figure 3.2.1-B). Generally with well-developed foliation. The formation present high grade of oxidation in the first 16 meters, and last until 63.60 meters. (Figure 3.2.1-A)

Pulverized quartz fragments are included, with sizes from mm to centimetric, the external structure is remained. (Figure 3.2.1-C).

Figure 3.2.1 Appearance of the cores obtained in boreholes FAM-1 and FAMSISIGN. A) Altered schists, B) quartz-schists, C) Fault Gouge, D) Blue phyllites.

soapy feel due to the presence of talc and other phyllosilicates. (Figure 3.2.1-D)

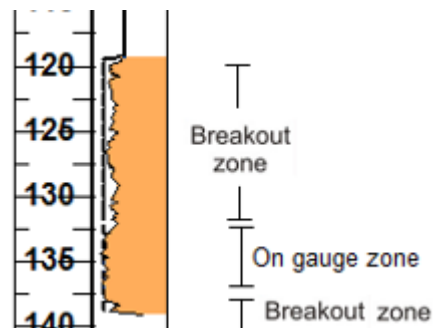
Figure C-02: Caliper log

-Irregularities in the borehole wall start with the fault gouge and continue until practically the end of the logging, except an interval of 5 meters from 132.5 to 137.5m. that is supposed to have better rock quality.(figure C-02)

Due to the small size of the breakouts, the cavings created can be supposed to be produced due to the eccentric movement of the drilling bit while drilling. This movement can be produced in zones where the rate of penetration (ROP) is low.

Thus, the final conclusion observing the calliper results is that there is presence of breakouts in the borehole walls but not caused by washouts or formation instability, at least until 139 meters depth. The corresponding fragments of the cavings created will be included in the drilling fluids and have to be evacuated anyway.

Therefore the generation of cavings in the borehole wall lead to cuttings accumulation in the annular space.

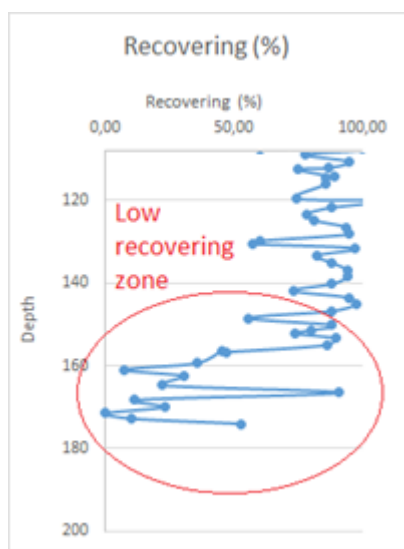
Figure 5.4.3, recovering percentages for the last 20 meters of borehole FAM-1.

Observing the results of recovering represented (figure , it is possible to observe that along the first 156 meters, the borehole was having very high recovering percentages, varying from good to excellent qualities after that a reduction in the recovering at the last 20 meters, from 156.60 to 174m, show poor-fair recovering qualities, see figure 5.4.3 and Appendix-B.

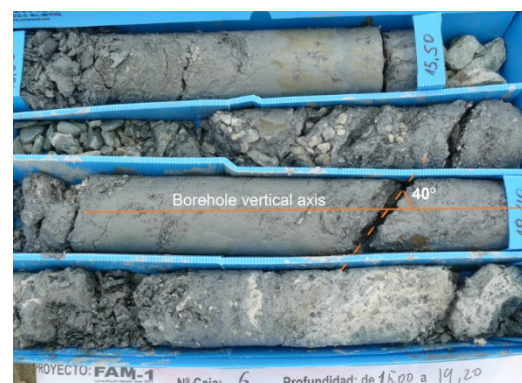
The results for FAM-1 show a 45° tendency of the dip angles along the last meters of the fault gouge, where the transition between this formation and the blue phyllites is produced

Thus, the inclination of the formations in borehole FAM-1 show that a vertical borehole has the maximum risk of a failure related with a borehole wall collapse. The zone with maximum probability of failure is reached from 135 to 174 meters depth, being larger in the last 20 meters.

In the case of borehole FAMSISIGN a tendency of 40-45° is observed all along the borehole, increasing to 50° in the last five meters, where there is transition from the fault gouge to the blue phyllites (figure 5.2.2).

Figure 5.2.2 Dipping angles of the weak planes of the formation with respect of the vertical axis of the borehole FAM-1

In conclusion, the angles of most susceptibility that can produce a collapse of the borehole wall coincide with the last meters in both boreholes, depths were the failures were supposed to be produced.
