## **Study of rehabilitation solutions and reinforcement of timber pavements**

**Madalena Barosa Vilela Pereira**

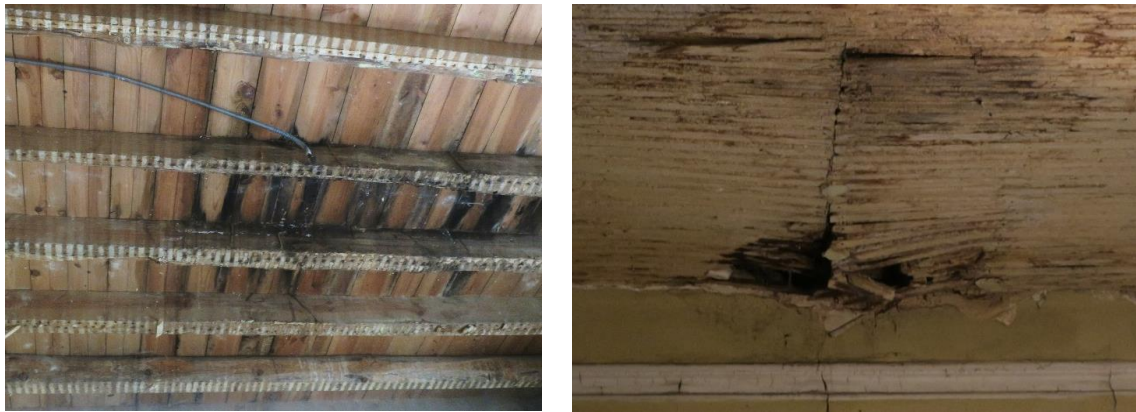
During the monitoring of the work, problems were identified in the pavements, caused by infiltrations near the exterior facades. Those infiltrations caused the degradation of some of the floor beams, weakening them and forcing them to be replaced.

*Figure 4.1 - Photographs of timber pavements degradation state in Rua da Esperança do Cardal*

In the initial analysis of the poor conditions of the existing framework, we conclude that the beam damage in all floors was, on average, up to about 30 cm of the support. Therefore, those 30 cm were considered as the cut-off zone for all the interventions adopted.

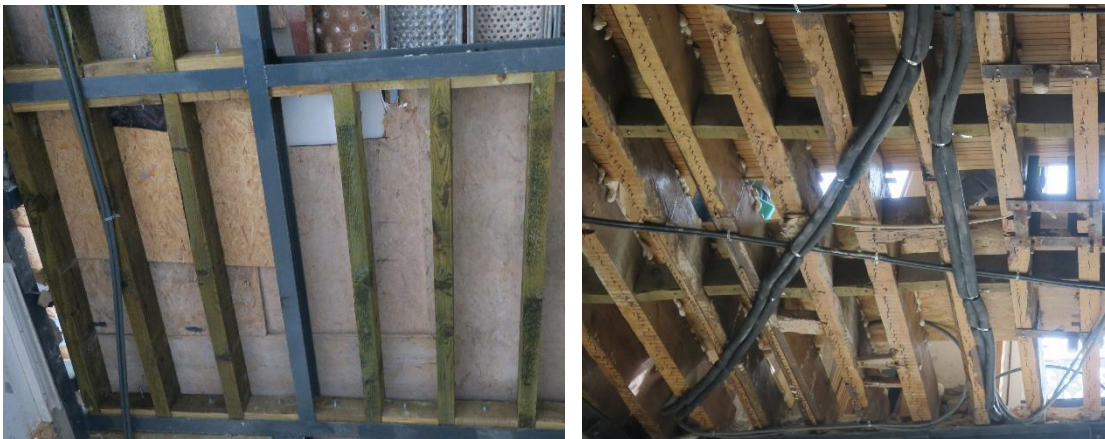
In Faria’s Palace there was some structural insufficiency in terms of timber elements of the pavements, in particular the absence of doweling, which causes the generalized buckling of the timber beams in the areas of greater span.

*Figure 5.1 - Photography of intervention in timber pavements in Palacete Faria*

A similar solution to the one described in the first case study was used by the engineer.

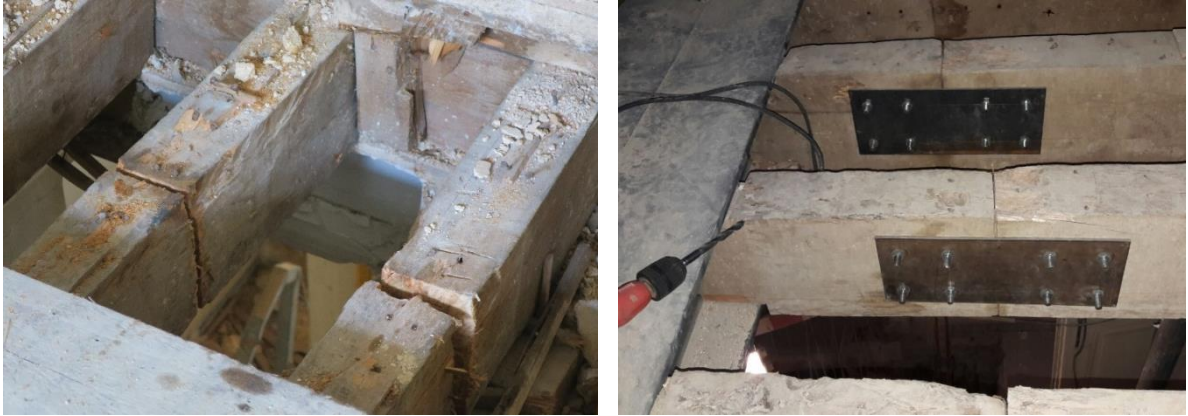
Figure 5.1 - Photography of the intervention adopt

In the first instant it was planned to use two lateral wood pieces bolted to unite the new wood beam and the existing one. However, the space between two parallel beams was not enough. So the second and effective alternative adopt was a top-to-top joint with reinforcement by means of lateral metal plates.
