## **Failures analysis of compressor blades of aeroengines due to service**

This paper presents the analysis of two in service failures involving blades breakage belonging to different compressor stages. Crack growth mechanisms were evaluated based on the visual inspection of the affected components and with both macroscopic and microscopic observations of the fracture surfaces. The origins of crack initiation were evaluated through the examination of crack path and beach marks on the fracture surface.

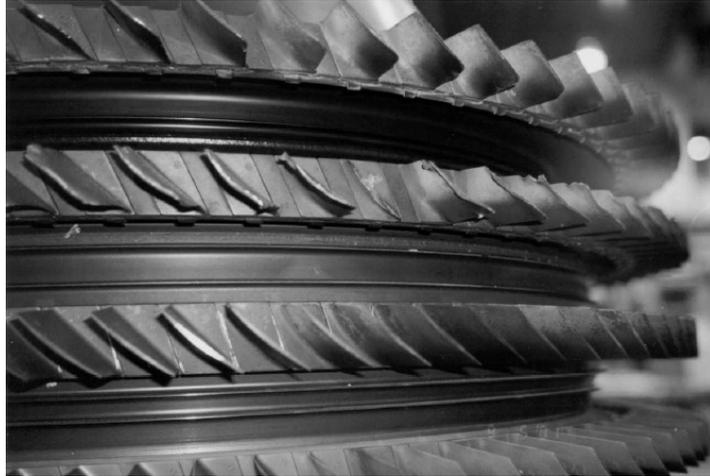
In this case, some blades belonging to the fifth stage of a high pressure compressor have been fractured. The blade geometry and the blade failure location are shown in Fig. 1. The compressor blade breakage took place after 32625 hours (8897 cycles). The objective of this investigation is to undertake a failure analysis in order to determine and describe the factors responsible for the failures of these compressor blades, as well as to show that the proper application of failure analysis techniques can produce a valuable feedback to design and testing procedure improvements.

Figure 1 – Blade geometry and location of failures.

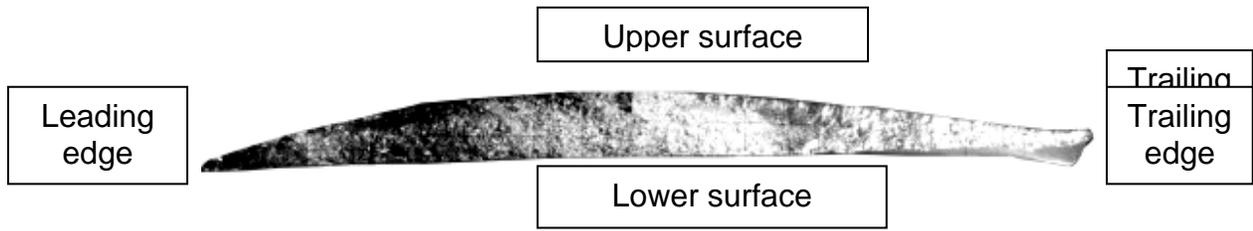
Fig. 2 shows a view of the fracture surface of the compressor blade mentioned in the previous sections. The fracture was developed in the normal plane of the blade axle and the tell-tale beach marks are indicative of clear fatigue mechanisms.

The crack propagated from the leading edge towards the trailing edge and from the lower surface towards the upper surface of the blade airfoil.

The beach marks reveal evidence of high cycle fatigue by blade vibration and dynamic stress as likely contributors to the failure. This indicates that there must have been a vibration condition sufficient to propagate cracking from initial defects formed at the leading edges of the blade.

Figure 2 – Fracture surface of the blade.

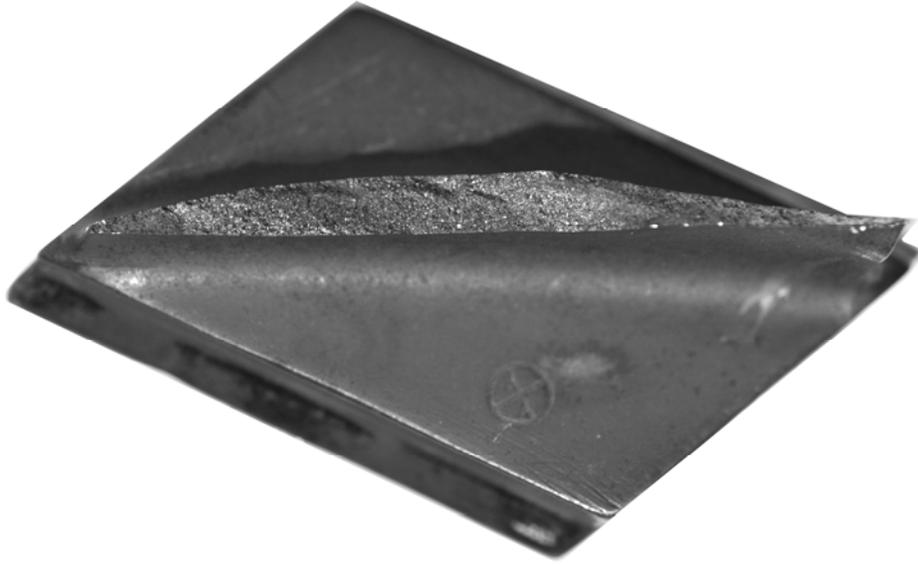
The fracture surface is relatively plane and its area is about  $2/3$  of that of the total blade section (Fig. 3). As already explained, flat fracture surfaces are generally associated with fatigue damage where cycle dependent mechanisms prevail.

Figure 3 – Morphology of fracture surface of the blade.

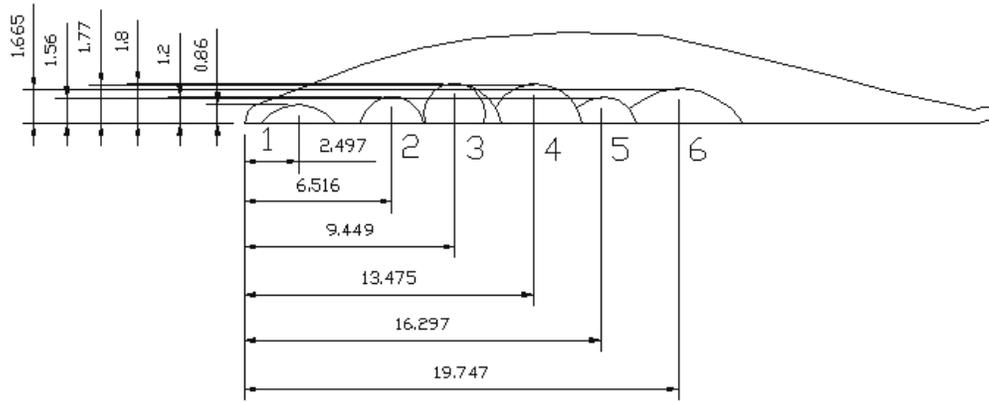
Fig. 5 and 6 show the fracture surface with six initial cracks on the lower surface of the blade, followed by a stable crack growth. The initial cracks propagated in different plans assuming a semi-elliptical shape.

The existence of multiple crack nucleation sites and the absence of any visible superficial nicks or other marks resulting from a possible foreign object impact suggest that fracture is mainly related with material defects.

After the merge of the six initial cracks (crack depth-2 mm, crack length 23 mm) a fast crack propagation resulting from the increase of the stress intensity factor was observed.

Figure 5 – Crack propagation lines observed in the fracture surface of the blade.

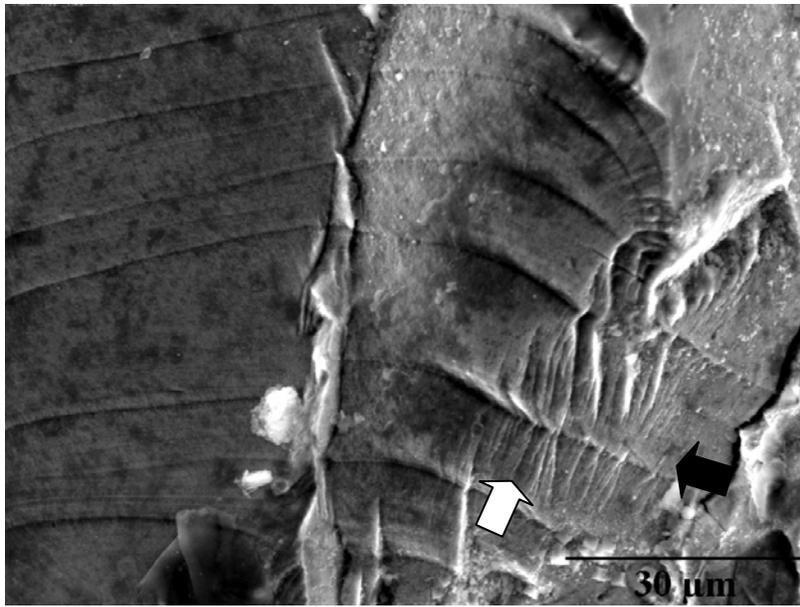
surface of the blade shown in Fig. 8 has clear striation marks which are closely spaced and propagating on flat plateaus joined by shear steps (white arrow).

Figure 8 – High-cycle fatigue striations in the fracture surface of the blade. The striations are closely spaced and propagate on flat plateaus joined by shear steps (white arrows); black arrow indicates direction of crack propagation.

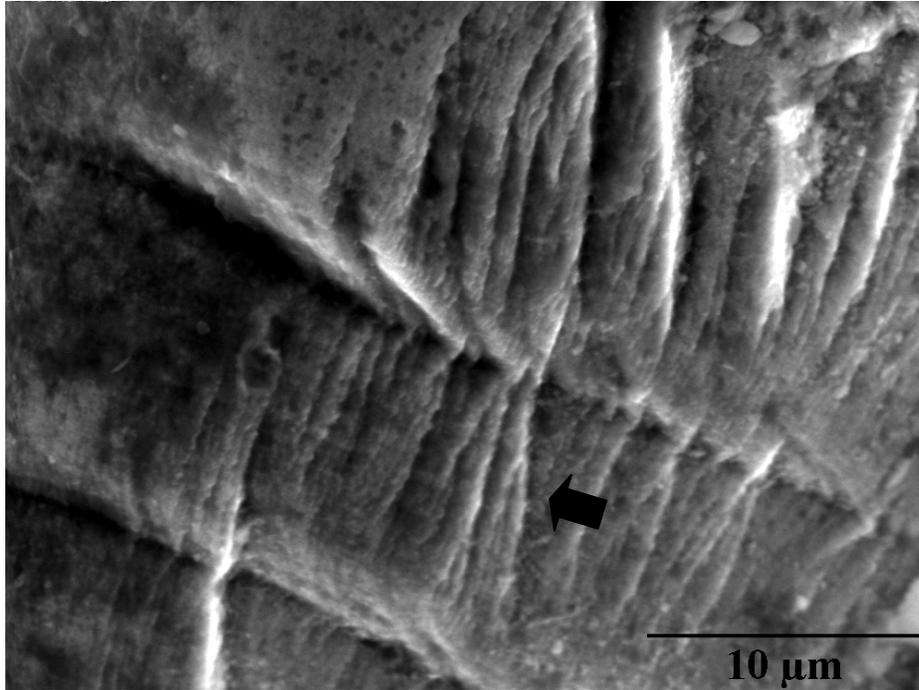
The image of the fracture surface of Fig. 9 was obtained with a higher magnification, allowing detecting fatigue striations indicative of the crack propagation direction, which in this case was found to be from the lower surface to the upper surface of the blade airfoil (black arrow).

Figure 9 – Fatigue striations with higher magnification as obtained in the fracture surface of the blade. The black arrow indicates the direction of crack propagation.

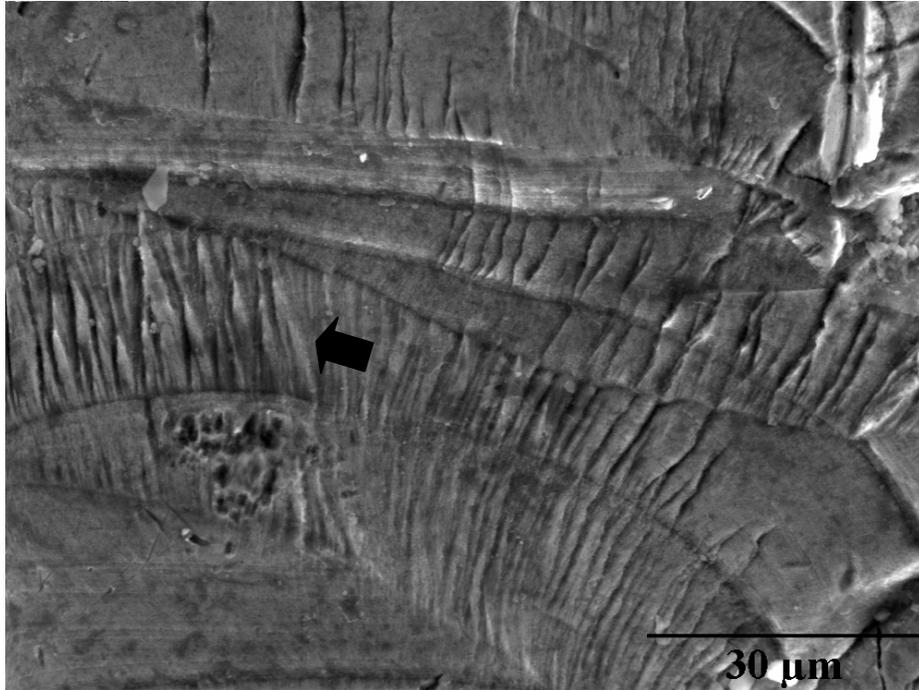
Figure 10 is another image of the fracture surface where a typical transgranular crack path with ductile fatigue striations is clearly visible. Fig. 11 reports to this same region but higher magnification allows detecting secondary cracking.

Figure 10 – The fracture path is transgranular with ductile fatigue striations. The crack propagation direction is indicated by the black arrow.

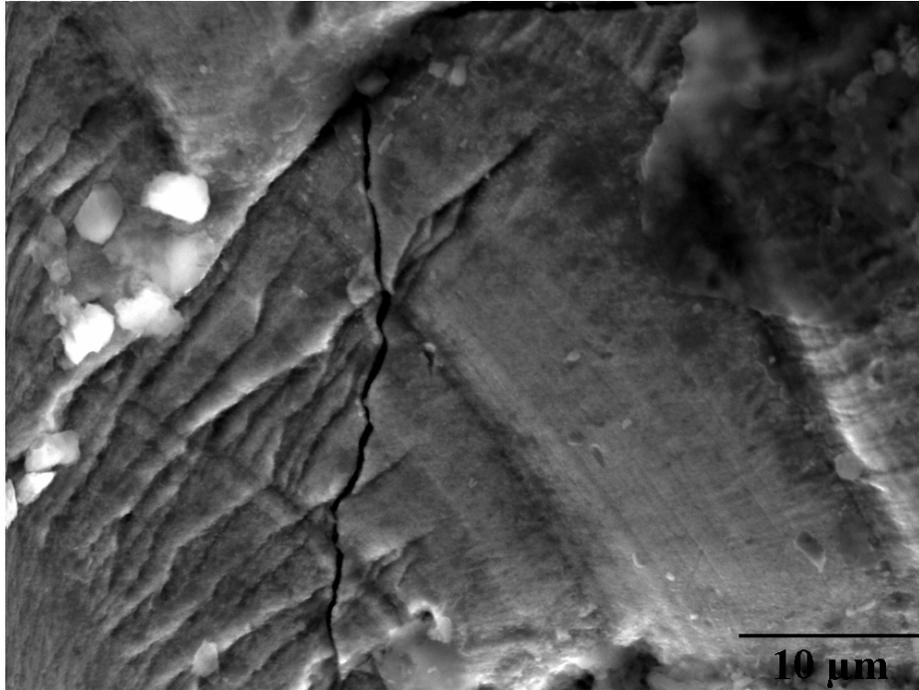
Figure 11 – Same region of interest presented in Fig.10 (but now with higher magnification) showing secondary cracks.

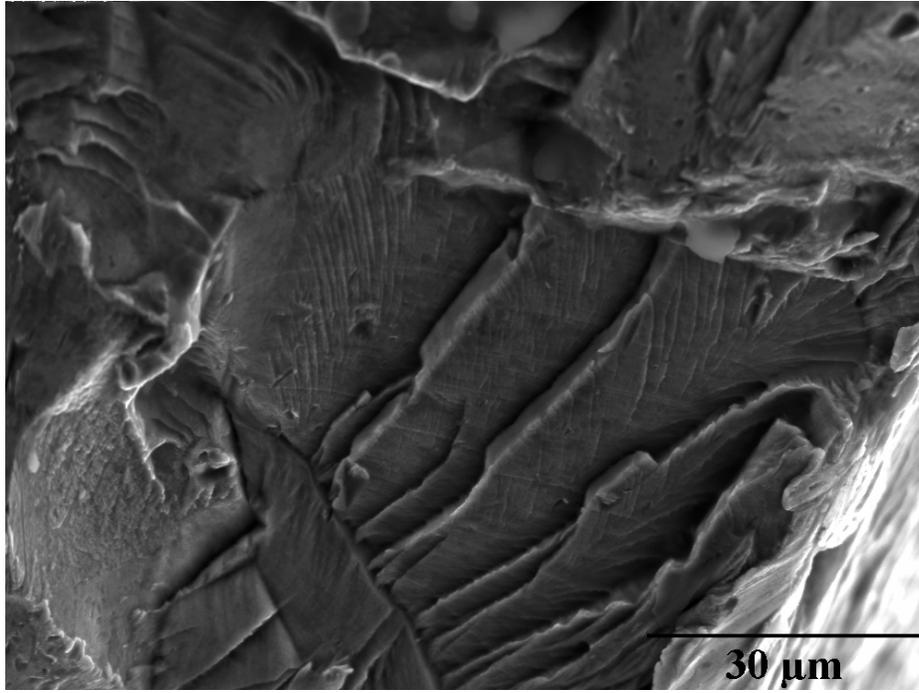
Finally, some evidences of brittle fracture near the final fracture region is observed in Fig. 12, as well as pronounced radial marks indicating the direction of crack propagation.

Figure 12 – Brittle fracture observed near the final fracture zone. The pronounced radial marks indicate the fracture directions.

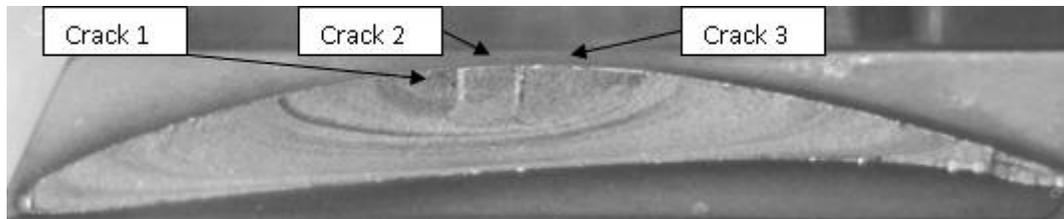
Figure 13 shows the fracture surface of the blade that failed by fatigue.

The fracture developed in a plane normal to the blade axis and it can be observed that the major part of the surface is smooth with several beach marks present on the fracture surface, having a semi-elliptic shape starting from the convex part of the blade. These marks are related with different crack growth phases starting from one or more points corresponding to crack initiation. Only a very small part of the surface is occupied by fast fracture, meaning that the failure was due to fatigue with low stress levels.

Two radial marks are also observed on the fracture surface. These marks correspond to the intersection of different fatigue crack propagation planes that formed one single fracture surface by joining together after a previous slow crack growth phase. Three cracks can be easily identified on the fractured surface merging on the radial direction and forming a final crack which, in turn, led to a faster crack growth rate with a subsequent final failure. This area is shown with major amplification on figure 14.

Figure 13 - Crack propagation lines observed in the fracture surface of the blade.

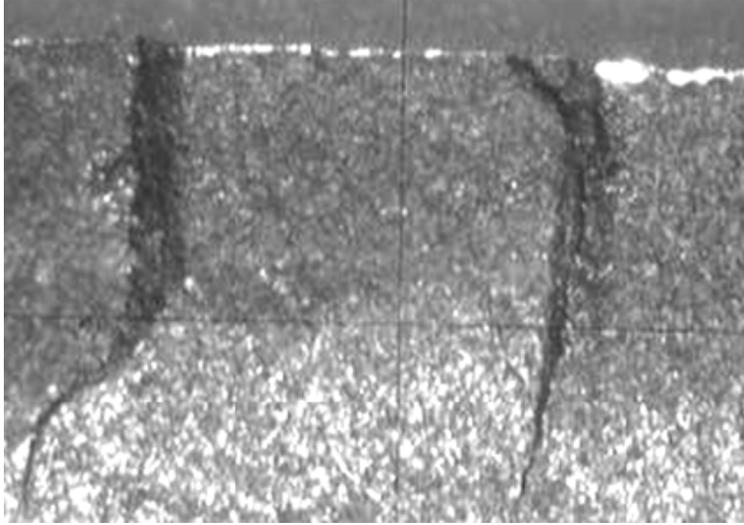
Figure 14 – Identification of the radial marks on the fracture surface.

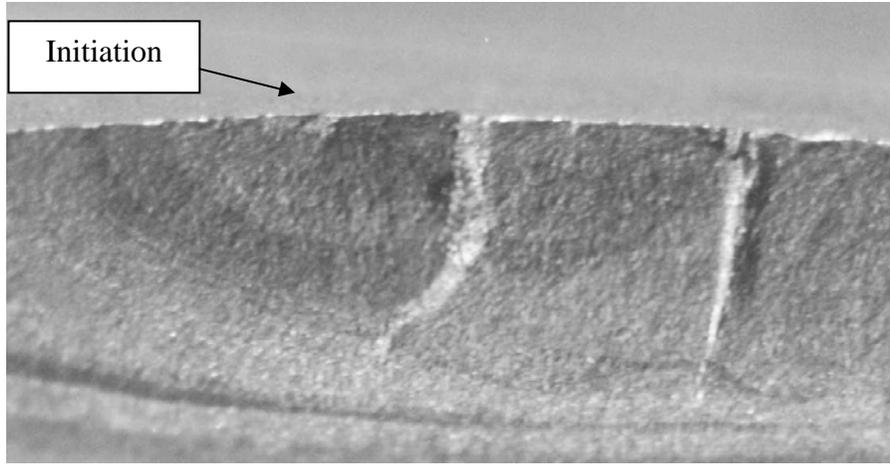
For two of these cracks it was possible to identify the initiation site. An example of the local of crack initiation for crack n°1 of figure 13 is shown on figures 15 and 16, corresponding to a pitting area on the surface of the blade.

It is interesting to refer that it was not possible to identify any beach marks of crack propagation for small dimensions of the crack, typically with a length of 1.8 mm and depth of 0.9 mm in the case of crack n° 1. This fact corresponds to a very slow crack growth and therefore it is not possible to observe different crack growth stages. When the three cracks merge to form the final crack it can be easily observed some beach marks corresponding to different stages of crack propagation during a fast crack growth process. A minimum of 13 and a maximum of 15 beach marks were identified on the surfaces of fracture for this crack propagation phase.

Figure 15 – Identification of crack initiation and beach marks.
