Failure Analysis of the Guide Vanes of the Pico Power Plant Wells Turbine

Mário Vieira

Instituto Superior Técnico, Universidade de Lisboa, Portugal

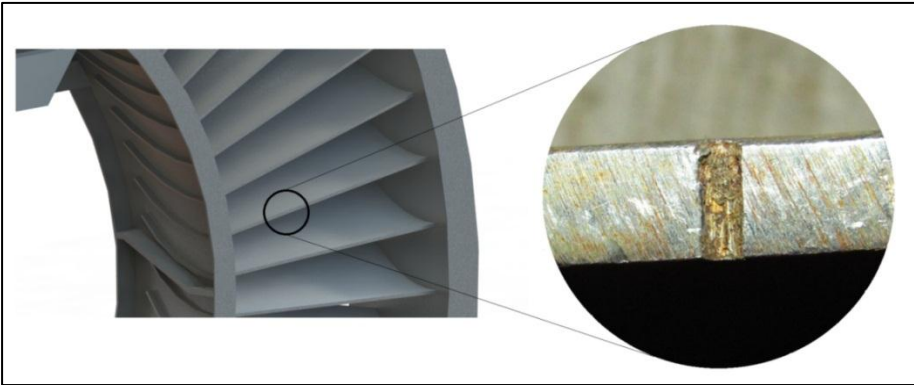
The stators under the scope on this project were not the ones installed with the original turbine, since the latter demonstrated, within the first hours of operation, a low rigidity that led to successive repairs and to its final withdrawal in 2005. A second pair of stators was then projected by Kymaner, which was built in AISI 316L steel, an austenitic stainless steel with superior corrosion capabilities and low carbon content for welding purposes. During the manufacturing of the blades' stator, several notches were created and left in them, supposedly due to the laser input in the laser cutting process, leaving all the blades with either two or four notches (Figure 3). So, even though these reinforced stators were built to resist to the harsh conditions they would be subjected to several cracks appeared in the earth-side stators' blades, with the nucleation of these visible cracks being held at the notch locations. There are, in total, one hundred and ninety notches distributed by the fifty-nine blades and, among these, sixty-six resulted in crack nucleation and consequent propagation.

Figure 3 - Detail of the location and visual inspection of one of the notches.

Although the earth-side stator suffered from crack nucleation and propagation, the sea-side stator has no visible cracks in the blade notches. In fact, near-shore waves have specific features due to seabed influence. One of these features is known as shoaling, where the waves tend, as they approach the

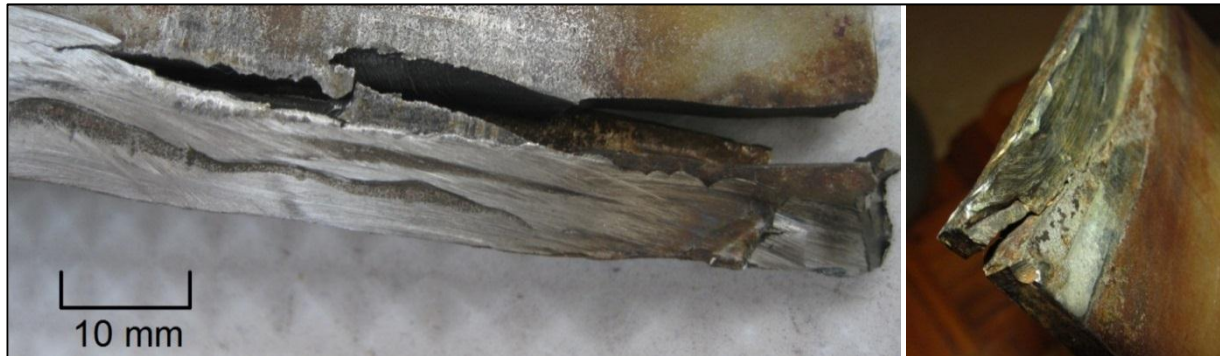
Although some blades developed two and three cracks in different notches, the most severe damaged blades (which have longer than 100 mm cracks) only developed one crack. One of these blades was removed and analyzed in laboratory, amongst others. After the removal of these blades, cracks were found at the embedded zone (Figure 4), which could not be viewed when the blades were installed, which represents then a new problem to the investigation.

Figure 4 – Representation of two of the cracks found at the embedded regions of the removed blades.

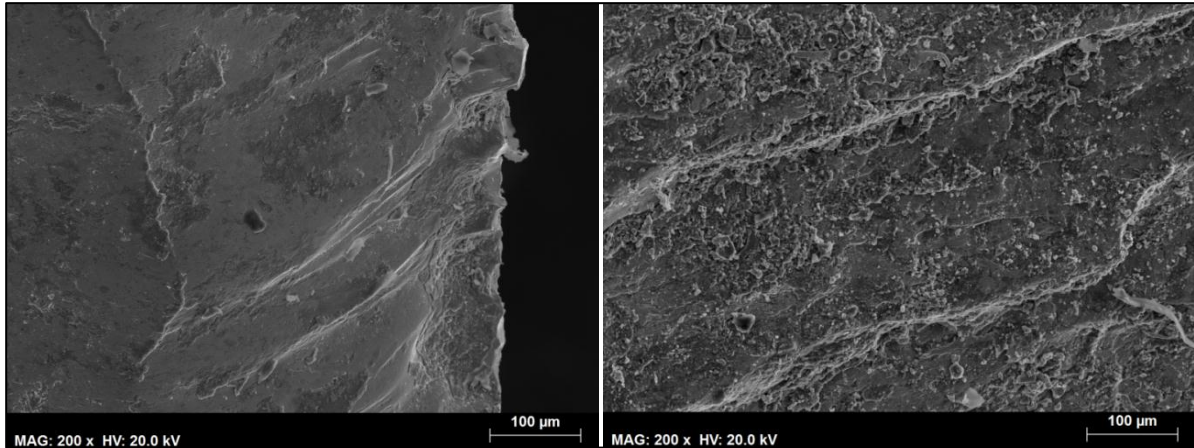
Three fracture surface specimens were analyzed with optical and scanning electron microscope devices, in order to understand the different origins of the developed crack. Several beach marks, which are typical of crack growth during fatigue, are observable.

Figure 5: SEM images obtained from the analysis of the first fracture surface.

At left: Magnified image with ratchet marks which suggest different crack nucleations in the region.

At right: Close view of the beach marks in the surface.

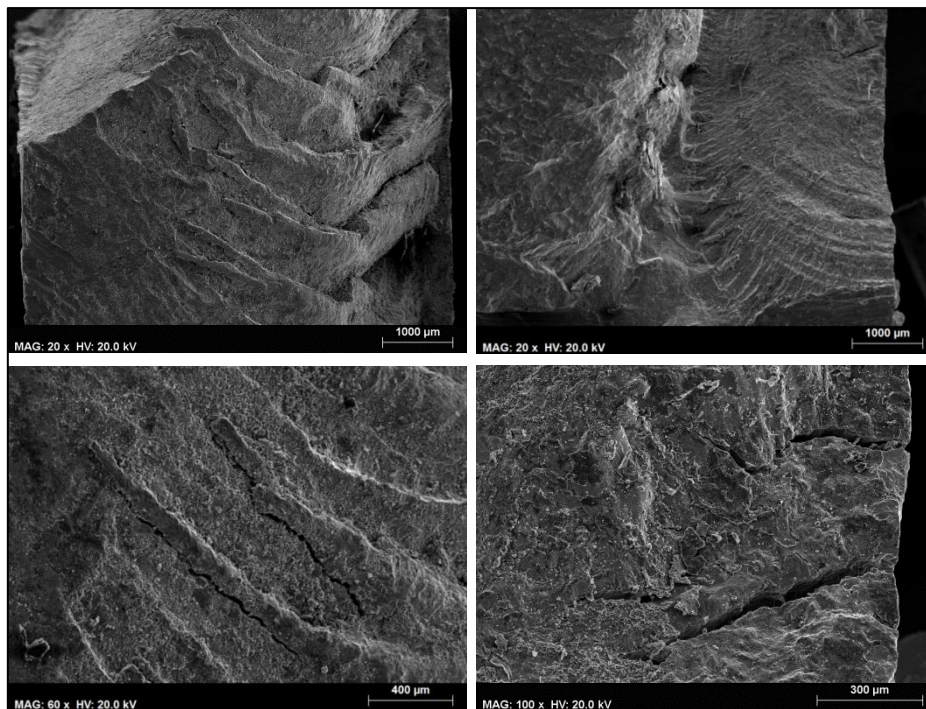
Figure 6: SEM images obtained from the analysis of the second fracture surface.

At top, left: Magnified image with ratchet marks which suggest different crack nucleations and high stresses in the region.

At top, right: Global view of the beach marks in the surface.

At bottom, left: Close view of small cracks in the beginning of the propagation phase.

At bottom, right: Detail of surface cracks initiated near beach marks.

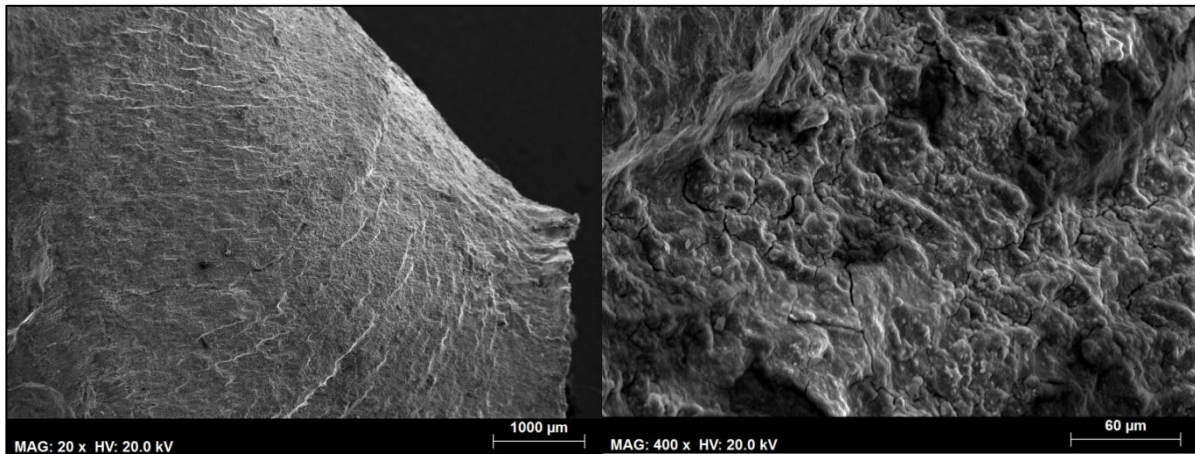
Figure 7: SEM images obtained from the analysis of the third fracture surface.

At left: Global view of the beach marks in the surface.

At right: Magnified image of crevice corrosion-like defect, with multiple cracks in the material surface.

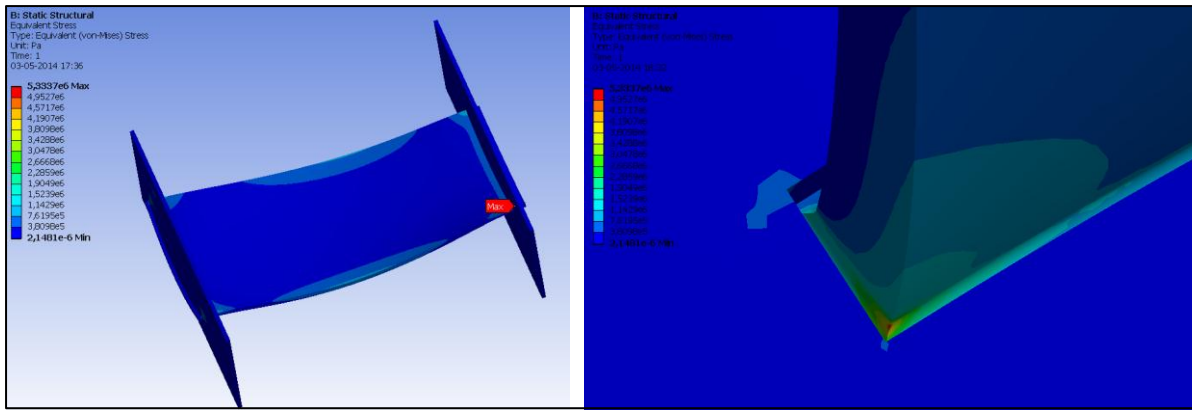
The results indicate a maximum Von Mises stress of 5.3 MPa on the embedded region of the blade (Figure 9 on the right) and 1.54 MPa on the notch.

Figure 9 – Geometric model used on the FEM analyzes (on the left) and detail of the embedded region of the blade (on the right).

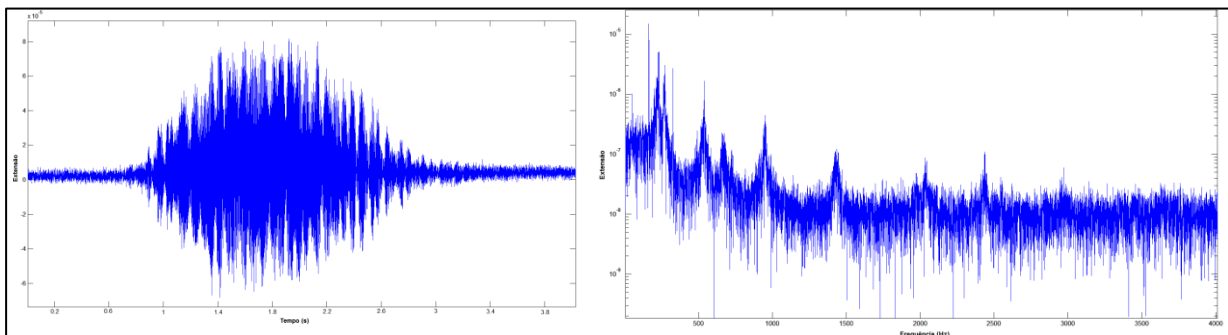
The results indicated that, besides stalling events, the stresses on the blades are very low. On the other hand, the stall induces, in each event, a severe vibration pattern on the time-based acquired data (Figure 10, on the left). Since the used strain gage is a rosette with 3-axis measuring, it is possible to obtain the equivalent stress on the material.

The acquisition frequency rate of the strain gauge signals was of 10 kHz, which permitted, through appliance of a Fast Fourier Transform to the signal, the attainment of the spectrum of this signal, revealing a pattern that suggests that the stalling events can result in the excitation of a frequency range that goes from 0 to 3000 Hz, at least (Figure 10 on the right). It can be seen that the obtained spectrum is quite similar to the structural curve of the blade, obtained in the model testing.

Figure 10 – Characteristic pattern of the effect of stall on the strain response of the blades (on the left), frequency spectrum one of these stall events (on the right)

These stalling phenomena occur in both the earth-side and the sea-side stators. Nevertheless, the maximum equivalent stress registered for the earth-side blade was of 46 MPa, whilst the one for the sea side was of 24 MPa. It can then be noted that the earth-side stator is loaded with higher forces due to shoaling; as a consequence, the earth-side guide vanes are submitted to more stalling events and to stronger ones. This could explain the difference on the damage found in each stator.

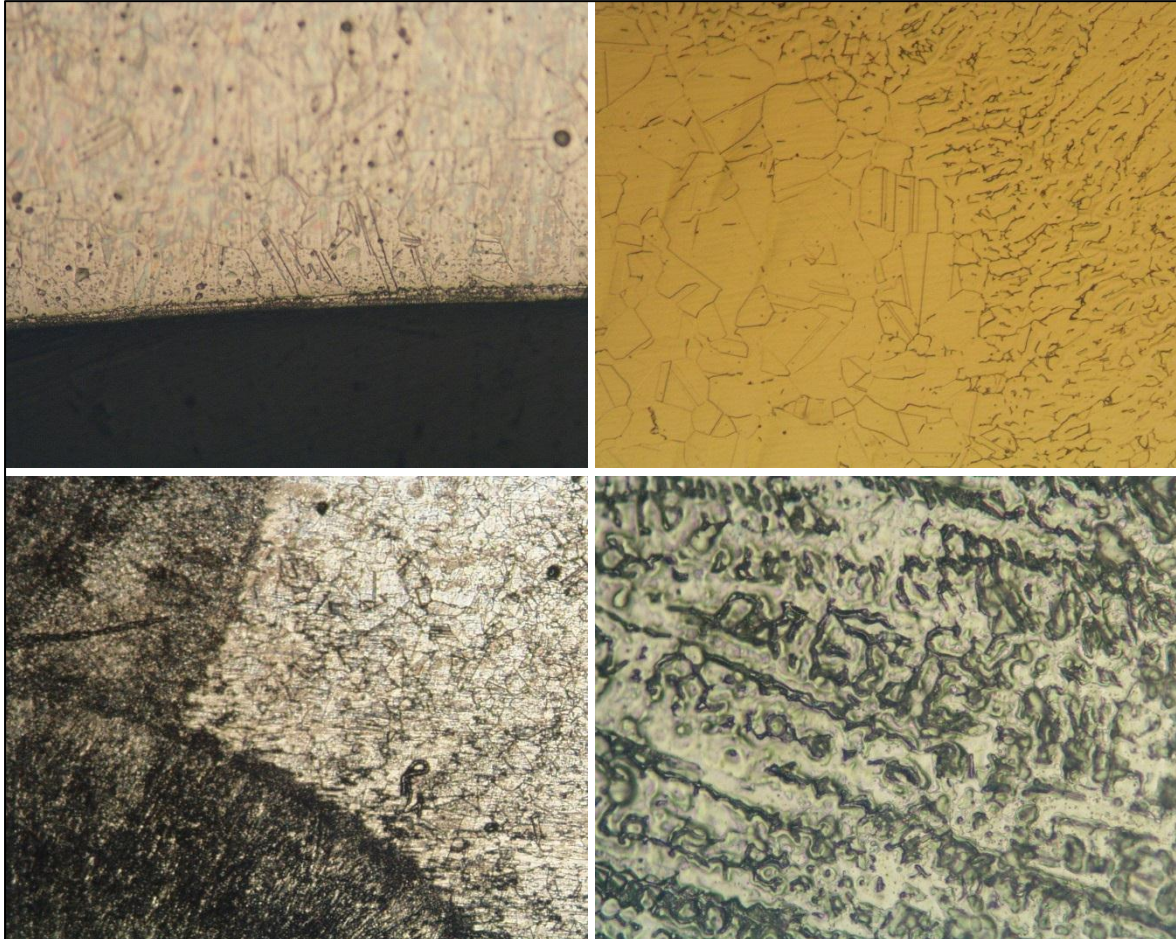
The results of the metallurgical analysis are shown below (Figure 11), where it is notable the kerf layer due to laser cut (Figure 11, top left), the influence of welding on the recrystallization of the material (Figure 11, top right and bottom left) and a detail of the welded region (Figure 11, bottom right):

Figure 11 – At top, left: Kerf layer resulting from laser cut (250x);
At top, right: boundary between base metal and weld metal, low etching attack (250x);
At bottom, left: boundary between base metal and weld metal, high etching attack (100x);
At bottom, right: detail of the welded region (500x).

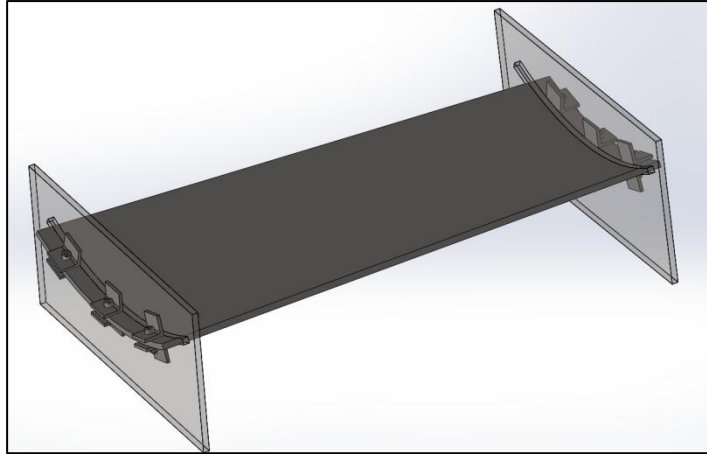
Figure 12 – Design of the mechanically-jointed blade.

One blade was installed following a new design which aims to allow for fast and efficient removal and substitution of blades and, more important, to avoid crack nucleation and propagation on the embedded region. This design, based on mechanical joints (Figure 12), is welding and laser-cut free, avoiding the negative impacts these processes have on the material properties, especially on corrosion and fatigue resistance.

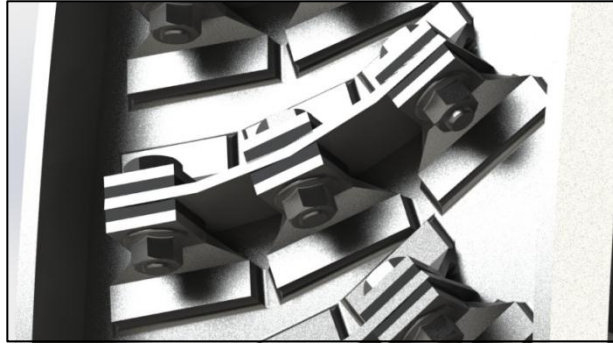
Figure 14 – Detail of the embedded region of the design suggestion for a new stator. Note the intermediate material between the blade and the supports, which can be made from absorbing materials to modify the dynamic response of the blade.

It is important then to design a completely new project, which should follow the suggestion made before; mechanical joints allow for fast removal and replacement of blades, thus despising the need for thermal processes that affect the microstructure of the material (Figure 14). This mechanical joint can, as well, include materials with different rigidities to modify the dynamic response of the blade.
