Characterization and Evaluation of the Conservation Status and Safety of the Monastery of *N^a Senhora do Desterro*

Rita Maria Veloso Queirós de Carvalho

Instituto Superior Técnico, Lisbon, Portugal

October 2015

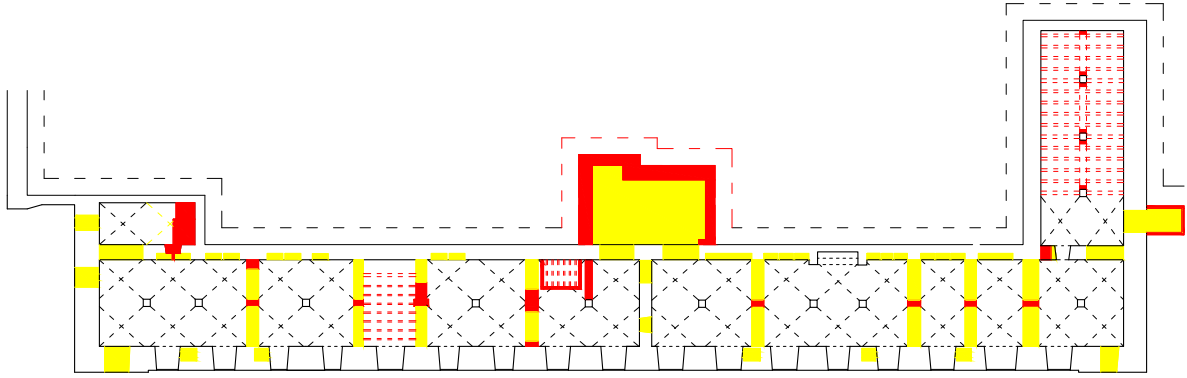
Figure 1 – Plant with the structural changes that occurred on the first floor.

After producing an exhaustive study that has as its main aim to represent the original structure plants of the monastery, the plants presented bellow resulted (Figures 1, 2, 3 and 4). These represent the actual structural characteristics of the different floors of the east wing, all the elements that are presented in yellow are related to structural elements, which were demolished, and the red ones are related to the elements that had been constructed with many different techniques.

Thanks to these studies, it was achieved with more certainty that the reconstruction of the walls along the first floor upgrades the greatest wing behaviour with an improvement around 38% of the actual performance. As for the cases of the second floors, it's better to opt for the reconstruction of the walls across the transverse direction. However, the wing performance improvement is around 6%. Before presenting the final proposal, a model that takes into account the original behaviour of the wing was

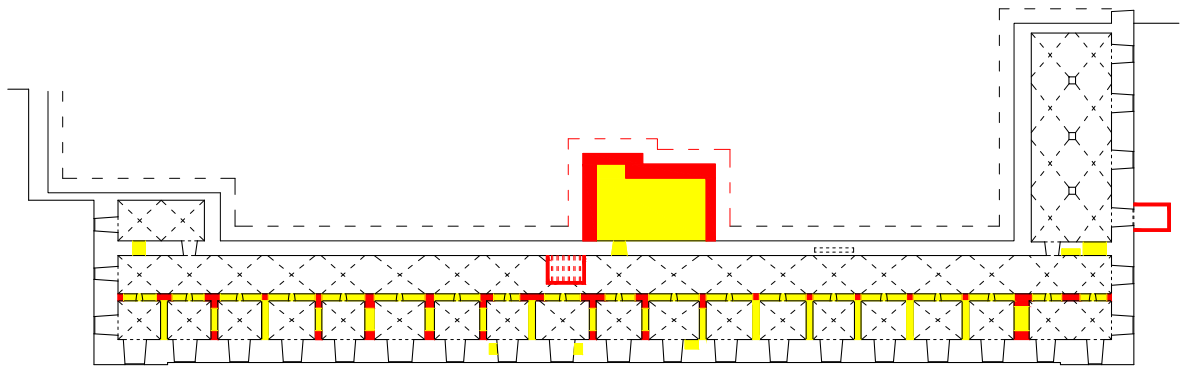
Figure 2 – Plant with the structural changes that occurred on the second floor.

With an goal to improve the actual performance of the wing during an earthquake, and in order to get an intervention plan that respects the history and architecture of the monument, different sensitivity models of study were elaborated. They were meant to realize the impact in case of a demolition of the interior walls, the compartmentalizing elements in the original structure of the first and second floors. For that purpose 3 different models were created, taking advance of the previous general model: the 1st is regarding the reconstruction of the original walls along the first floor, in the transverse direction (as may be seen in the Figure 1, in yellow); the 2nd is regarding the reconstruction of the original walls in the transverse direction along the second floor (yellow elements over the smaller length on the wing plant, Figure 2); and the 3rd modulation is similar to the previous reconstruction over the second floor, but refers to the original wall along the longitudinal direction of the wing (yellow elements in the Figure 2 along the greater wing length).
