LOW COST SUSTAINABLE BUILDING REHABILITATION

SOLUTIONS SEEKING SUPPORT INSTRUMENTS

Extended Abstract

INTEGRATED MASTER IN CIVIL ENGINEERING

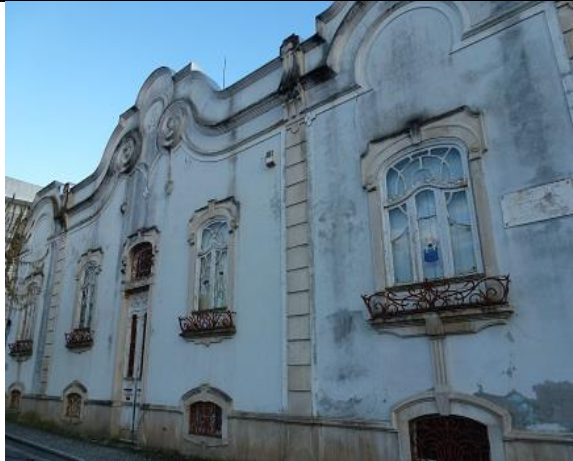
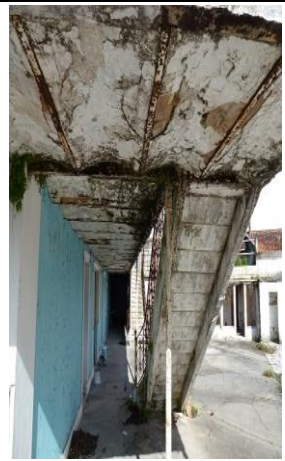
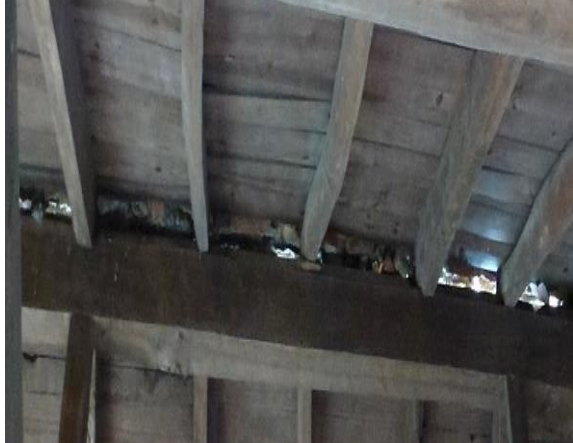
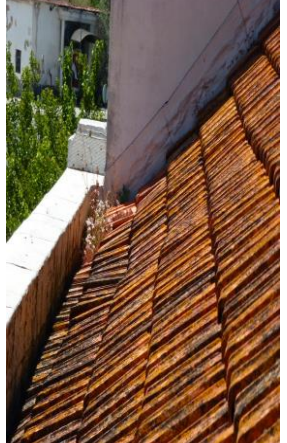
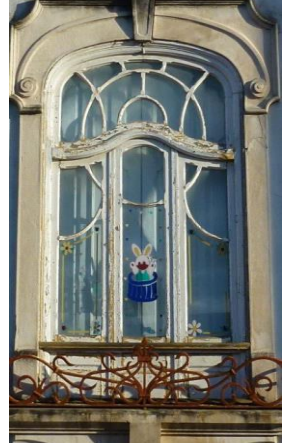
Table 2- Examples of anomalies found

Anomalies: Leaching and debark of liners; cracks; disaggregation; efflorescence and subflorescence; broken and cracked glazes; corrosion; opening joints; wood warping.		Inspection date: 15.3.15
