**Methodology to assess microbiological colonization on
ETICS façades**

Thesis to obtain the Master of Science Degree in
Civil engineering

ETICS, Microbiological growth, Type of stain, Visual assessment, Diagnosis method

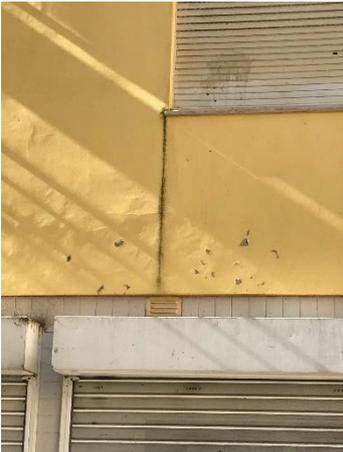
Figure 5.1: Peeling on the back of Lot No. 18

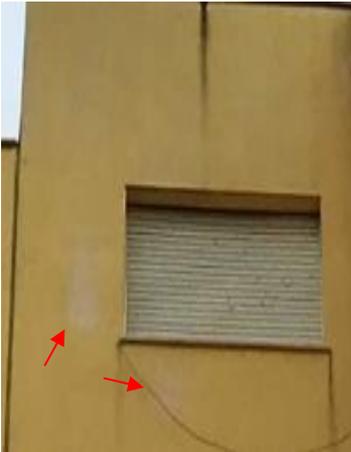
Figure 5.2: White stains (near the window) on the back of Lot No. 1

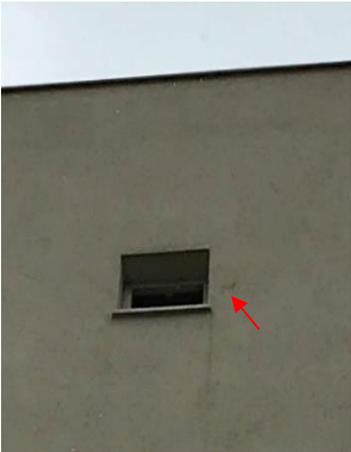
Figure 5.3: Oxidation stain on the right of the window

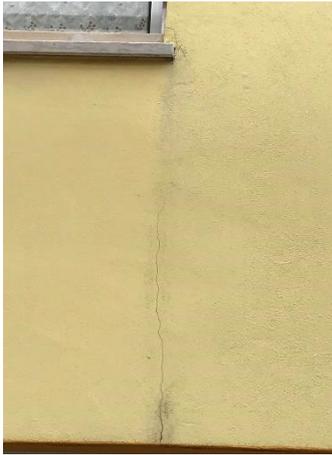
Figure 5.4: Vertical crack on the back of Lot No. 11

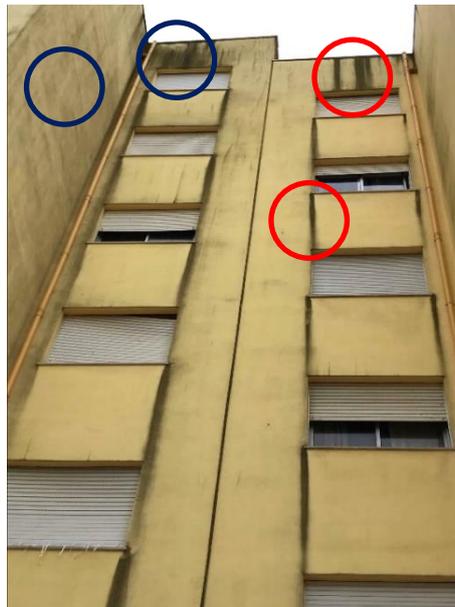
Figure 5.7: Façade (back of Lot No. 24) that is affected by different types of stains

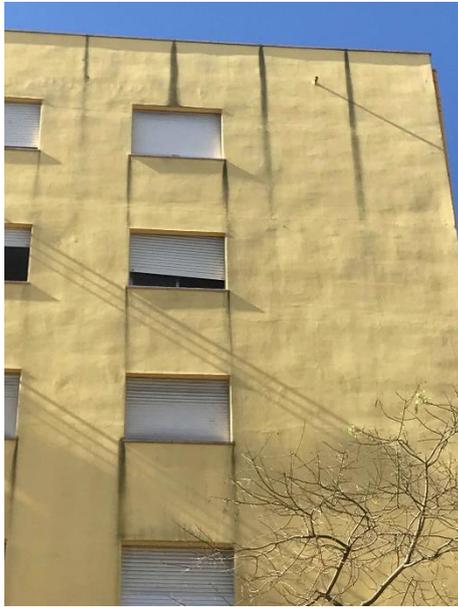
Figure 5.9: Lack of flatness of the surface (Front of Lot No. 19)

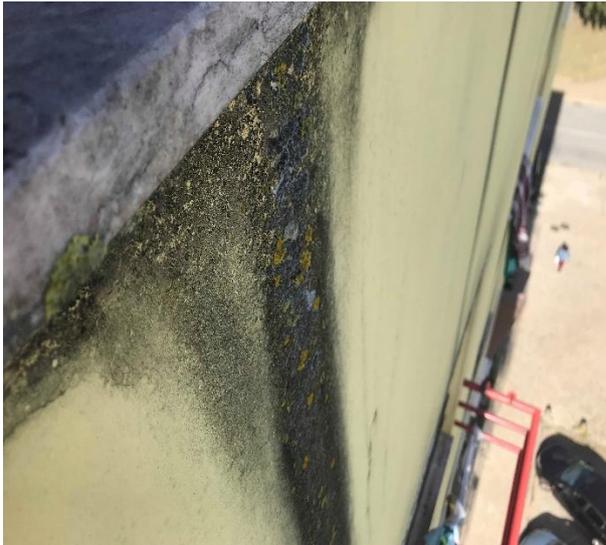
Figure 5.17: Biological colonization on the front of Lot No. 11

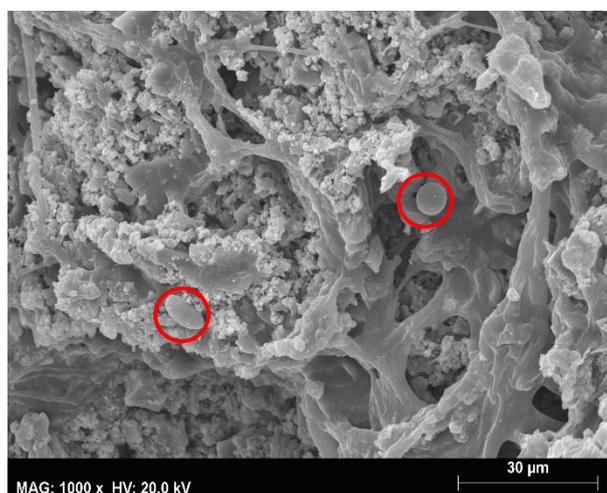
Figure 5.31: Sample 2, magnification 1000x with the circles indicating another type of biological colonization

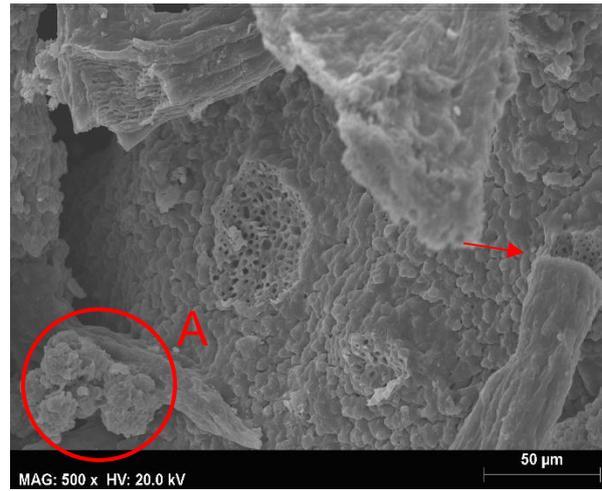
Figure 5.33: Sample 2 (area 2), magnification 500x with the arrow indicating fungi and circle A is another type of biological colonization

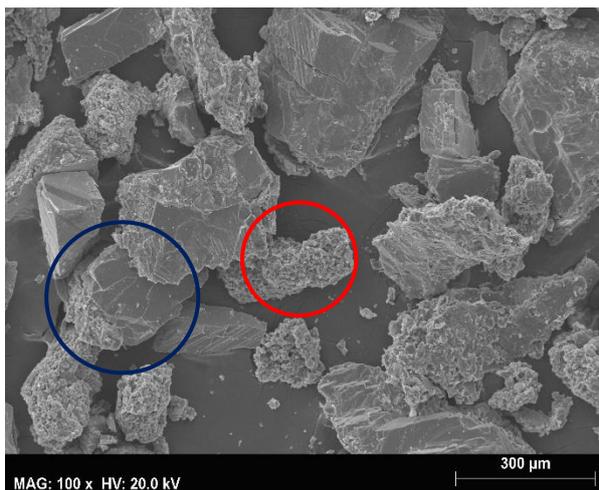
Figure 5.42: Sample 6, magnification 100x
(Some particles can be paint, blue circle)
