INSPECTION AND REHABILITATION OF FIRE-DAMAGED REINFORCED CONCRETE STRUCTURES

ANA SOFIA TORRES BORGES VIEIRA

INSTITUTO SUPERIOR TÉCNICO

OCTOBER 2017

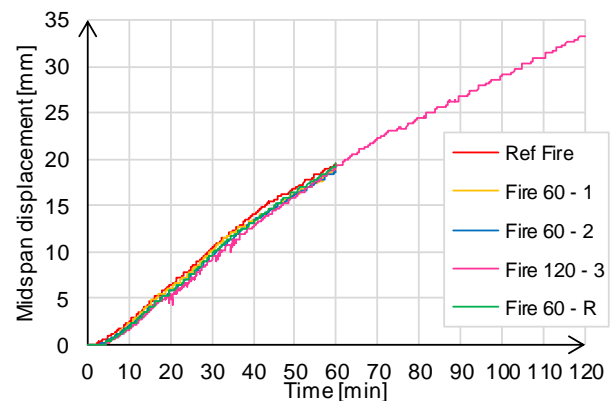
Fig. 7 –Midspan displacement increase vs. time of fire exposure.

The midspan displacement increase (measured in the second phase of the tests) obtained during the fire exposure tests is presented in Fig. 7.

Regarding the mechanical response during the fire exposure tests, it was found that the variation of midspan displacement of all the slabs increased with the time of fire exposure at an approximately constant rate; this expected behaviour was due to the stiffness (and strength) decrease of the constituent materials. At the end of the tests, the midspan displacement increased 19 mm and 33 mm in the slabs exposed to fire for 60 and 120 min, respectively.

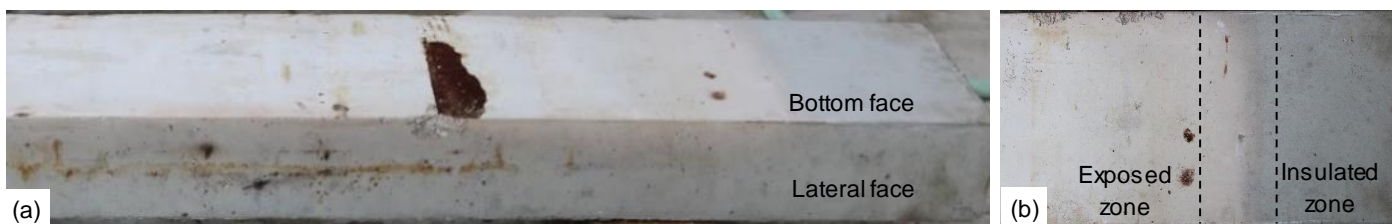
Fig. 8 – Appearance of slab *Fire 60 – 1* after exposure to fire: (a) Overview of the bottom and lateral surfaces of the slab; (b) Intermediate zone of the bottom surface of the slab, between the exposed zone and the unexposed zone.

After exposure to fire for 60 minutes, the bottom surface of slab *Fire 60 – 1* presented a whitish grey colour with some shades in yellowish brown in the central zone (cf. Fig. 8); this coloration is in accordance with the literature and the temperatures measured. In Fig. 8 (b) it is possible to notice that the whitish grey colour in the central zone changed to a pink tone in the transition zone, and finally to grey (original concrete colour); the pink coloration corresponds to temperatures between 300 and 600 °C, which is in accordance with the lower temperature reached in that zone. There was also a colour change in the lateral face of the slabs, being more distinctive in the central zone; thus, as presented in Fig. 8 (a), in the zone between the lower face and up to about half-height, there is a pink tonality, and for higher depths the concrete presents its original colour. The slabs exposed to fire for 60 minutes showed surface cracking at the bottom face, with greater expression in the zone directly exposed to fire.

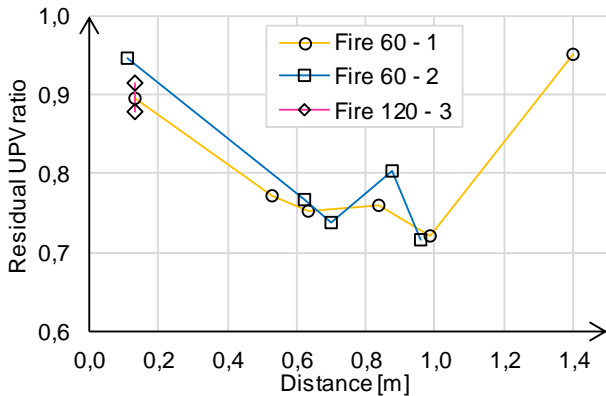
Fig. 11 – Residual UPV ratio vs. longitudinal distance.

Fig. 11 presents the residual UPV ratio (relative to the reference UPV, measured in the reference concrete core at ambient temperature) vs. the longitudinal distance (relative to one end of the slab), for each of the slabs. The points marked in this figure correspond to the measurement of the UPV in the total height of the concrete cores; it should be noted that only two “complete/intact” cores of slab *Fire 120 – 3* were extracted (located in the unexposed zone), due to the very extensive damage of concrete induced in the central zone of that particular slab.

The cores from the unexposed zones (thermally insulated) showed reductions of the UPV ratio up to 12% (considering the average of the entire depth of the concrete core); these results confirm that the concrete located in the zones not exposed directly to the fire were only slightly affected; this is in agreement with the (relatively low) temperatures measured in those zones. On the other hand, as expected, it was found that the relative UPV values in the zone directly exposed to fire were lower than those obtained from the thermally insulated zones (despite some scatter). Thus, the concrete cores extracted from the central zone of the slabs presented a reduction of the UPV ratio between 20% and 28% (again, considering the average of the entire depth of the concrete core), which confirms, as expected, the higher damage introduced to the concrete that was directly exposed to fire.

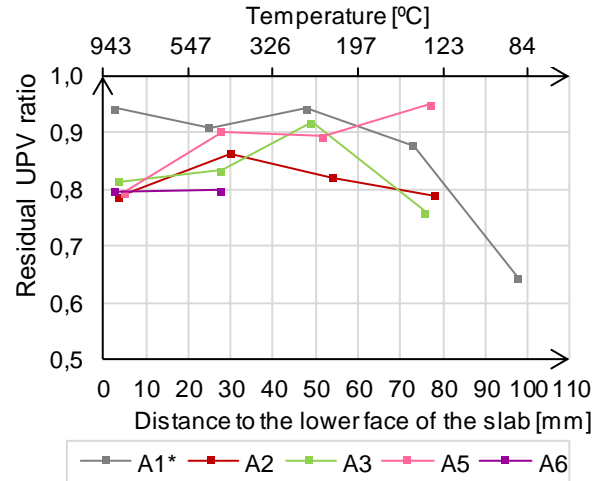
Fig. 12 – Residual UPV ratio vs. distance to the bottom face of the slab *Fire 60 - 2*.

The results obtained from the UPV (relative) measured in the remaining length of cores (after successively slicing discs from the original cores), along the slab thickness, are presented in Fig. 12 and Fig. 13 for specimens removed from slabs *Fire 60 – 2* and *Fire 120 – 3*, respectively. In these figures the maximum temperatures (obtained from a numerical model [18]) expected at each depth (in the midspan section) are also presented. With the exception of the curves labelled as A1, F1, E1, all curves presented in these figures were obtained from concrete cores extracted from the central zone of the slabs (directly exposed to fire).

Fig. 12 suggests that, in general, there is no clear relationship between the UPV ratio and the distance to the lower face of the slab. Nevertheless, in cores extracted from the central zone of the slab and measured in their total length (distances near 0 mm) there was a reduction of 20% in the UPV (compared to the reference value). For higher distance values and, consequently, lower temperatures, there was a

decrease of the UPV ratio in samples A2 and A3, which was not expected, since the degree of concrete damage should decrease with depth; however, the sample A5 presented a relative increase of the UPV ratio with the increase of the distance to the bottom face of the slab, suggesting a more compact and resistant concrete, as expected. The sample A1 (taken from the extremity) presented higher values of UPV ratio than the cores of the central zone, as expected; however, the UPV ratio of this sample showed reductions along the slab thickness, which is not logical.

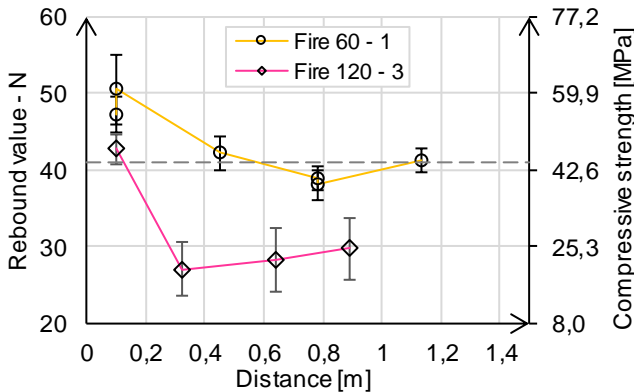
Fig. 14 – Rebound number and the corresponding compressive strength of concrete vs. longitudinal distance.

Fig. 14 presents the rebound number (N) with the corresponding standard deviation, obtained from measurements made on the lower surfaces of the slabs, and the estimated values of the concrete compressive strength, as a function of the longitudinal distance where the tests were carried out.

As expected, the slab *Fire 120 - 3* presented lower rebound number values than those measured on the slab exposed to fire for 60 minutes, since the damage introduced in the first slab was higher. The standard deviation values associated to the measurements in the slab *Fire 120 - 3* were considerably higher than those obtained in the slab *Fire 60 - 1*, which can be justified by the fact that measurements of the rebound number in the central zone of the slab *Fire 120 - 3* were carried out on an irregular surface (in which concrete cover disintegration occurred). Despite the variability of the rebound numbers, from the results presented in Fig. 14 it was possible to conclude that this inspection technique allowed to assess the reduction of the compressive strength of the concrete cover due to fire action, which, as expected, was higher in the slab exposed to fire for 120 min.

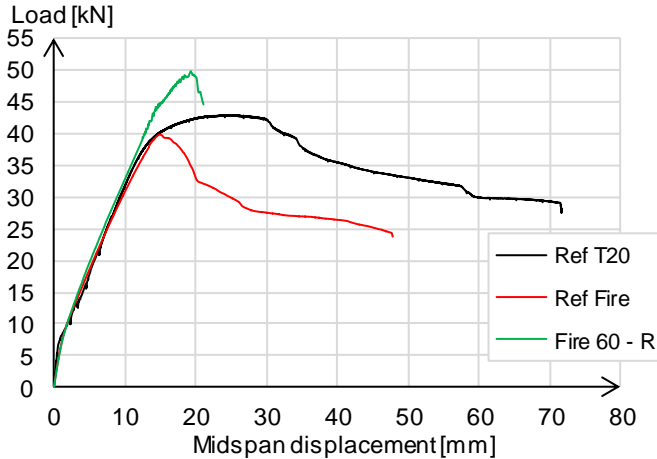
Fig. 19 – Load-midspan displacement curves, flexural tests.

The load vs. midspan displacement curves of the three slabs tested are presented in Fig. 19. It is worth mentioning that it was not possible to obtain results from the flexural test performed on the reference slab, due to a problem in the instrumentation; thus, the curve of slab *Ref T20* presented was obtained from a flexural test at room temperature carried out in another thesis (Santos [18]), on a similar slab.

Up to a load of 7 kN, slab *Ref T20* presented the highest stiffness corresponding to the elastic phase, until the beginning of cracking. As the load increased, there was a gradual stiffness decrease due to cracking; for loads above 32 kN a significant decrease in stiffness (and force) was observed, associated with a high deformation, corresponding to the yielding of the (tension) steel reinforcement. In a first phase, up to a load of 8 kN, the slab *Ref Fire* showed a stiffness slightly lower than that observed in slab *Ref T20*, as the slab was already cracked due to the thermal and mechanical actions. For higher loads, slab *Ref Fire* presented approximately constant stiffness up to the peak load, although the slope of the F-d gradually decreased when the peak load was approaching. However, there were no significant reductions in strength at failure and stiffness (reductions of about 7% and 8%, respectively), although the displacement associated to the peak load decreased significantly (-41%). The relatively small reductions in strength and stiffness are due to the fact that the mechanical properties of the steel reinforcement were not affected by fire (as concluded in section 3.2.5); moreover, the compressive strength of concrete on the slabs' upper face was not significantly reduced, which also contributed to a good flexural behaviour of this slab. Regarding the slab *Fire 60 - R*, it was found that the repair/strengthening with CFRP NSM strips was responsible for the increase of load carrying capacity by 16%, although the stiffness remained practically unchanged (increased 1%). In a first phase, up to 8 kN, the F-d curve presented a similar slope to that of slab *Ref Fire*; after which the stiffness decreased due to concrete cracking; for load values higher than 44 kN, a significant reduction of stiffness was observed until failure occurred.

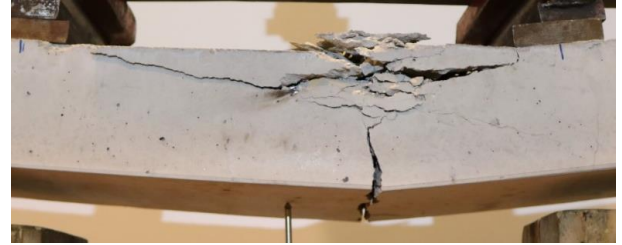
Fig. 20 – Failure mode of slab *Ref Fire*.

The slabs *Ref T20* and *Ref Fire* (cf. Fig. 20) failed due to concrete crushing in the compression zone, with yielding of steel rebars, as it was expected. The slab *Fire 60 - R* failed due to shear failure, with a good bond between the CFRP strips, the epoxy adhesive and the surrounding concrete being observed, thus highlighting the effectiveness of the flexural strengthening technique (cf. Fig. 21).
