**Analysis of Road Accidents in a Small Size Municipality:
The case of Ponte de Sor**

Nicole Marie Calção

Instituto Superior Técnico, Departamento de Engenharia Civil, Lisbon, Portugal

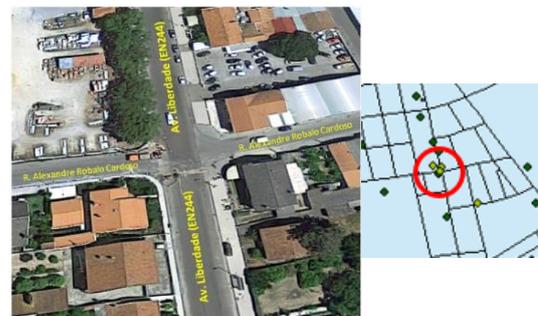
The traffic of the main road runs on the section of the EN244 that crosses the Municipality, called Avenida da Liberdade and the traffic that crosses it, runs on Rua Alexandre Robalo Cardoso (Figure 8). The geometry and amount of traffic that flows in each road are considerably different.

Fig. 8: Zone 1 corresponds to the intersection between Avenida da Liberdade and R. Alexandre Robalo Cardoso. Indication of the accidents using ArcGis

This spot is characterized as a two-way priority intersection, where the traffic that circulates in the secondary road is subject to a loss of priority, benefiting crossing movements along the priority route which are not subject to any delay.

The accidents that occurred in this place agree with the expected ones for an intersection of this kind, that is, front-side or lateral-lateral collisions, and the damages caused by crashes like those are strongly related to the angle of convergence and the speed at which the vehicles involved were circulating at the time of the event.

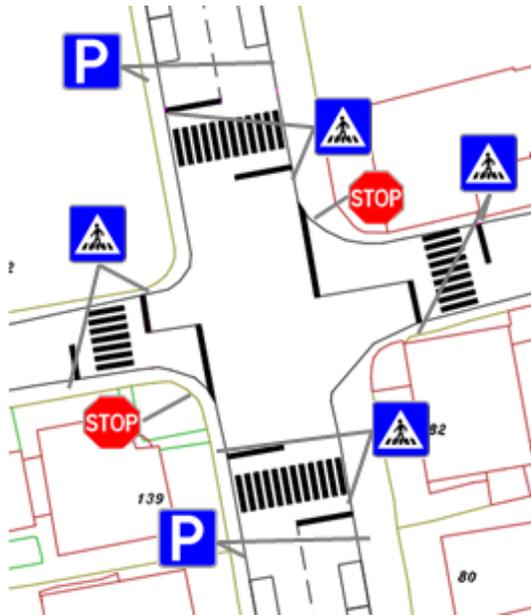
Another measure to consider was the demarcation of parking in the lane on both sides on Avenida da Liberdade as shown in Figure 9.

Fig.9: Example of some corrective measures proposed, in this case, for the intersection between Avenida Liberdade and R. Alexandre Robalo Cardoso

Proposals to intervene in this area should aim to discourage the practice of speeds that are higher than allowed for urban areas, in particular, in the prioritized movements, because the fact that those vehicles are circulating at a much higher speed than permitted by law it results in a reduction of the intersection's capacity, because it makes it more difficult for the non-priority vehicles to converge or cross over in the intersection.

In this sense, speed regulation measures should be implemented, and it was considered as a more

appropriate solution to implement 4 zebra crossings, because these will coerce drivers be more aware and moderate the speed at which they circulate.
