# **Extended Abstract: Excavation and retaining walls in urban centers**

## **Case study – Hotel at Andrade Corvo street and Sousa Martins street, Lisbon**

João Pedro Esteves Leal

Department of Civil Engineering, Instituto Superior Técnico, Universidade de Lisboa, Portugal  
joao.leal94@gmail.com

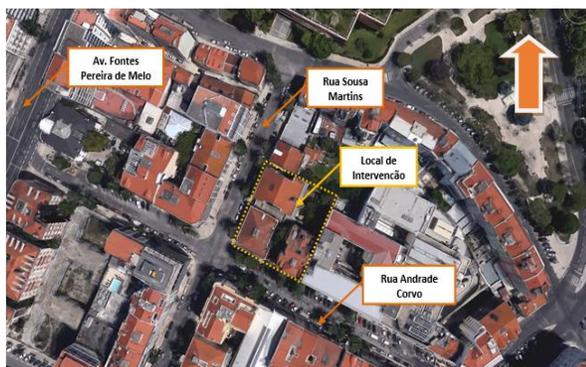
FIGURE 1 – CASE STUDY LOCATION

This thesis´ case study is located at the intersection between streets Andrade Corvo and Sousa Martins, in Lisbon. It is surrounded by two buildings, in the North and in the East, as shown in Figure 1 and in the scheme presented in Figure 2.

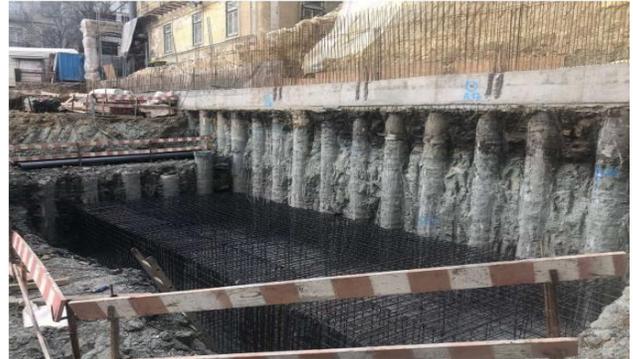
FIGURE 5 - FOOTING'S REINFORCEMENT

On the North side, the elements used to support the wall were different in the two halves. In the first half, temporary ground anchors and corner steel profiles shoring were used. In the second half, characterized by the presence of the patio at the level -1, it was built a concrete wall to support the earth pressures. To support this wall, five concrete buttresses with 12,80 meters of height were built. These buttresses were founded over a big footing, with an "L" shape, and with 2,10 meters of thickness.

In Figure 5 is shown a part of the reinforcement for this footing.

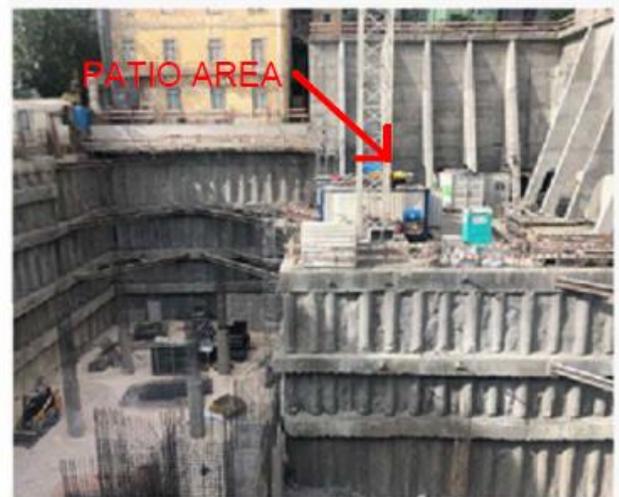
FIGURE 6 - PATIO AREA

On the East side, the support was similar to the one in the North Side. In its first half, there was the concrete wall with 12,80 meters of height, and the five buttresses supporting it, in the patio area. In the second half, only shoring at the corners was used. In Figure 6 is shown the patio zone.
