Abstract

Keywords: slope stability, limit equilibrium, finite element, stabilizing solutions, numeric modeling

2. CASE STUDY

This case study is related to the stability analysis of the slope where the Miradouro de São Pedro de Alcântara (Figure 2.1) sits, near Bairro Alto, Lisboa. This site is one of the most emblematic viewpoints in Lisbon, from which can be seen part of the downtown area of Lisbon.

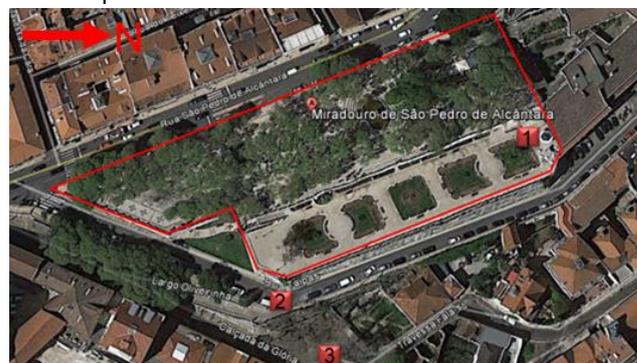
Figure 1 - Case study plant view

Basically, Miradouro's belonging area is shaped on two levels (platforms), both sustained by masonry retaining walls with relative high thickness (about 3 to 5m).

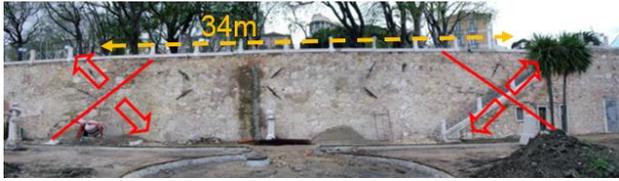
Figure 2 - Cracks in upper retaining wall (R_{sup})

Although, the beautiful view of the city contrasts with the anomalies that have been detected over the last years. Since 2006, several pathologies, like settlements (Figure 3), were reported on the Miradouro's platforms. At the same time, some cracks were identified on its retaining walls

(Figure 2 and Figure 3), which seems to indicate a scenario of global instability of the slope, that includes the Miradouro's implementation area.

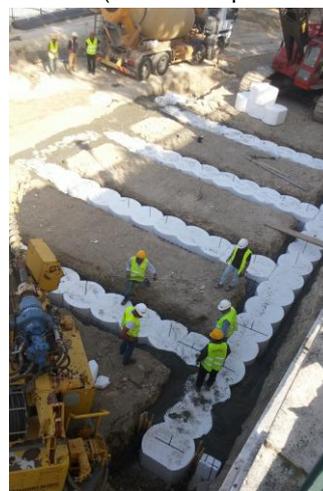
Figure 27 - Stabilization solution: Pile grid location in lower platform

The construction work's related to this solution can be seen in the follow photos, Figure 27 and Figure 28, where is possible to identify the pile grid placed in the lower platform, in accordance with the previews considerations, as so as the further pile's execution (excavation process in Figure 29).
