Structural Health Monitoring of concrete bridges

Case Study: The São João das Areias bridge

Maria Francisca Beirão do Carmo Abreu

Instituto Superior Técnico

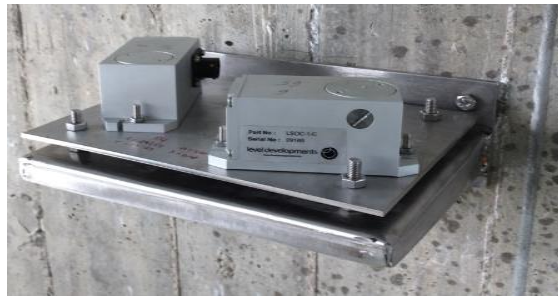
Figure 3: inclinometers of th type LSOC-1-C

Both longitudinal and transversal rotations are measured through electrical inclinometers using the type LSOC-1-C present on Figure 3. All the six pillars were monitored with two of those equipment, one that is responsible for measure longitudinal rotations and the other for transversal rotations.

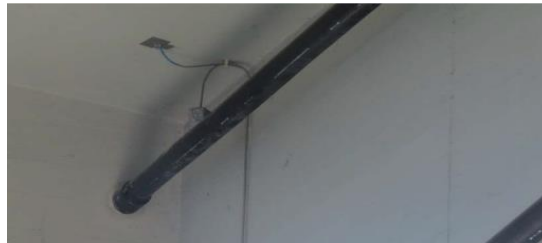
Figure 5: PT100 sensor temperature type

Temperature effects have a huge influence on the structure behaviour, it is not only responsible for structural changes but also affects the sensor equipment installed. The temperature sensors used was those of the type PT100 presented on Figure 5.

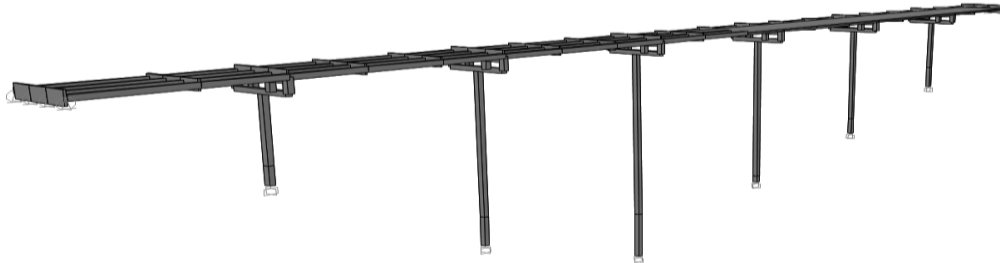
Figure 10: São João das Areias bridge numerical model

Based on the bridge configuration, in the three-dimension model of São João das Areias bridge were used several elements to model the different structural elements. The beams were individually modelled using a frame element with a T section and considering their development

in the longitudinal direction of the bridge. A shell element with the thickness of 0,205m was used to represent the span slab. To represent the pillars, as they have the same section in all their development, a frame element was used. Their foundations were represented as an inlay while the abutments were considered as longitudinal free and transversal fixed supports. The all model can be seen at Figure 10.

As mentioned before, the model calibration was done recovering to the results achieved during a year of observation. The Table 1 refers to the numerical values obtained in the model after attention calibration and to the comparison to the real ones.

The model results present in the table above were corrected by a transformation factor (1,25 in the longitudinal direction and 1,30 in the transversal direction) to considered the pillars modelling with a frame element instead of considering shells element to model the six different pillars walls. The table 1 also shows that the error between the real values felt by the bridge and the numerical ones are not significant. All the entities have errors with rates around the 10%.

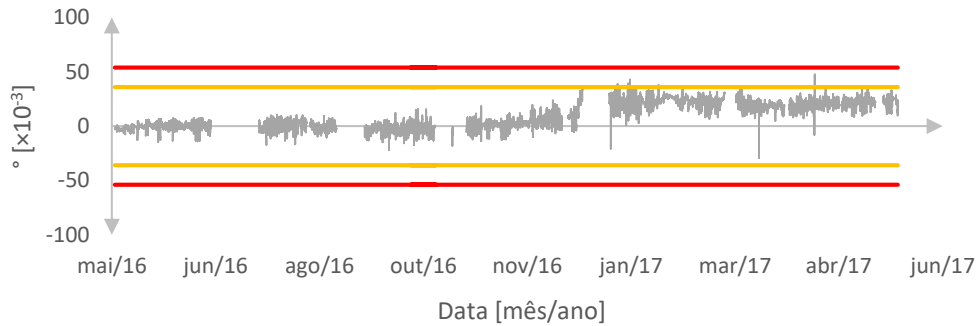
Figure 13: Resíduo indicator of pillar P2 longitudinal rotation

To complete the structural behaviour analysis and to detect possible structural changes, the structural health system included the development of a statistic model able of estimate the structural behaviour evolution through the isolation of environmental effects, in this case the measured temperatures. This model generated a series of estimated values for the entities that most characterize the structure behaviour. The difference between these values and the real ones was considered an indicator named *resíduo* and was carefully evaluated over time, because, fundamentally, it draws attention to any behaviour change and allows for an immediate action. For other hand, it was the essential bases for the implementation of damage limits. Figure 13 shows the *resíduo* indicator for the pillar P2.

The red and yellow lines present on the figure are related to the red and yellow limits. Those limits were created and defined by the design team and means an alarm level which means an abnormal rotation value. When the indicator values reach these levels the monitoring system sends a notification to all involved employers.

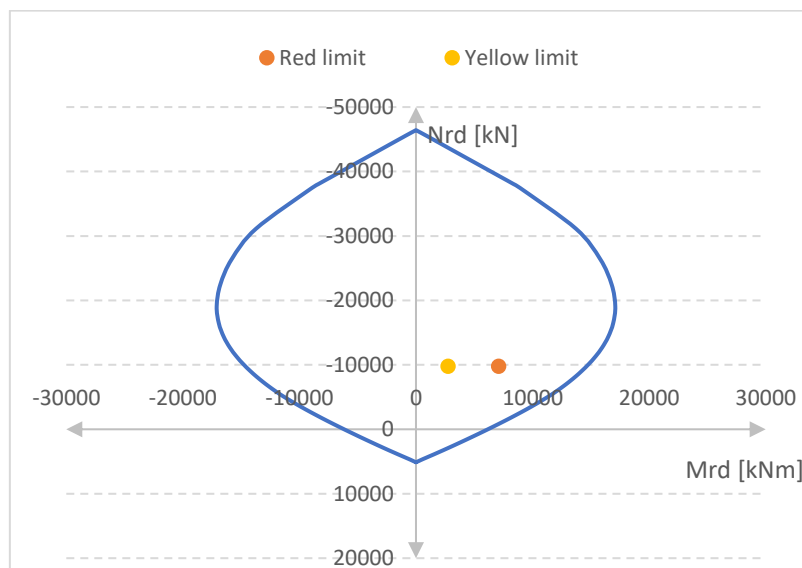
Figure 14: N-M interaction diagram

Finally, the study carries on with an evaluation of the physical meaning of yellow and red limits. So, for the case of pillar P2, the yellow and red limits are reached when the rotation values are $36 \times 10^{-3} \text{ }^\circ$ and $60 \times 10^{-3} \text{ }^\circ$, respectively. Figure 14 represents the N-M interaction diagram for the pillar section and shows the pair of values for the bending moment and the compression level that the pillar was submitted, for both limit cases. The values also can be seen on Table 1.

The chart present on Figure 14 shows that, for the case of pillar P2, when the rotation values reach the yellow limit, the bending moment expansion values are near 20% of section capacity. On the other hand, as predictable, regarding to red limit values, its implications are worst. In this case the bending moment expansion presents values about 50% of all section capacity.

For this procedure, the structural evaluation includes a second order analysis. So, in a simple way, to consider the material non-linear behaviour the initial stiffness was reduced in 50%. While the numerical model analysis itself takes in account the second order effects through the structure geometry non-linear consideration.

Finally, with the well calibrated model it was possible, not only to simulate damages in the pillars bases related to the deterioration conditions and evaluate the effects on the structure, but also to study the influence of the damage limits in the structure integrity. The second point allowed to conclude that, in what concerns to the pillar P2, a rotation on the top with yellow and red limit values leads to bending moment values expansion around 20% and 50%, respectively, of the section capacity.
