**Corrosion Inspection in High Temperature Surfaces  
using EMAT Technology**

Thesis to obtain the Master of Science Degree in  
**Mechanical Engineering**

**June 2019**

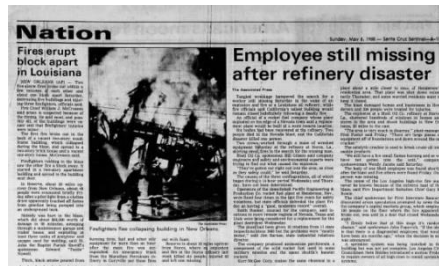
Fig. 1 - Image from the *Santa Cruz Sentinel* newspaper (8th May 1988) reporting what happened in Norco [11].

Following further investigation, Occupational Safety and Health Administration of the USA Department of Labour concluded that the explosion and fire was due to corrosion of a Ø20,32 cm vapour line, causing a gas escape. The failure of this vapour line, (which was under 18,6 bar) released over 7711 Kg of hydrocarbon vapour for approximately 30 seconds, which probably ignited when in contact with a furnace [10]. The following Fig. 1 shows a newspaper from that time exposing what happened [11].

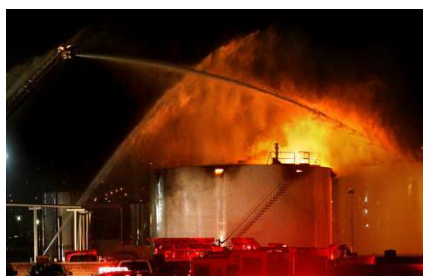
Fig. 2 - Fire in *Silver Eagle* refinery after hydrogen explosion [12].

Another tragic accident occurred in Woods Cross, Utah, on the 4th November 2009. At *Silver Eagle* refinery, a leaking in a Ø25,4 cm hot pipe, which typically operated between 260 °C and 427 °C, led to a massive release of hydrogen that immediately caught fire and exploded, projecting four nearby workers to the ground, with burns in the face, neck, arms and hands (one has even suffered lung damage due to inhalation of hot air). The blast wave generated by the explosion damaged over one hundred houses, ripping one of them off its foundations [12][13]. Fig. 2 shows the fire that consequently spread in the refinery due to the explosion (as reported by [12]).

Posterior analysis revealed that the hydrogen leakage was due to severe corrosion along the pipe which was not inspected since the day it was installed in the facility, and ended up thinning over the years [14].

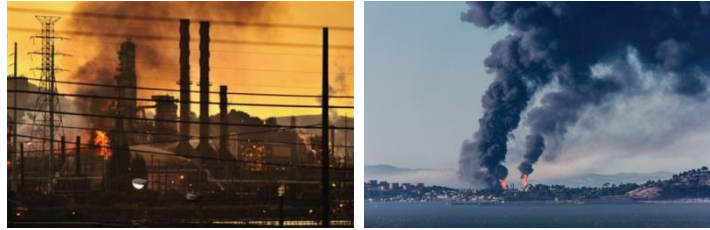
Fig. 3 - Left: The fire being extinguished at *Chevron* refinery [15]. Right: The big cloud of smoke that emerged after the refinery explosion [16].

But these types of accidents in refineries are not uncommon. On 6th August 2012, a ruptured pipe in *Chevron USA Inc.* refinery (Richmond, California) released high temperature gas oil which partially vaporized and ignited two minutes later, creating a fierce fire and a dense plume of black smoke which travelled to the vicinities (that can be seen on Fig. 3, as in [15] and [16] respectively).

concluded that the main cause for the pipe rupture was gradual thinning due to corrosion, and stated that it could be prevented if proper testing and procedures were conducted [17].

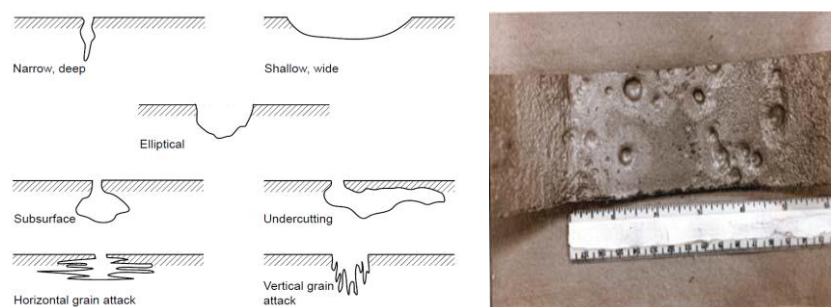
Fig. 4 - Left: different shapes of pitting corrosion defects in cross sectional view [26]. Right: pitting corrosion due to dissolved oxygen in Carbon Steel boiler tube [21].

It is a localized form of corrosion with formation of cavities in the material, being more dangerous than uniform corrosion because it is more unpredictable and difficult to detect [26], due to the usual small sized defects, the varying depths and numbers of pits that may occur under identical conditions, and because they are often covered with corrosion products. Sometimes one single pit can lead to the failure of an entire system [25]. This kind is more prone to happen in liquid retaining or exclusion systems such as pipelines and tanks, for example [24]. Fig. 4, left shows typical variations in the cross sectional shape of pits (according to [26]), and Fig. 4, right shows an example of pitting corrosion on a Carbon steel Boiler Tube (as in [21]).

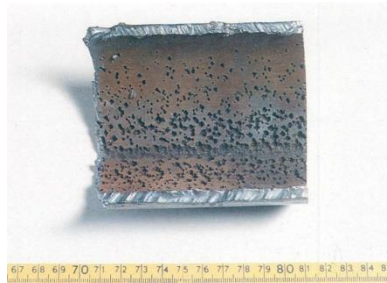
Fig. 6 - Cavitation corrosion in a Carbon Steel pipe of a steam condensate system (detail of the upper part) [28].

It occurs when the flow of a corrosive liquid creates localized lower pressure spots, leading to the formation of bubbles which produce shock waves and high-velocity microjets when the same bubbles collapse. These impacts cause mechanical damage due to continuous and local bombardment of the surface by the vapour bubbles, that is intensified by the corrosive effect of the liquid [21][22]. Fig. 6 shows the effect of cavitation in a steel pipe (according to [28]).

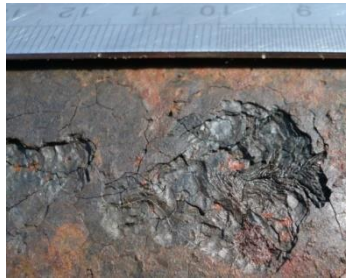
Fig. 7 - Massive microbial corrosion on a pump housing [30].

This kind of corrosion, as its name states, happens due to the influence of microorganisms and/or their metabolites. They usually form aggregated colonies on the material surface, creating corrosion cells which are the basis for accelerated attack [26]. These microorganisms have been reported to cohabit in structures above 100 °C and pH values of -1 [29]. Fig. 7 shows a case of massive microbial corrosion on a pump housing (as in [30]).

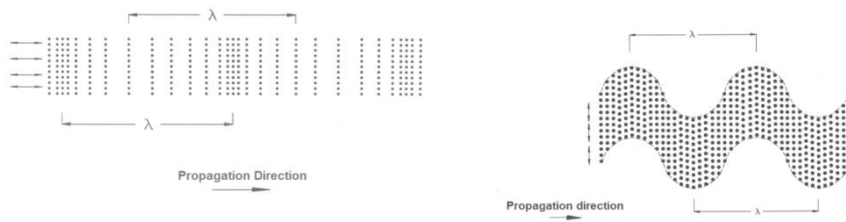
Fig. 8 - Left: Longitudinal wave. Right: Transversal wave (adapted from [34];  $\lambda$  corresponds to the respective wavelengths).

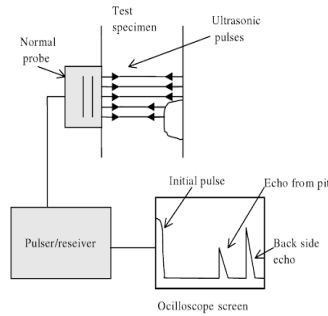
Fig. 9 - General representation of the basic functioning principle of UT Pulse Echo inspection [32].

A general representation of the basic functioning principle in Pulse Echo can be seen in Fig. 9 (according to [32]). Like the figure suggests, the probe emits and receives ultrasonic waves which travel along the inspected material. When the waves strike a discontinuity, ideally part of them are reflected and the other is transmitted through the interface, as already mentioned [33][39]. The respective reflection is then shown on a proper device screen in an A-Scan, which usually gives information about the amplitudes of the echoes and the distance (or travelling time) between each discontinuity in the test specimen [34]. As seen on the figure's A-Scan, the initial pulse represents the reflected waves at the top of the inspected material, the backside (or back wall) echo represents the reflected waves at the bottom of the material, and the echo from pit represents the reflection that occurs when the ultrasonic waves find that certain defect.

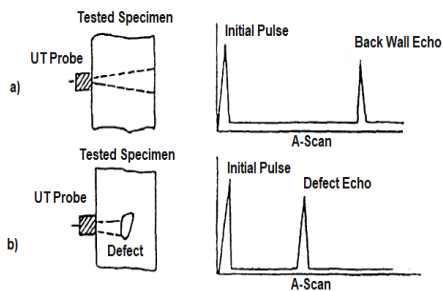
Fig. 10 - a) UT Pulse Echo inspection with no defects; b) UT Pulse Echo inspection with a defect wider than the ultrasonic beam (adapted from [39]).

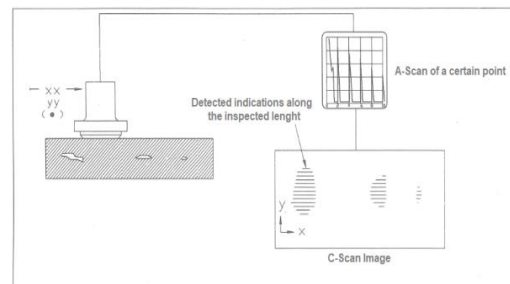
Fig. 11 - Scheme of a C-Scan representation (adapted from [34]).

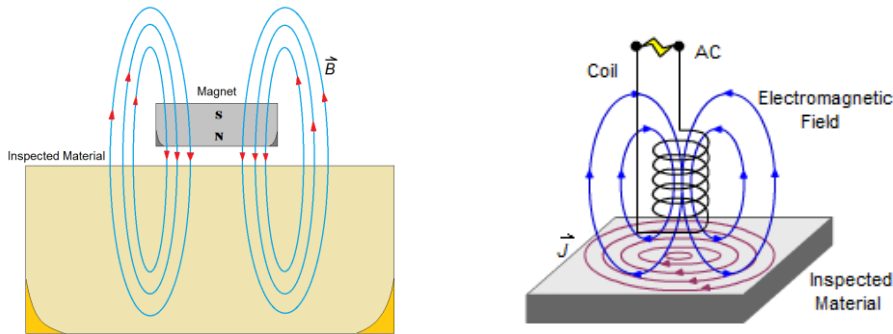
Fig. 13 - Left: scheme of influence of the magnetic field generated by a vertical bias magnet on an inspected material (adapted from [41]). Right: scheme of generation of Eddy Currents on a material by a meander coil (adapted from [44]).

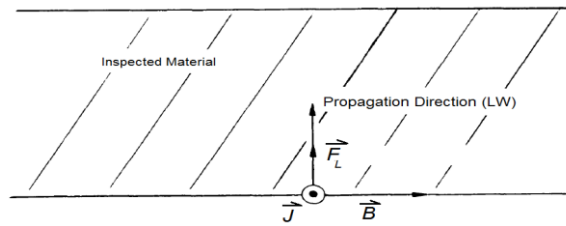
Fig. 15 - Generation of a Longitudinal Wave (adapted from [46]). Note that the Eddy Current density vector is normal to the image plane.

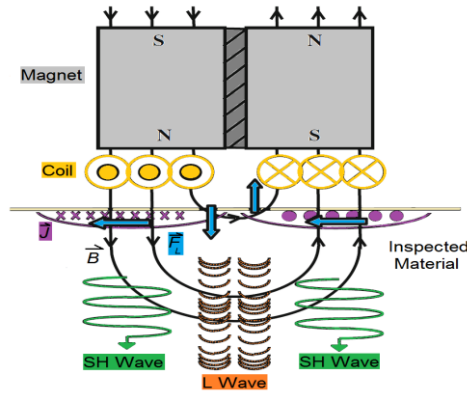
Fig. 16 - Simultaneous generation of SH and L waves with a periodical bias magnet and a racetrack coil (adapted from [41]). Note that the coil and Eddy Current density propagate in a direction normal to the reading plane.

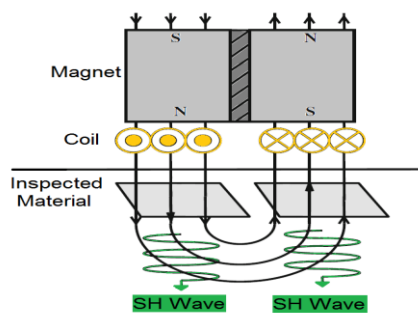
Fig. 19 - Example of SH wave generation in an inspected material due to magnetostrictive force, with a periodical bias magnet and racetrack coil (adapted from [41]).

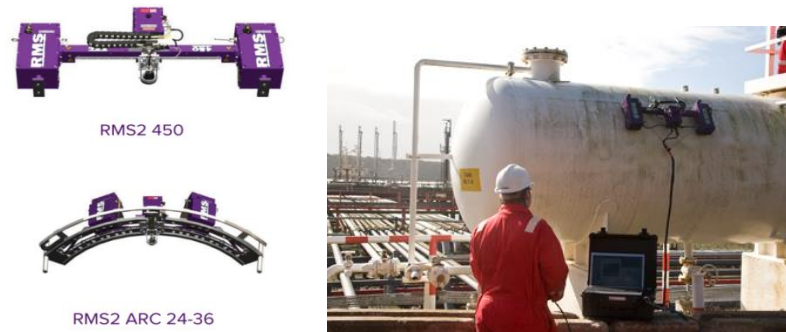
Fig. 20 - Left, up: *RMS2 450* equipment. Left, down: *RMS2 ARC 24-36* equipment [57]. Right: industrial application of *RMS2 450* [58].

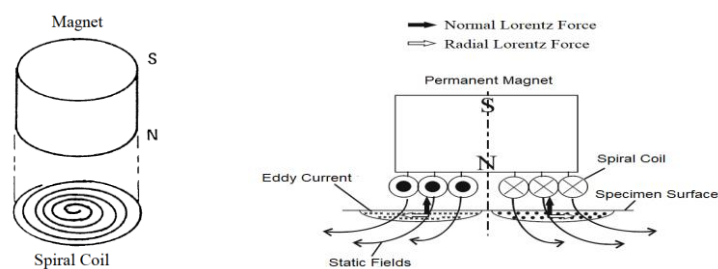
Fig. 22 - Left: scheme of permanent magnet and spiral coil (adapted from [50]); N and S stands for North and South poles of the magnet. Right: side view of Lorentz Force generation with permanent magnet and spiral (or pancake) coil (adapted from [41]).

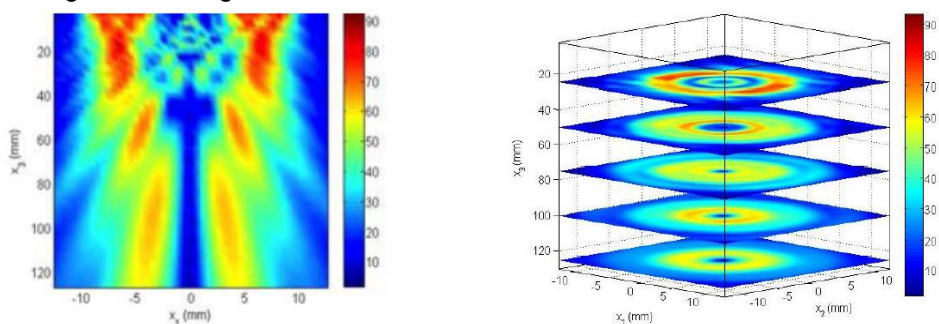
Fig. 23 - Ultrasonic beam profiles of *Innerspec High Temperature Sensor SH Spiral* [64]. X1 stands for length, X2 for width and X3 for thickness. The colour grade chart (which goes from 0% to 100%) is related to the ultrasonic signal strength.

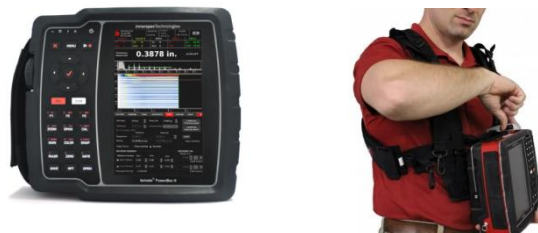
Fig. 24 - Left: *PowerBox H* frontal view [51]. Right: *Powerbox H* used with an arness [67].

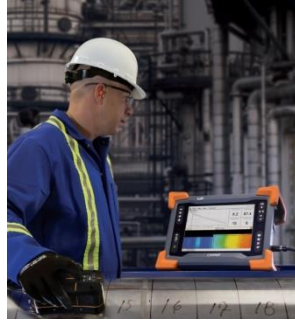
Fig. 26 - Eddyfi Lyft with Single Element PEC Probe being used at on-site inspections [70].

It has a digital interface that is portable, water and dust resistant, and cools without any external air exchange, making it appropriate for on-site inspections as seen in Fig. 26 (as seen in [70]). Running in *Windows* software, it can be easily connected to any computer. It also comes with two batteries (which can last up to 8h each) for extended autonomy. With two USB and one HDMI port, this even comes with an extra USB entry to perform quick copies, transferring all inspection files at the touch of a button [69].

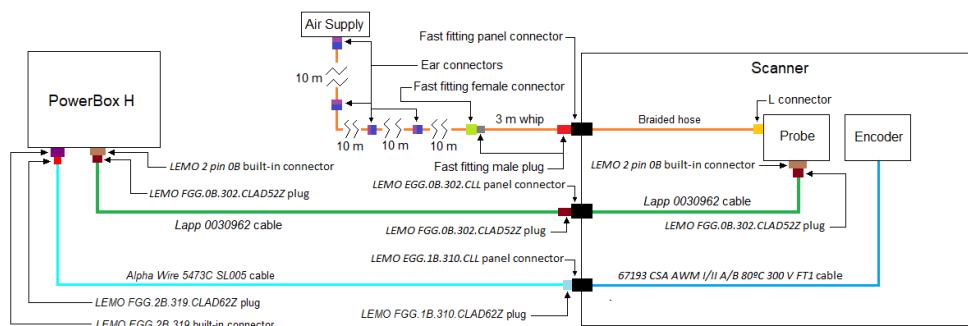
Fig. 29 - Connection schematic with information on connectors and cables (not on scale).

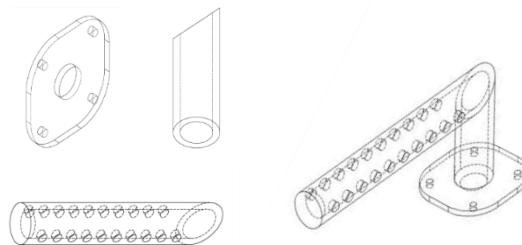
Fig. 31 - Left: preliminary drawing of the different handle parts. Right: preliminary drawing of handle subassembly (invisible lines are present in order to better perceive that the handle was hollow).

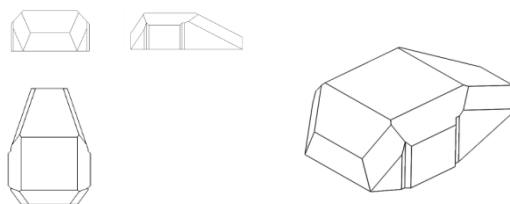
Fig. 32 - Left: first angle view of casing prototype drawing. Right: isometric view of casing prototype drawing.

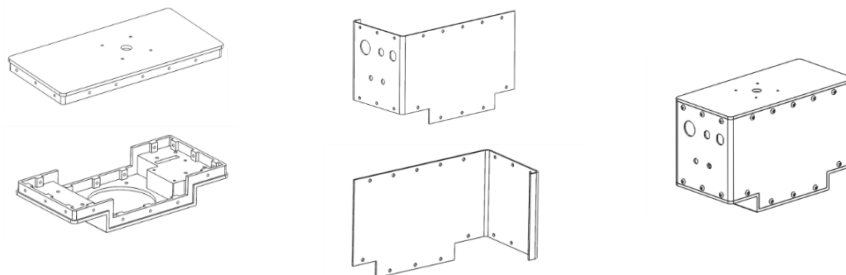
Fig. 33 - Preliminary drawings of the different casing parts. Left, up: Aluminium top. Left, down: Aluminium base. Middle: two Stainless Steel sheet metal parts. Right: casing subassembly, held together with screws.

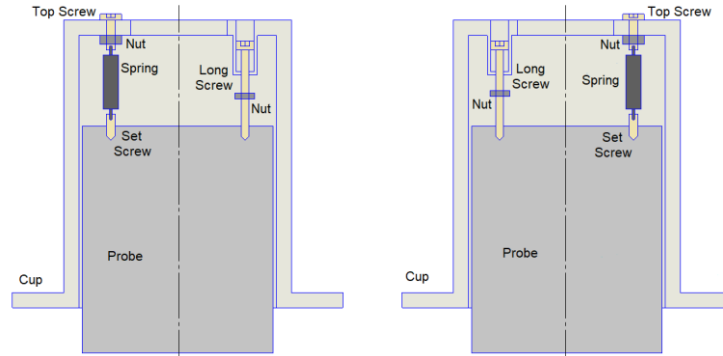
Fig. 34 - Scheme of probe cup functioning principle.

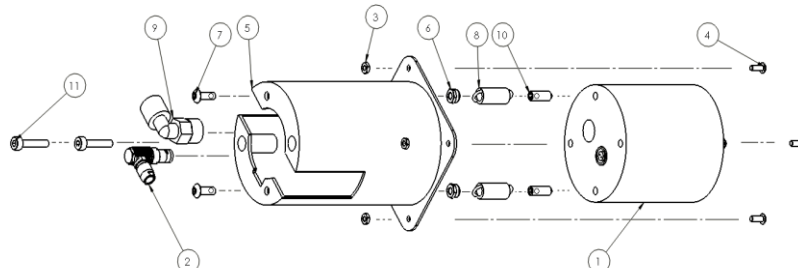
Fig. 35 - Cup subassembly exploded view. 1: probe; 2: *Lemo FGG.0B.302.CLAD52Z* plug; 3: nuts to fix the cup; 4: screws to fix the cup; 5: cup; 6: nuts to fix the top screws; 7: top screws to fix the springs; 9: L air connector; 10: set screws to fix the springs.

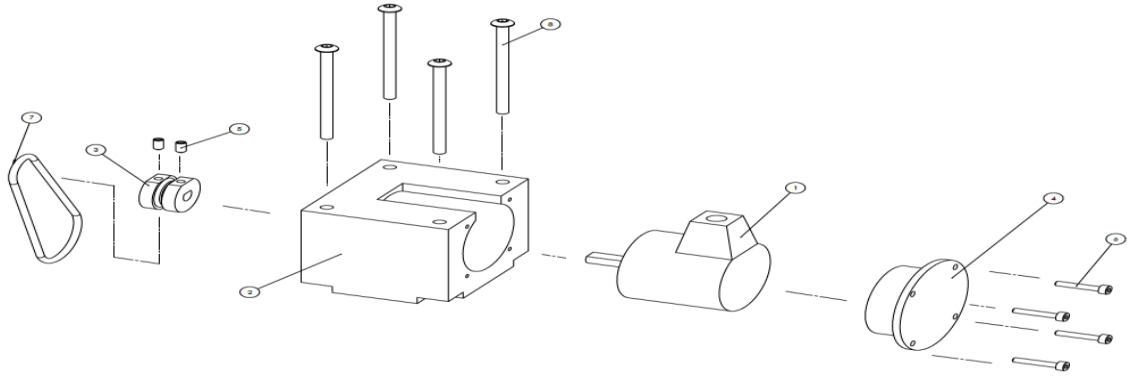
Fig. 37 - Exploded view of the encoder subassembly. 1: encoder; 2: encoder holder; 3: plug which fits in the encoder spindle; 4: encoder holder lid; 5: screws to fix the plug; 6: screws to fix the encoder lid; 7: o-ring; 8: screws to fix the encoder holder.

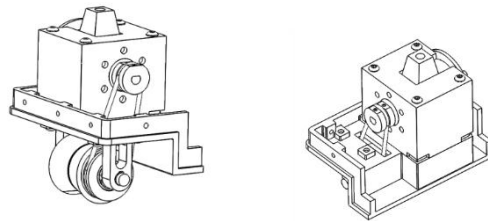
Fig. 38 - Simplified scheme of scanner section including the encoder, o-ring and coupled wheel.

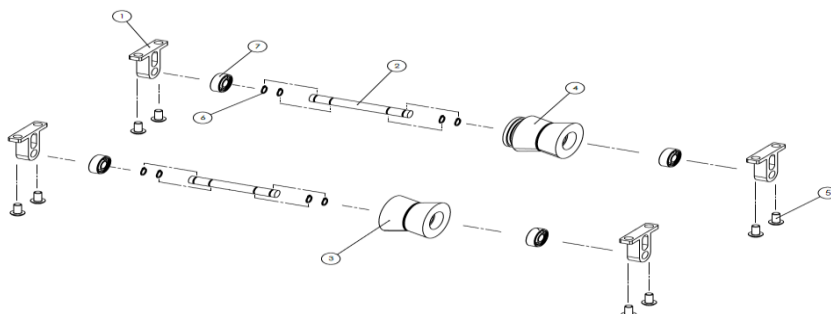
Fig. 39 - Scheme of wheels subassembly in exploded view. 1: wheel supports; 2: spindles; 3: normal wheel; 4: wheel to couple with encoder; 5: screws to fix the wheel supports; 6: retention rings; 7: roller bearings.

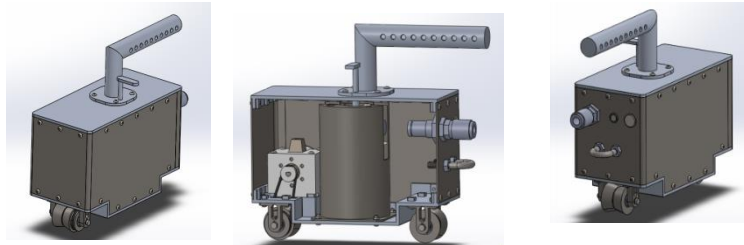
Fig. 40 - Right and left: two external views of the final scanner prototype model. Middle: internal view of the final scanner prototype model (made with *Solidworks 2017* software).

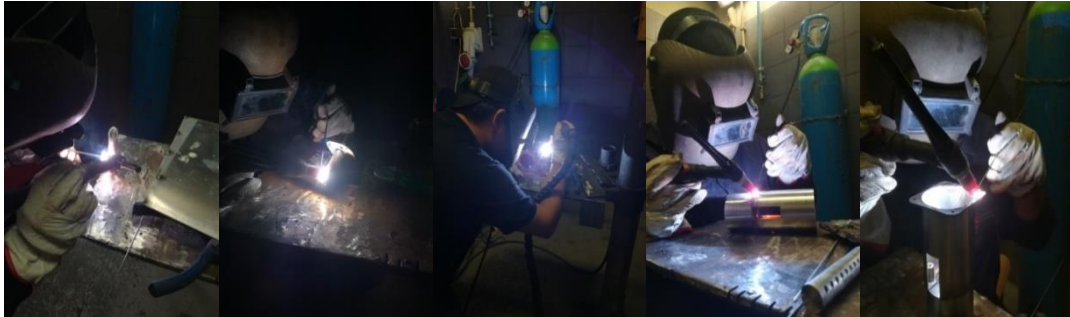
Fig. 41 - From left to right: welding of the handle base; welding of the handle rods; welding of the casing middle; welding of the cup top; welding of the cup base.

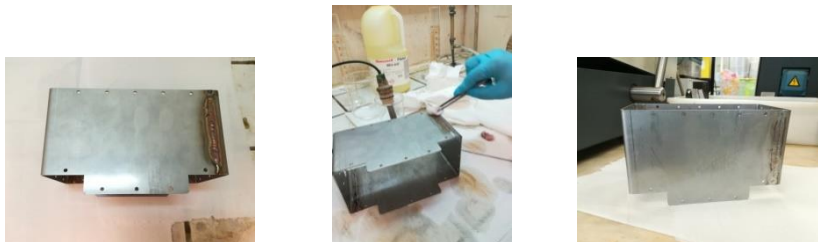
Fig. 42 - Left: the casing middle frame after being welded. Center: the casing middle frame during the passivation process. Right: the casing middle frame after the passivation process.

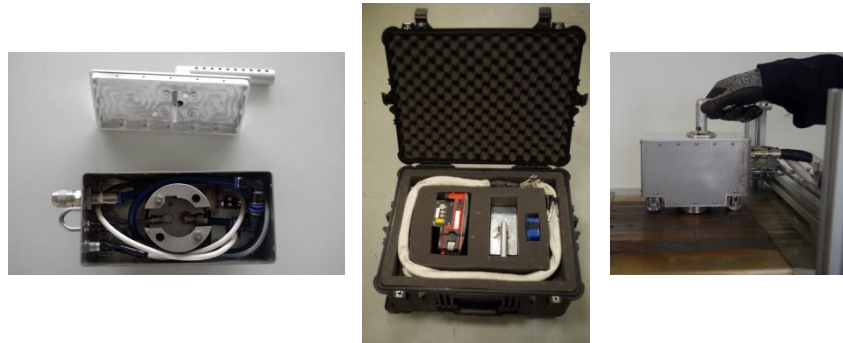
Fig. 44 - Left: scanner prototype inside view. Center: the equipment in its respective travelling case. Right: scanner prototype outside view.

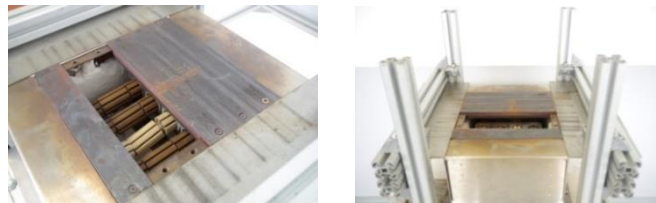
Fig. 45 - Left: various testing blocks on top of the heating box. Right: structure of aluminium profiles on the heating box.

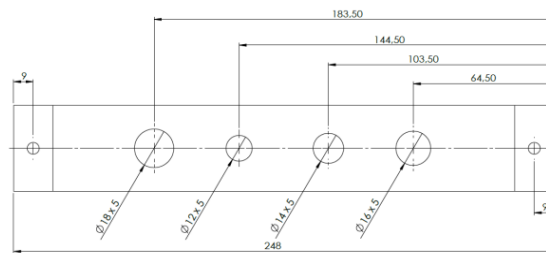
Fig. 46 - Drawing scheme of the hole configuration for all 1<sup>st</sup> category inspection blocks (bottom view); the holes near de edges were made to screw the bars on the heating box.

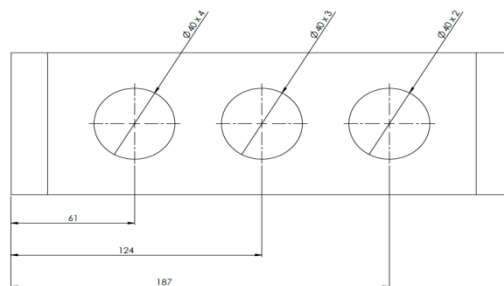
Fig. 48 - Drawing scheme of 3<sup>rd</sup> category validation block (bottom view).

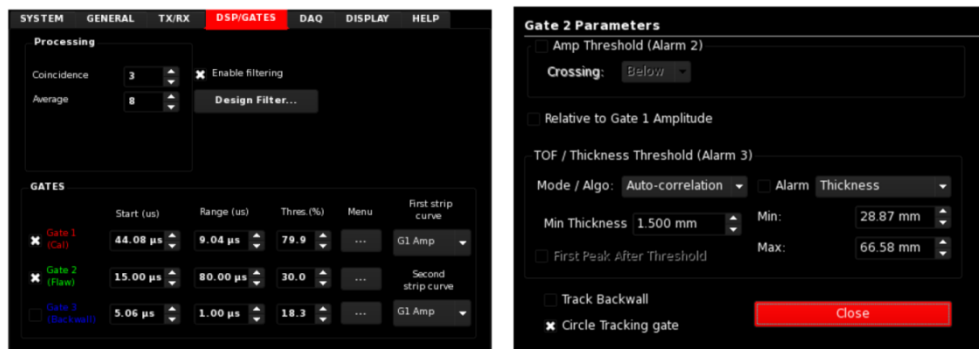
Fig. 50 - Left: printscreen of typical *DSP/Gates* menu of *Innerspec PowerBox H*. Right: printscreen of typical *Gate 2 Parameters* menu of *Innerspec PowerBox H*.

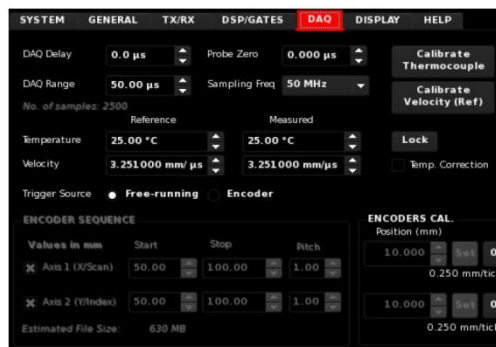
Fig. 52 - Printscreen of typical DAQ menu of *Innerspec PowerBox H*.

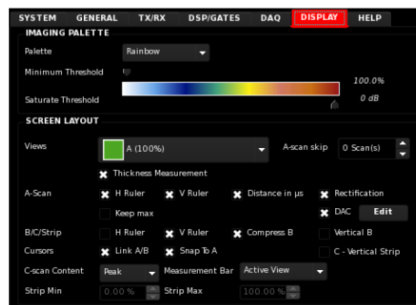
Fig. 53 - Printscreen of typical *Display* menu in *Innerspec PowerBox H*.

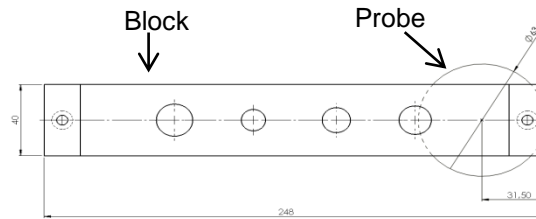
Fig. 54 - Simplified scheme of the first calibration position for 1<sup>st</sup> category 10 mm block (bottom view).

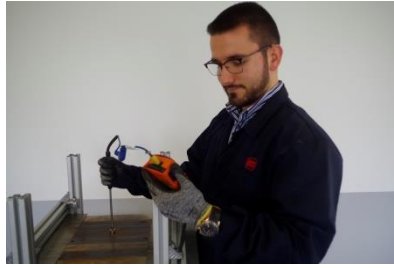
Fig. 55 - Temperature check using the thermocouple.

as already explained) using the thermocouple to monitor the block temperature as suggested previously (Fig. 55).

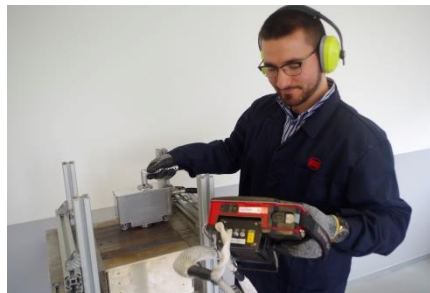
Fig. 56 - Inspection on a given block.

7. Turn on the air cooling,
8. Place the scanner on top of the first block and move the scanner along the block until a temperature equilibrium of 50 °C is reached.
9. Perform the inspection on the given block at 50 °C (as exemplified in Fig. 56)

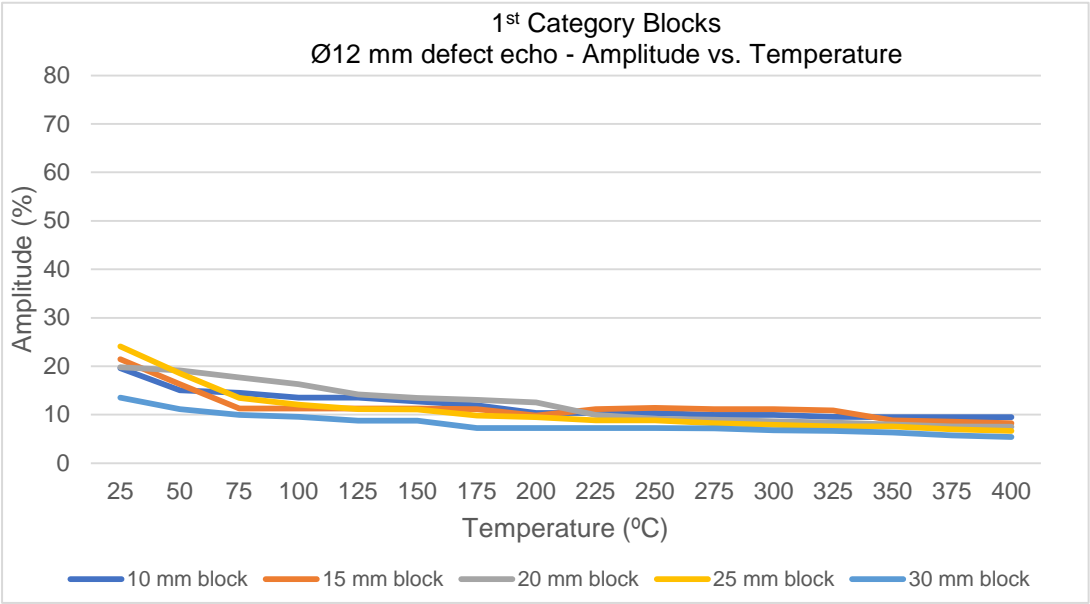
Fig. 58 - Amplitude vs. Temperature for the 1<sup>st</sup> category blocks Ø12 mm defect echo.

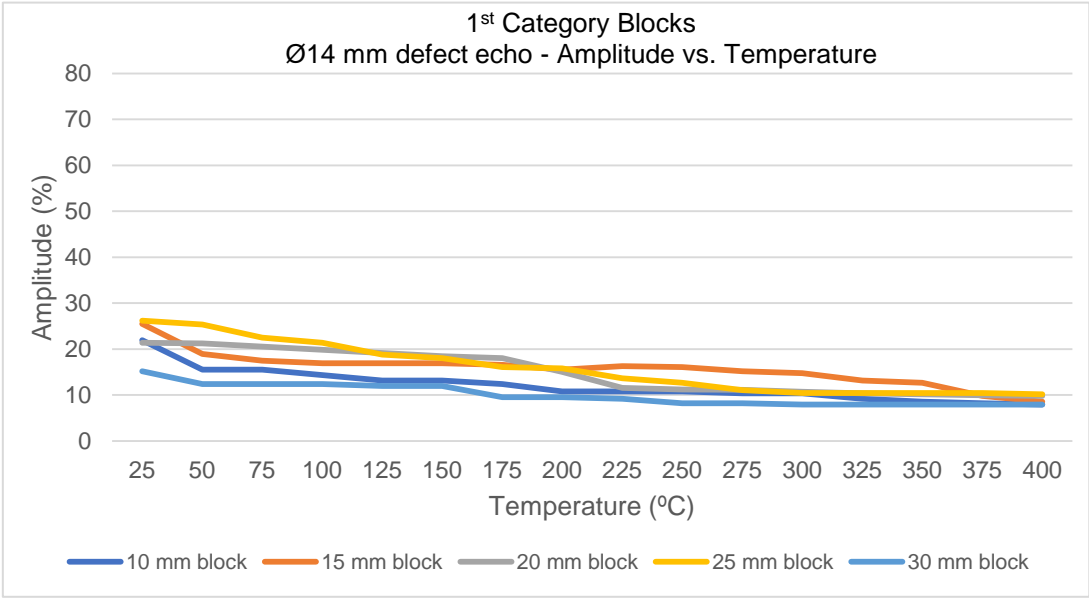
Fig. 59 - Amplitude vs. Temperature for the 1<sup>st</sup> category blocks Ø14 mm defect echo.

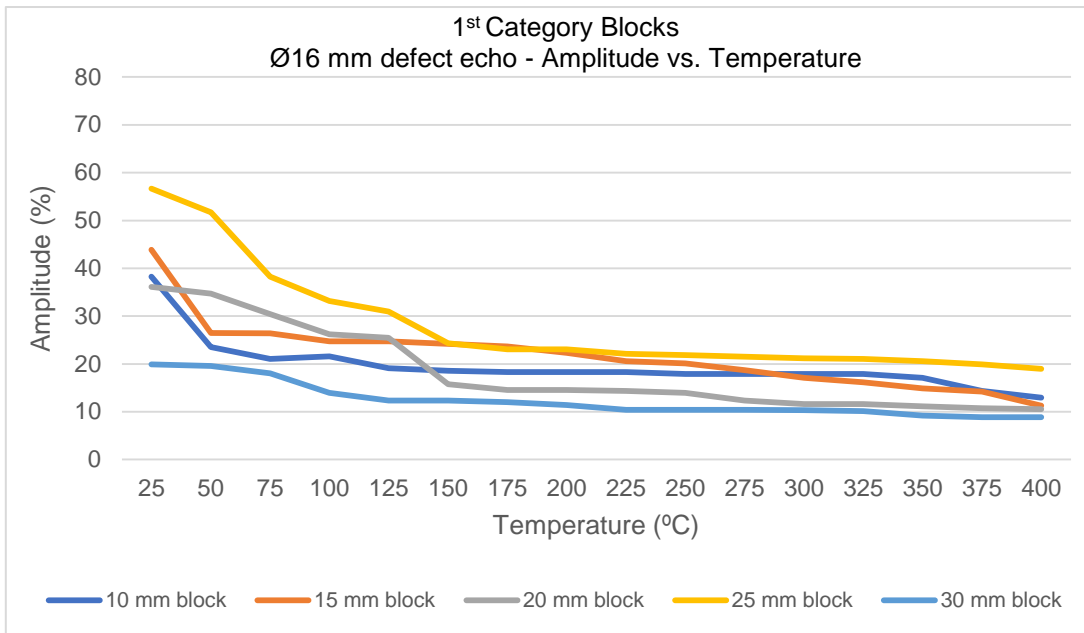
Fig. 60 - Amplitude vs. Temperature for the 1<sup>st</sup> category blocks Ø16 mm defect echo.

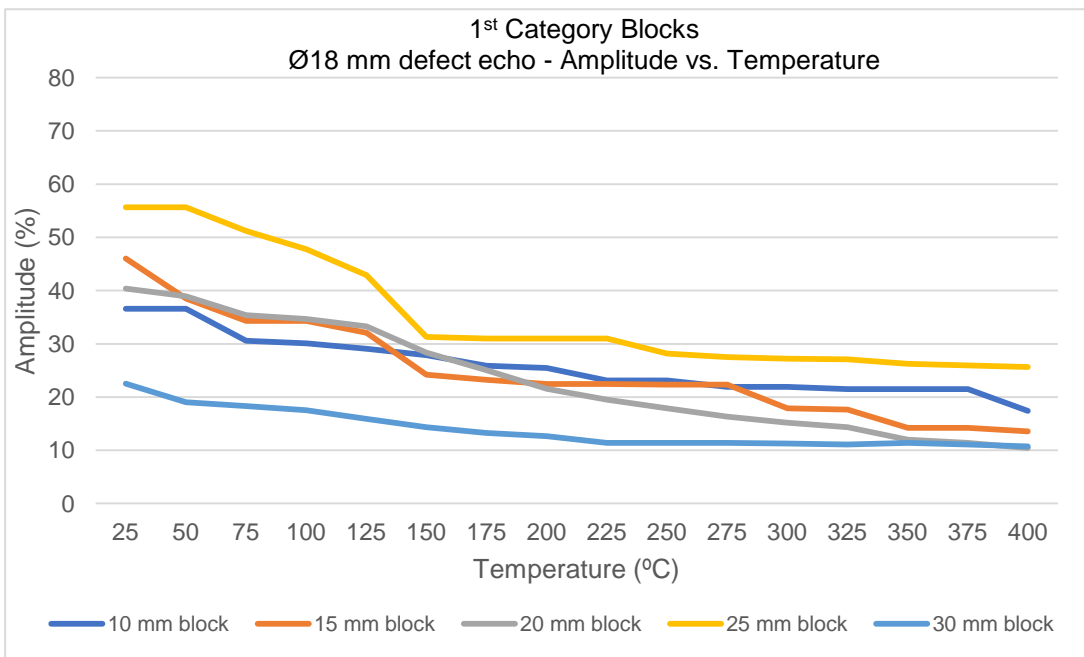
Fig. 61 - Amplitude vs. Temperature for the 1<sup>st</sup> category blocks Ø18 mm defect echo.

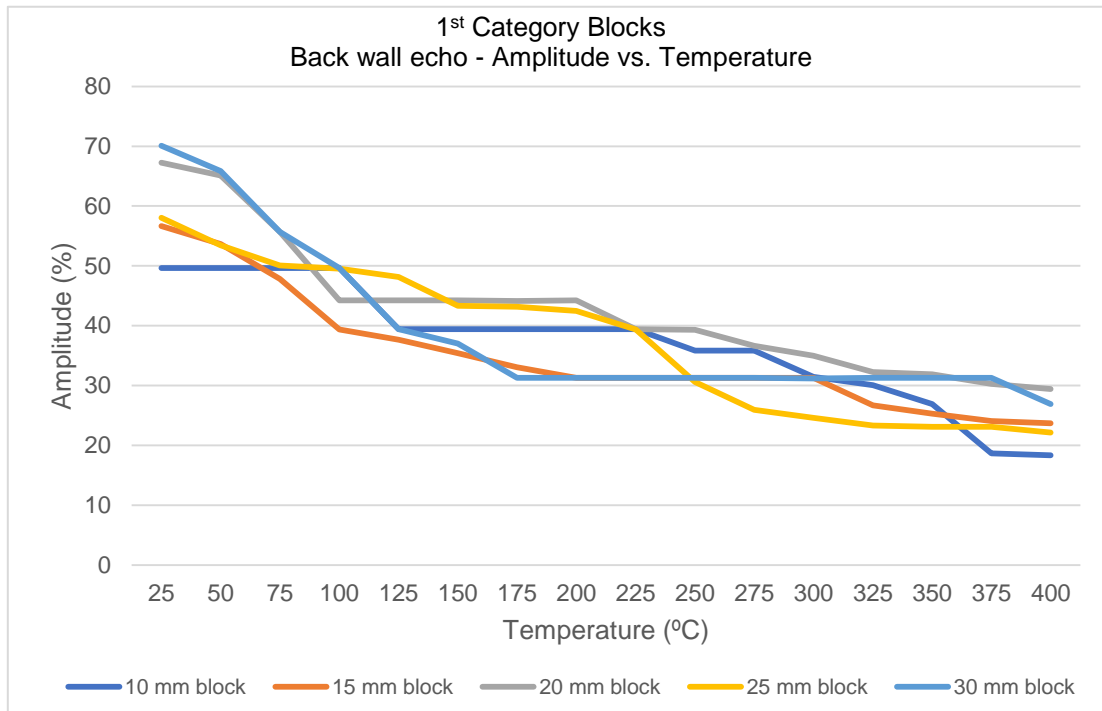
Fig. 62 - Amplitude vs. Temperature for the 1<sup>st</sup> category blocks back wall echo.

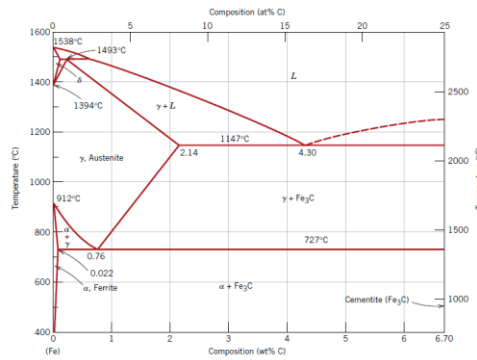
Fig. 63 - Phase diagram of iron-iron carbide, also known as cementite [106].

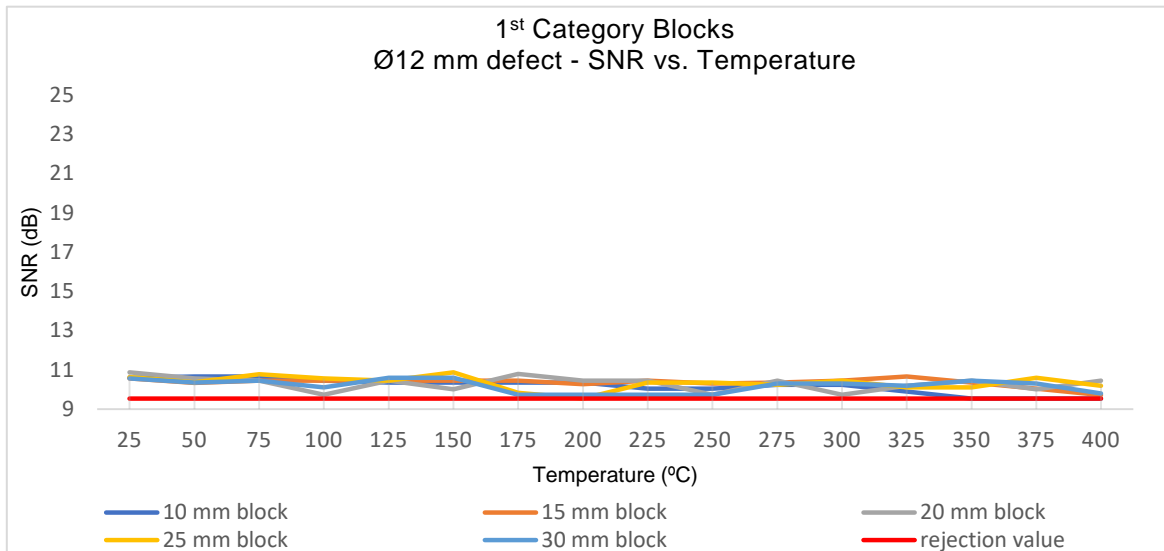
Fig. 64 - SNR vs. Temperature for the 1<sup>st</sup> category blocks Ø12 mm defect echo, along with the respective rejection value.

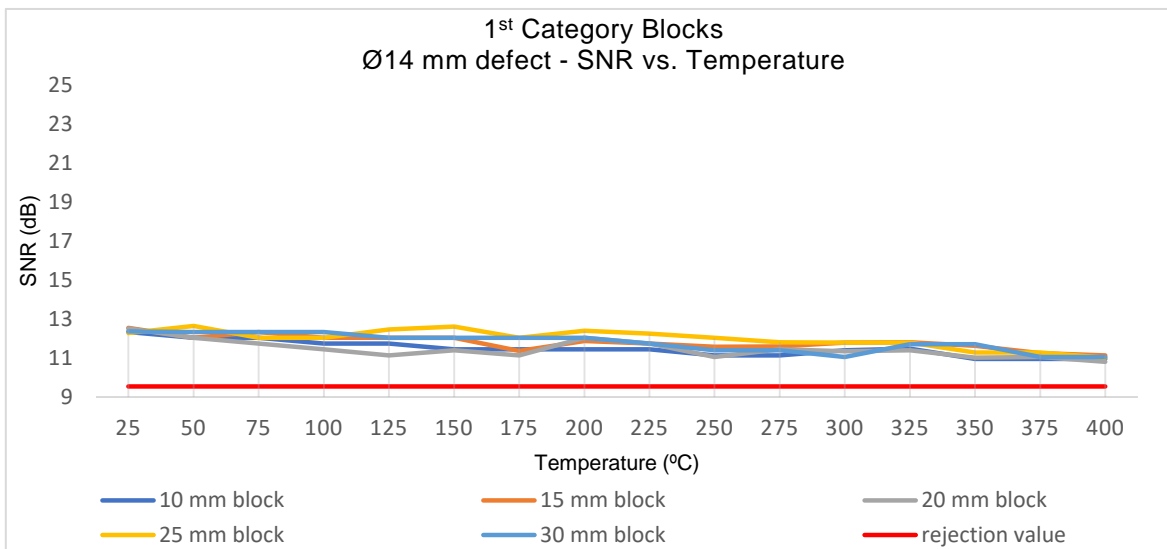
Fig. 65 - SNR vs. Temperature for the 1<sup>st</sup> category blocks Ø14 mm defect echo, along with the respective rejection value.

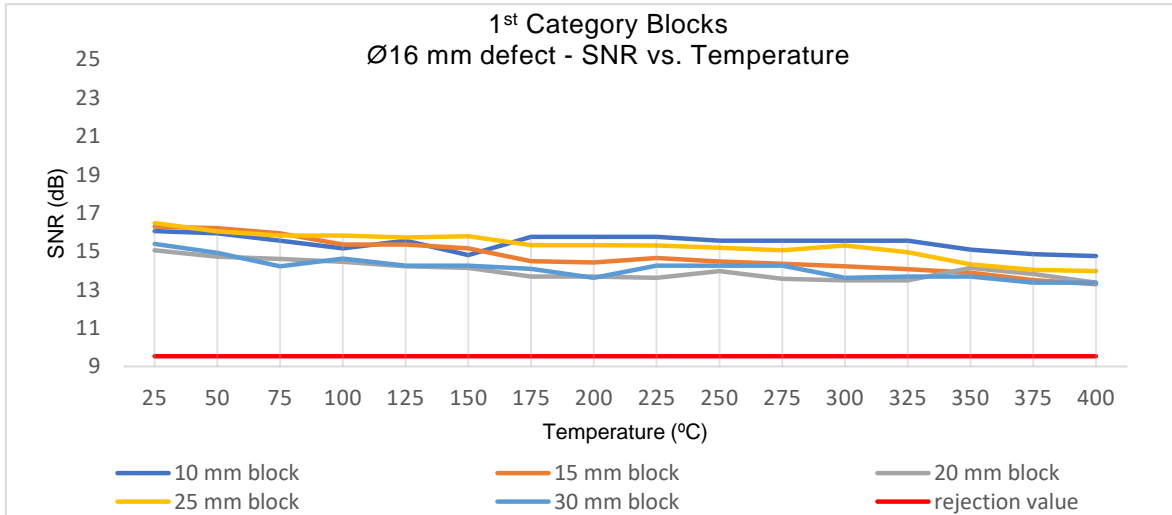
Fig. 66 - SNR vs. Temperature for the 1<sup>st</sup> category blocks Ø16 mm defect echo, along with the respective rejection value.

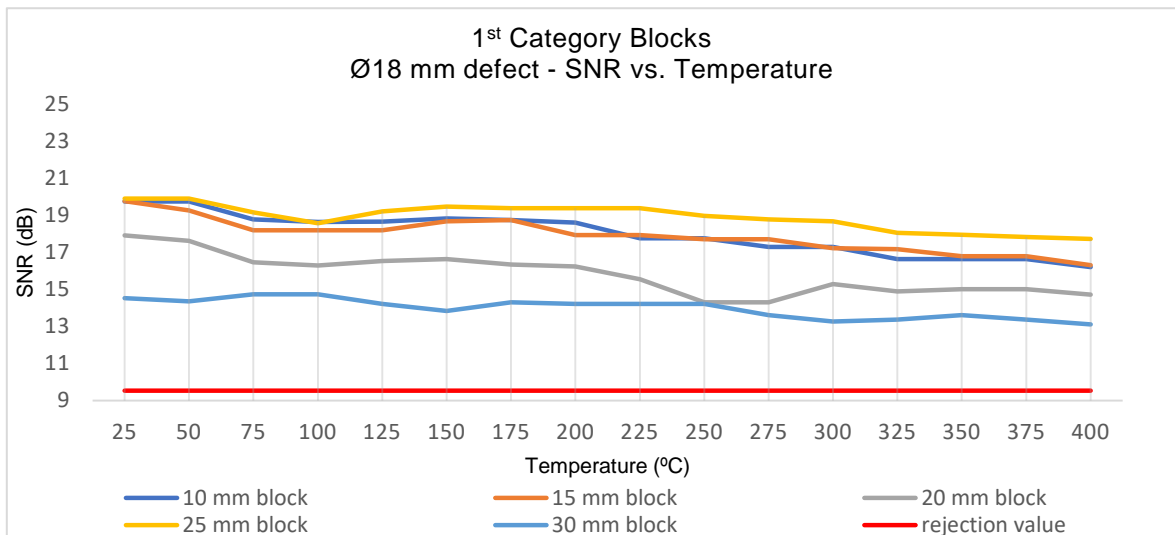
Fig. 67 - SNR vs. Temperature for the 1<sup>st</sup> category blocks Ø18 mm defect echo, along with the respective rejection value.

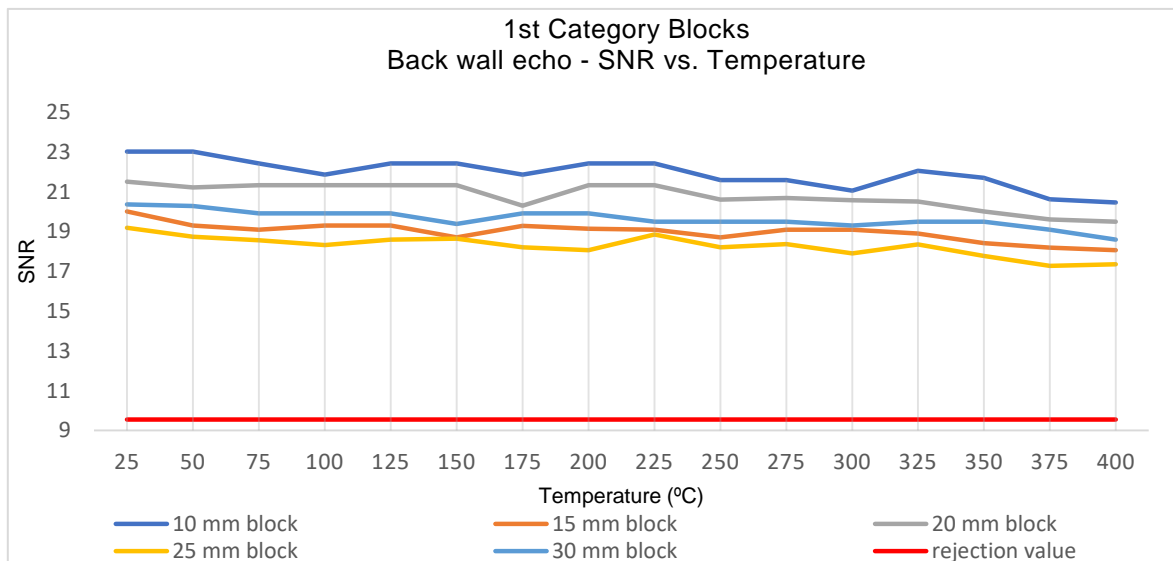
Fig. 68 - SNR vs. Temperature for the 1<sup>st</sup> category blocks back wall echo, along with the respective rejection value.

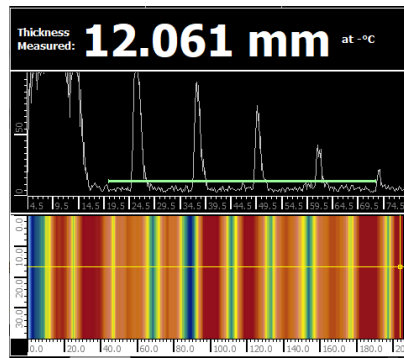
Fig. 69 - A+C Scan of 2<sup>nd</sup> category block at 400 °C using *Innerspec PowerBox H*.

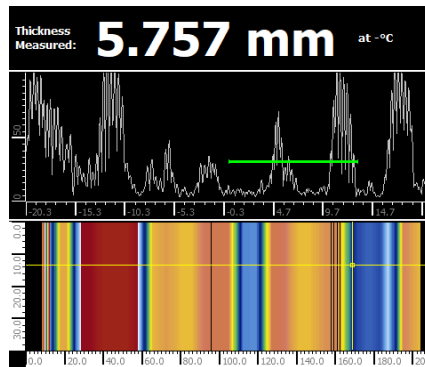
Fig. 70 - A+C Scan of 3<sup>rd</sup> category block at 100 °C using *Innerspec PowerBox H*.

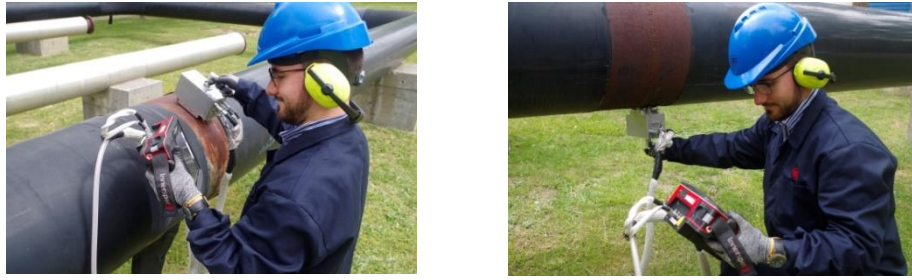
Fig. 71 - Left: *EMAT Heat Inspection* prototype on a OD 400 mm pipe. Right: *Emat Heat Inspection* prototype on upside-down test (same pipe as left image).

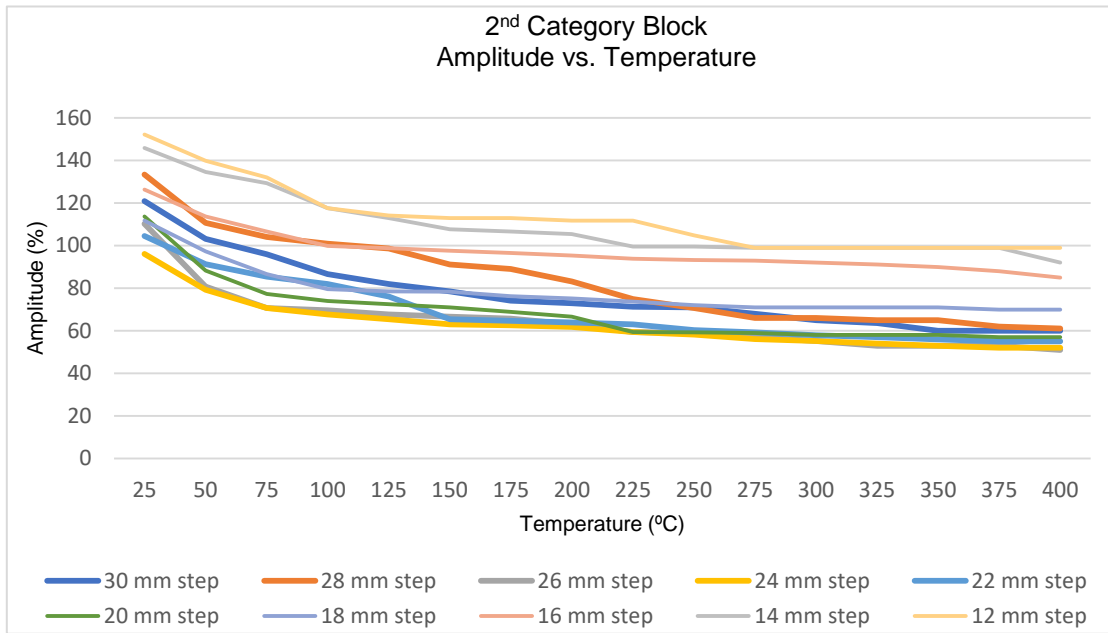
Fig. 72 - Amplitude vs. Temperature for the 2<sup>nd</sup> category block back wall echo.

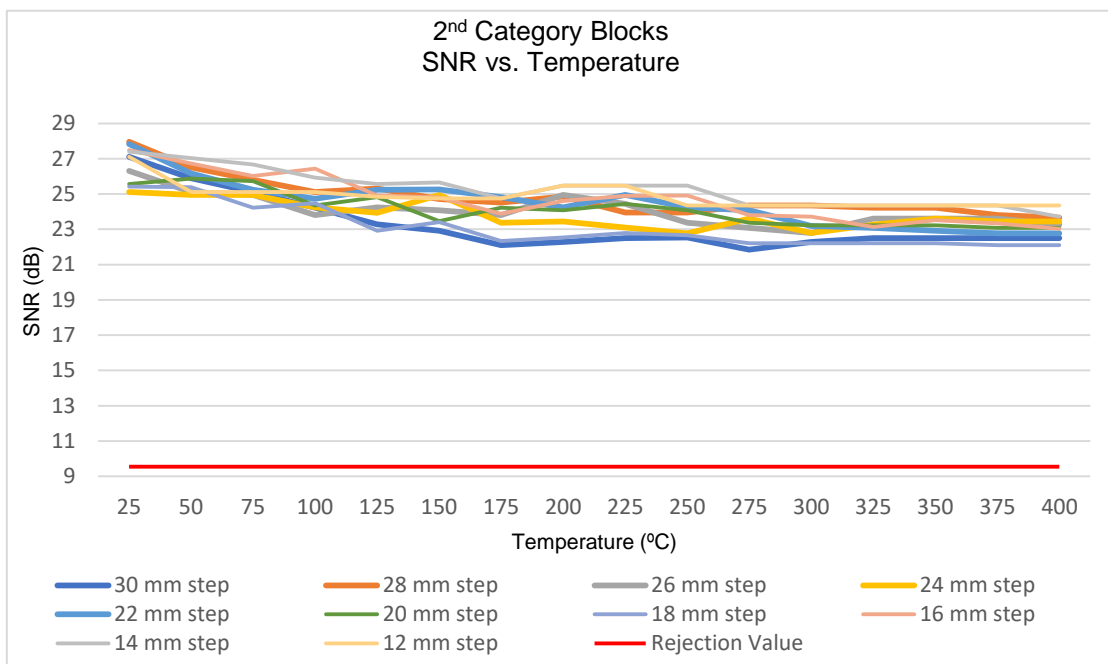
Fig. 73 - SNR vs. Temperature for the 2<sup>nd</sup> category block back wall echo.

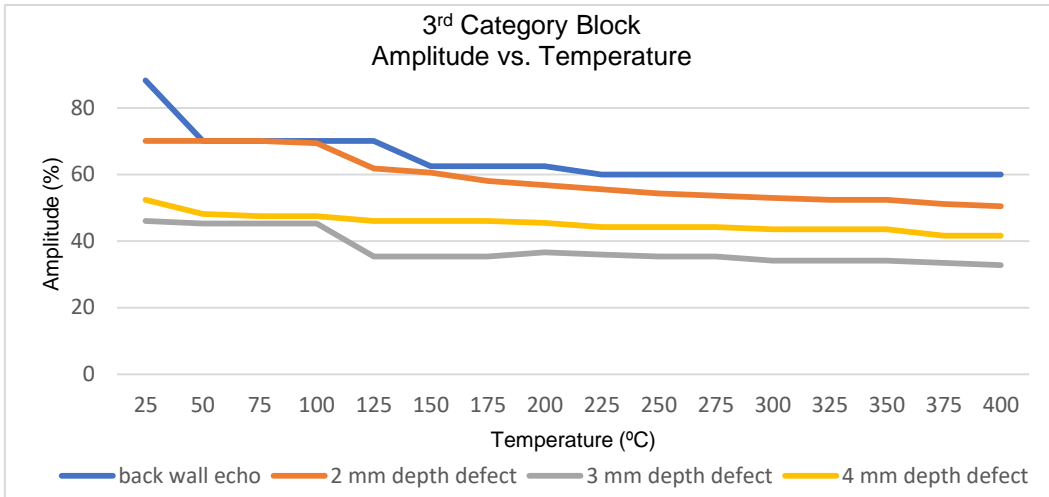
Fig. 74 - Amplitude vs. Temperature for 3<sup>rd</sup> category block defects and back wall echo.

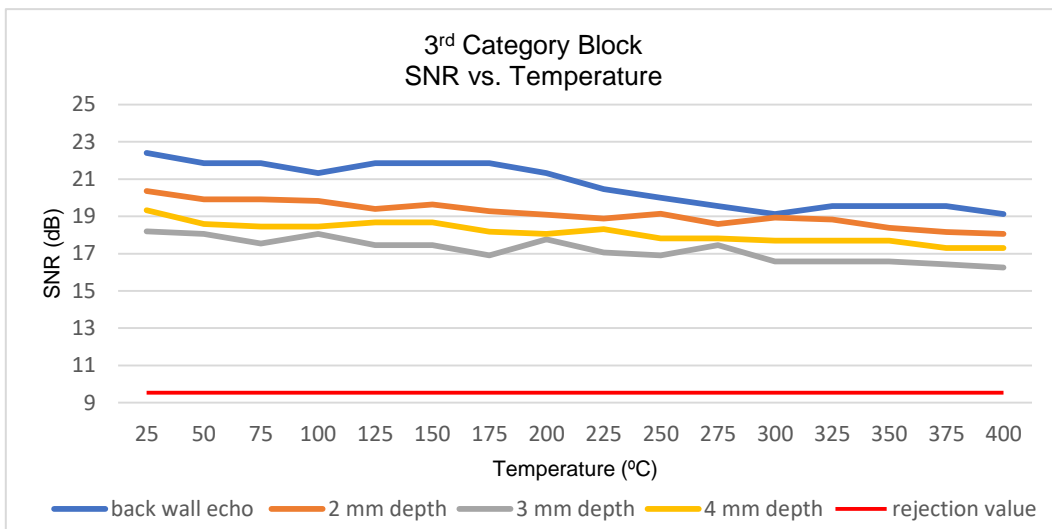
Fig. 75 - SNR vs. Temperature for 3<sup>rd</sup> category block defects and back wall echo.

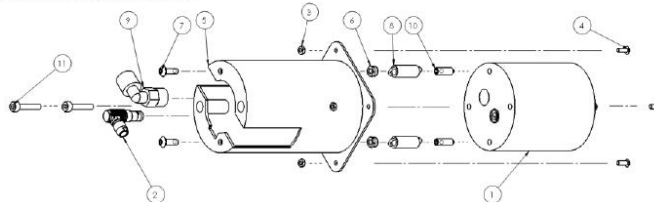
Being 1 – probe; 2 – *Lemo FGG.0B.302.CLAD52Z* plug; 3 – nuts to fix the cup; 4 – screws to fix the cup; 5 – cup; 6 – washers to fix the springs; 7 – screws to fix the springs; 9 – L air connector; 10 – set screws to fix the springs; 11 – long screws.

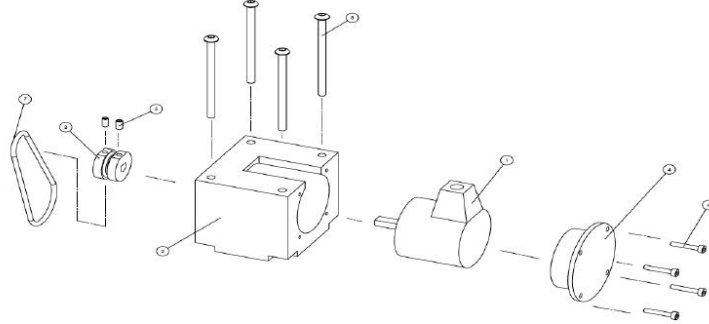
Where 1 – encoder; 2 – encoder holder; 3 – plug which fits in the encoder spindle; 4 – encoder holder lid; 5 – screws to fix the plug; 6 – screws to fix the encoder lid; 7 – O-Ring; 8 – screws to fix the encoder holder.

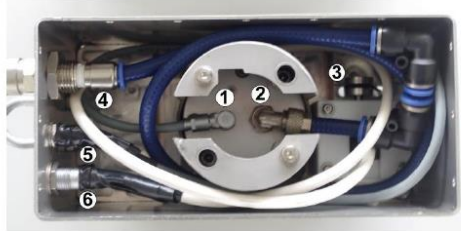
Being: 1 – *Lemo* probe connector; 2 – air probe connector; 3 – encoder O-ring; 4 – air panel connector; 5 – *Lemo* probe panel connector; 6 – *Lemo* encoder panel connector.
