# Seismic Assessment of an Old Reinforced Concrete Building in Lisbon

Martim Eiró

Instituto Superior Técnico, Universidade de Lisboa, Portugal, 2019

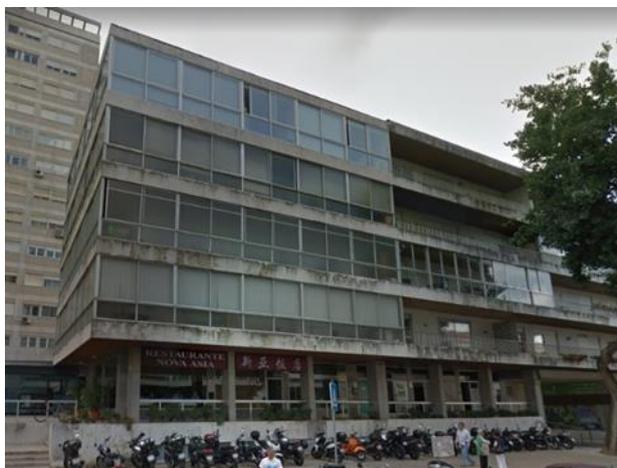
Figure 1 - Case study building

The case study on this dissertation is a building located in the *Avenida da Igreja*, in the *Alvalade* area. It is a reinforced concrete framed structure and can be considered as a representative example of this typology, i.e. RC framed buildings built before 1970. The building was built in 1967 and has five storeys above ground and one below with 2483m<sup>2</sup> of gross construction area and 331.2m<sup>2</sup> of deployment area.

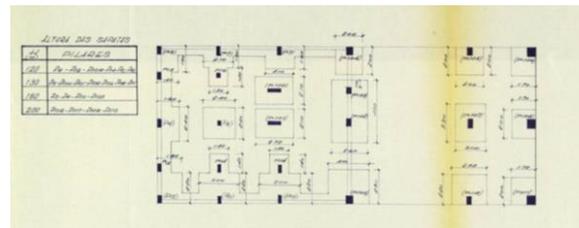
Figure 2 - Foundations plan

As showed in the next figure, the vertical elements in the middle of the building have isolated foundations and the ones on the outer perimeter are embedded in the retaining wall.

The foundations of the building were design accordingly to the simplified Morsch theory which is based on the compression struts that are still nowadays the bases for this type of design.

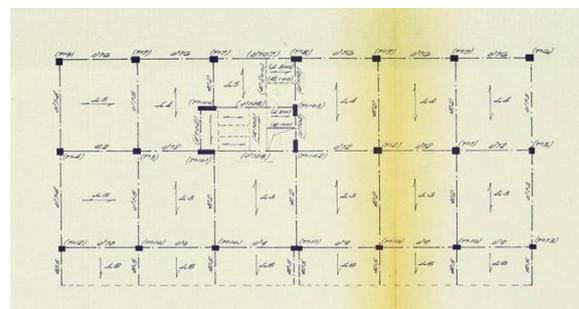
Figure 3 - Typical structural floor plan

The slabs on the building, with the exception of the balconies, and the stairs landing, are composed by prefabricated slabs with 0.17m thickness aligned in the directions showed in Figure 3.

The reinforced concrete frame, columns and beams, were designed using the worst case scenario between hypotheses I and II defined in REBA [1], that differ mainly on the loads considered in the structure. The cross sections of the vertical elements vary from 0.30x0.30m to 1.15x0.20m, and the beams vary from 0.20x0.40m to 0.65x1.20m. The distribution of this elements may be verified on Figure 3.

The stairs of the building are approximately on its centre and were built with reinforced concrete and with a thickness of 0.15m.

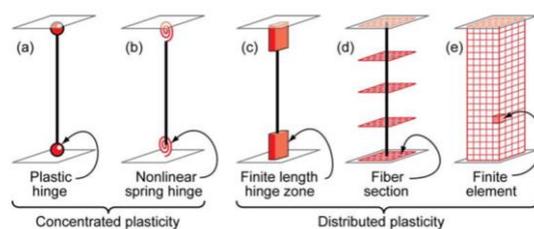
Figure 4 – Plasticity models for linear elements (adapted from[9])

The modelling of nonlinear behaviour of elements can be done in several different ways. As shown in Figure 4 there are two main groups, the concentrated plasticity in the extremities of the elements by means of plastic or nonlinear spring hinges and the distributed plasticity that are defined by the finite length hinges, fiber sections or finite elements along the element.

The concentrated plasticity models, used in this thesis for beams and columns, are based on the simplification that the nonlinear behaviour is concentrated on the extremities of the elements, either on vertical or horizontal elements. According to Paulay [9] definition of the length of the hinge will lead to values that are approximately 50% of the height of the cross section, but as Varum demonstrated on [10] the consideration of smooth rebars leads to values of around 25% of the cross section height, which can be calculated based on the following equation.

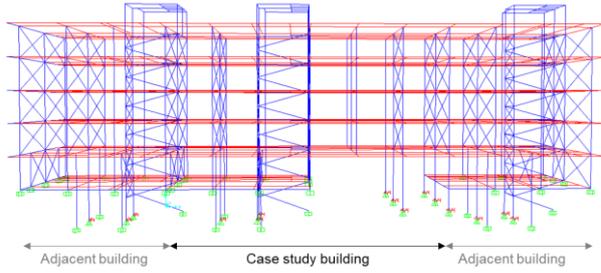
Figure 5 - 3D representation of the case study building considering both adjacent buildings

The building used as a case study is part of a block with adjacent buildings on both sides. To take in consideration the impact of these buildings in the case study, they were also included in the model. Due to the lack of information on these buildings, it was considered that they both had the same characteristic as the case study. The 3D representation of all model is represented in Figure 5.

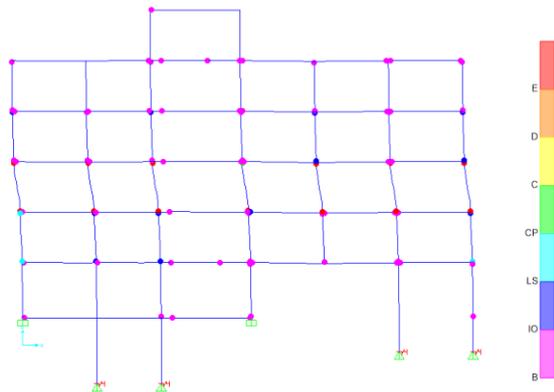
Figure 6 - Damage distribution for the structure without stairs

The following figures demonstrate the damage distribution for the critical lateral load distribution and for the ultimate displacement of the building. In the model considering the stairs, it is evident that the damages are concentrated on the second storey, specifically at the connections between stairs and columns. The significant reduction of the rebars and cross section dimensions used, justify the damage distribution of the structure without stairs. The consideration of the stairs will aggravate the vulnerability of this storey; the columns were not design to take into account the landing slab of the stairs at half height which cause higher interstorey drifts on the columns and would lead to their premature collapse.

In the following figures the color scale represents the state of the plastic hinges for each element, were B stands for the yielding, IO for immediate occupancy, LS life safety limit, CP the collapse prevention and E for the collapse of the section.

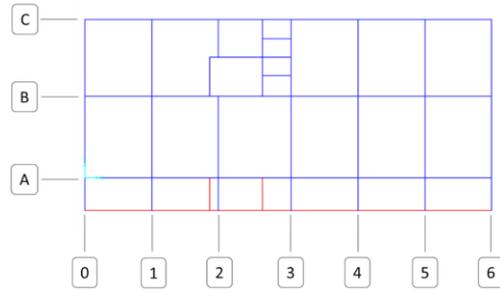
Figure 8 - Frame alignments considered on the structure

Due to the low values of the interstorey drifts on the structure, the flexure demands on the vertical elements are reduced, with exception to the ones where the stairs land at half height. In Table 6 are represented the ductile safety verifications of the vertical elements, for each frame alignment shown on

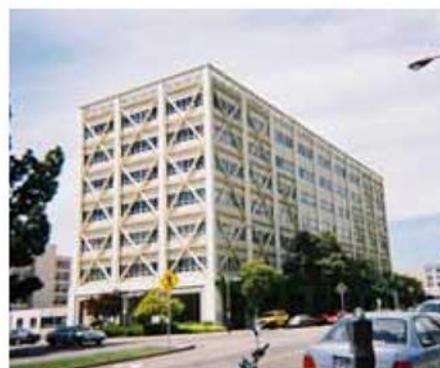
Figure 9 - Example of steel bracing on the exterior of a building (adapted from [14])

During the past decades, a few studies have been developed around the best solutions to increase the strength capacity of a building as a whole. One of the solutions that has been gaining recognition along the years is the steel bracing. This solution can be applied on both the inside and the outside of the building, but it is on the outside that this solution is gaining recognition as it can be installed in a building without the need to relocate the inhabitants. In Figure 9 an example of steel bracing on a building is presented.

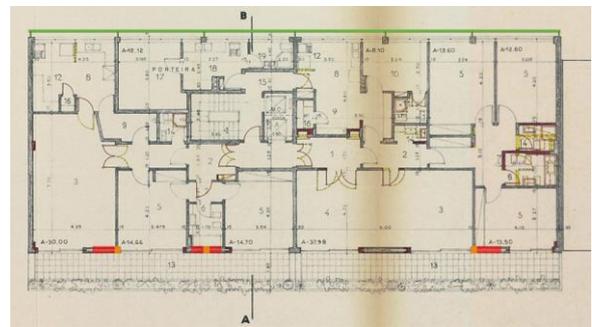
Figure 10 - Main Retrofit solution

The results of the seismic analysis indicated that the building's structure did not comply to the minimum requirements for the safety verification of the structure. It was verified that most the vertical elements had insufficient shear resistance. Moreover, for the columns of the stairs, the collapse is controlled by flexure. Due to the vulnerable seismic behavior of the building's structural elements the approach strategy to be followed should be global. This approach would include new elements in the structure to reduce the seismic demands upon the structural elements (see Figure 10).

The retrofitting proposal for the current building foresees a steel bracing on the back façade, represented in green in Figure 10), and the inclusion of reinforced concrete walls in the main façade, represented with yellow the existing columns and red the new walls. This solution, presented in Figure 10, has the advantage of having a minimum intervention in the building's architecture, being the steel bracing on the back façade the only visible change.
