ANALYSIS AND UNDERSTANDING OF HEAT TREATMENT OF L-PBF TITANIUM PRODUCTS

Abstract

Keywords: Titanium, L-PBF, Mechanical Properties, Heat Treatment

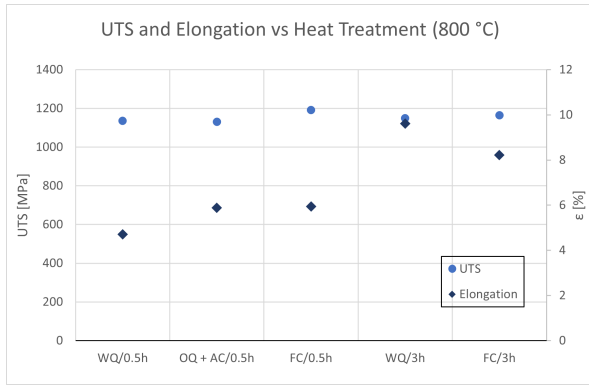
Figure 2: Graphical representation of the UTS and the elongation according to the applied heat treatment, more specifically, at the sitting temperature of 800 °C.

Looking at the coupons heat treated at 800 °C, they all reach values of UTS between 1130 and 1200 MPa. However, those that were treated for 0.5 h present strain values up to 6 %. The ones treated for 3 h reached 8.22 % (furnace cooled) and 9.61 % (water quenched). Interestingly, the specimen that has the highest fracture strain also has the lowest yield stress of coupons that reached the plastic region. The yield stresses covered a wide range from 850 to 1100 MPa. Just like the yield stresses, the elasticity moduli values covered a wide range (90-127 GPa), which is generally not expected and is certainly a result of the defects still present in the specimens.

It seems like the temperature at which the coupons were treated was the main impacting factor of the UTS as it was the only common factor among the parts. After that, the resting time played the major role in affecting the elongation values as they increased for higher times. This is consistent with the fact that the low ductility microstructure found in as-built parts, α' -phase martensite, starts to decompose into more favorable $\alpha + \beta$ phases at around 800 °C. [8] The longer sitting times allow for a greater amount of the previous microstructure to be transformed, and thus improve its ductile properties while maintaining the UTS. At sub-transus temperatures, the cooling rate is expected to be the factor with less influence in the final properties.

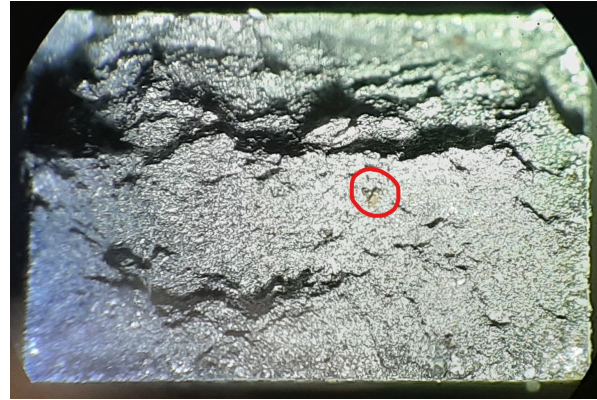
Figure 4: Fracture surface of coupon 15. The photo was taken with a cellphone through a microscope. The red circle highlights a brown spot, which is unexpected in this material.

In figure 4 the fracture surface of coupon 15 is shown. Data for this coupon was not used for the discussion because it slipped twice during the tensile test and the results were not feasible. However, it could be observed that it fractured in the plastic region. There are some differences when compared to P5, namely that the outer area no longer appears to be of ductile nature. Another topic of interest is that there is a brown spot in the center region of the fracture (highlighted with the red circle), the source of which is unidentified.

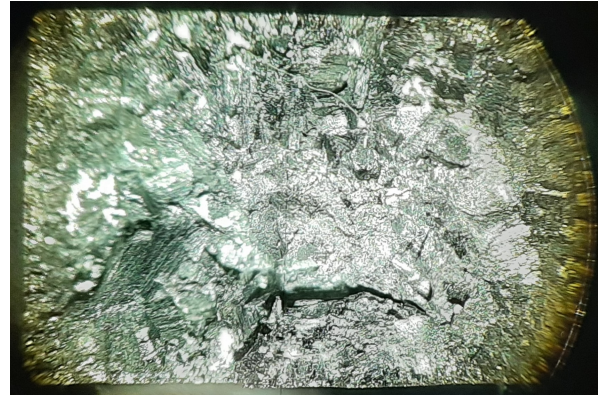
Figure 6: Fracture surface of a coupon treated at 1100°C. The photo was taken with a cellphone through a microscope.

In figure 6 the fracture surface of a coupon treated at 1100°C is shown. Here the type of fracture is completely different from the previous 2 as it is considerably more brittle. This comes as a result of treating the coupon above the β -transus completely altering the microstructure, as previously mentioned.
