# Rehabilitation and Reinforcement of the Industrial Building Reconverted in University with Elimination of Main Columns

Patrícia Alexandra Nogueira Peixoto

**Abstract:** The objective of this work is present a study of the rehabilitation of an industrial building from 1970 to a university building. For this purpose this document can be used afterwards for design and definition of reinforcement solutions for similar situations.

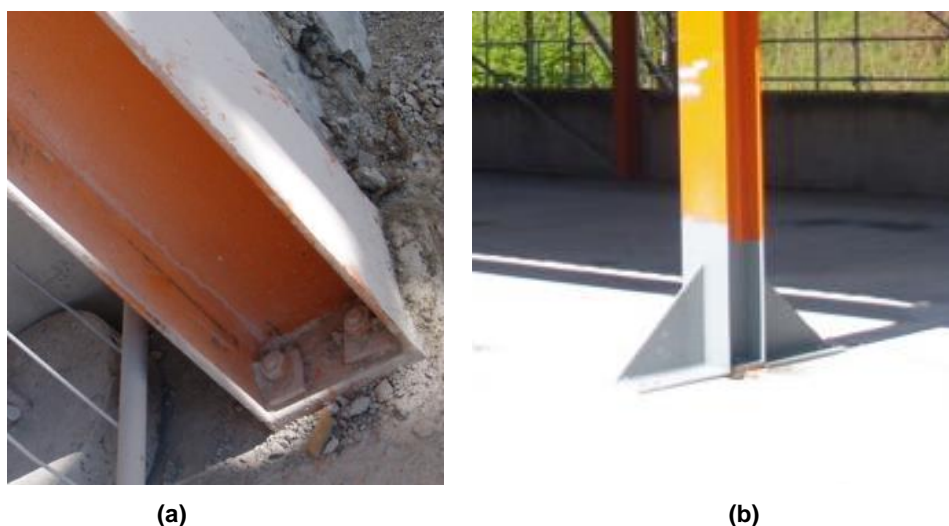
The horizontal displacement of the frame with the interruption of the structure increases 57% in comparison to the previous situation, in the case of suction in the roof, whose horizontal displacements are superior compared to the case of pressure. One of the solutions considered to guarantee stability of this frame was the clamping of its vertical elements in order to increase stiffness and to reduce its displacements, with the introduction of two lateral steel profiles, HEA600, that prevent the rotation of the base of the profile, connected to the reinforced concrete slab (Figure 4).

**Figure 4** – Change in support conditions: **(a)** Fixed support - previous situation. **(b)** Clamping support - current situation .

The introduction of the patio into the steel structure forced the changing of the support conditions of the interrupted frames, avoiding high horizontal displacements. In order to reduce the flexibility of the frames and increase their rigidity, the bases of the frames were fixed to support the frames and their displacements reduce.

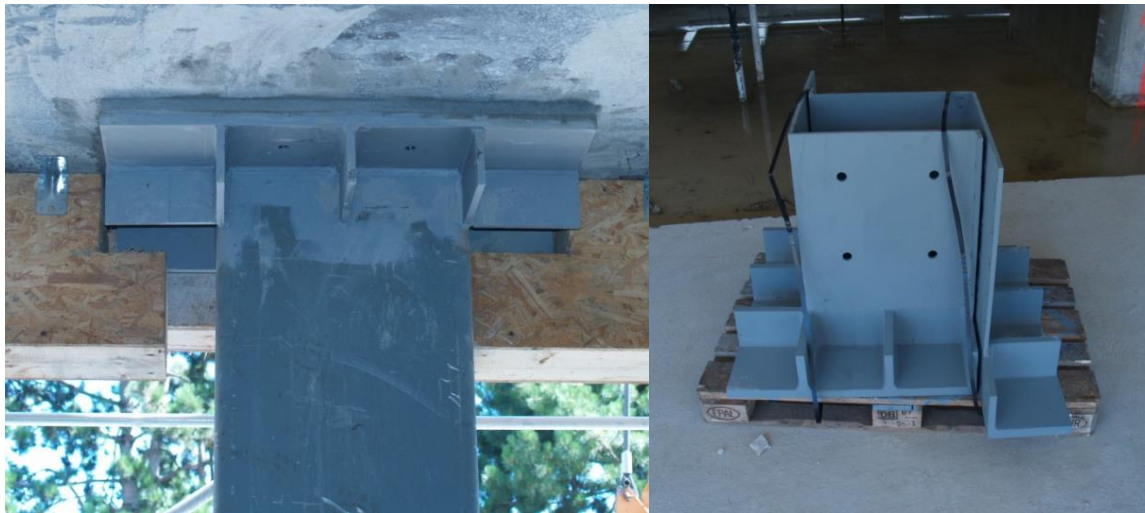
The introduction of a complementary concrete layer is not current used, since the location of the HEB550 profiles adopted would prevent the concrete from being placed on the slab. The increase of the dimensions of the columns throughout its length where the concreting of the superior section of the column near the slab would have to be realized with vertical holes in the slab, affecting its resistance, because the positioning of the ordinary reinforcement in this one is not totally known. The application of steel capitals in the heads of the columns is the solution used (Figure 5).

(a) (b)  
**Figure 5 - (a) (b) Steel capitals in the heads of columns.**

The comparison of the transverse acting force, with the transverse resistant load of the slab, by the equation (1), validates the safety of the slab to punching shear for most of the vertical elements. In the case of columns B6, D4, E3, E4 and E5, the strength of the slab is insufficient to transfer the forces.

As previously mentioned, changing the load of the building and changing the conditions of support of the slab require checking the safety of the slab by comparing the two loading conditions of the slab which lead to the need of increasing punching shear capacity by means of steel capitals.
