Detection of Corona Effect on Composite Insulators

João Miguel Esperança de Brito, 73394
 Instituto Superior Técnico
 joao.m.brito@tecnico.ulisboa.pt

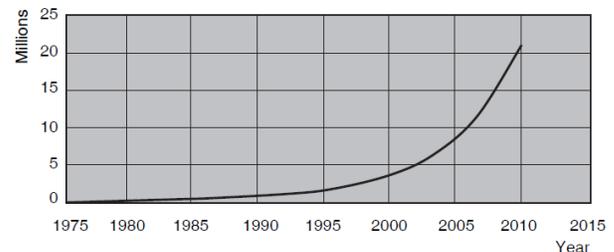
Fig. 1 – Number of polymeric insulators, for voltages higher than 69 kV, extracted from [2]

The main advantage on the use of composite insulators is their higher performance over traditional ceramic and glass insulators, under pollution conditions. In Portugal, they are currently used in medium, high and very high voltage lines, mainly located in coastal regions, where there is strong saline pollution.

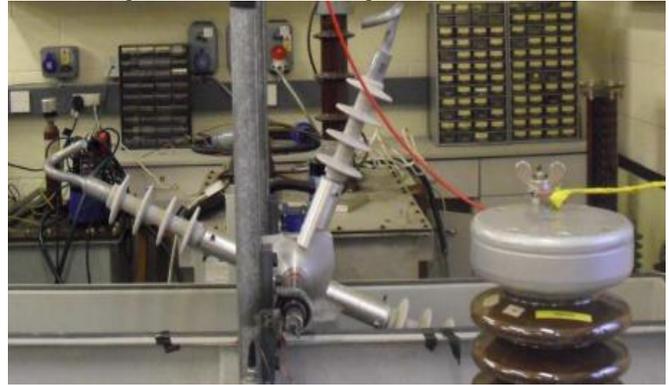
This test is included in the category “salt-fog” as it aims to test the strength of an insulator to erosion, by subjecting it to a salt water spray. The insulator is mounted in a wheel test (Fig. 2) and subjected to a voltage depending on its leakage distance (28.6 mm/kV).

Fig. 2 – Insulators on a wheel test, extracted from [5]

This test is usually conducted following one of two different procedures, low salt concentration with the duration of 1600 hours, or high concentration during 1000 hours [4].

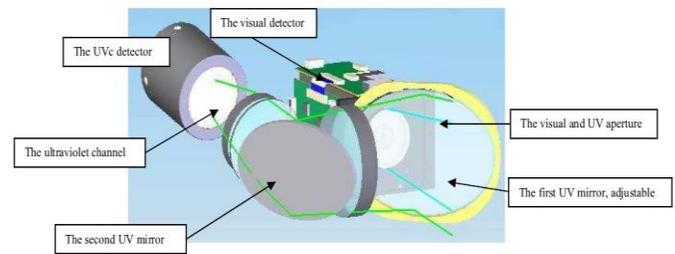
The UV radiation is then filtered to exclude the wavelengths outside the solar blind area and is then received by a suitable sensor. On the other hand, the visible radiation is received by another sensor dimensioned for processing the wavelengths of this radiation range.

Finally, a bispectral image with the two synchronized components is obtained by using the visible signal as background on which the UV emission points are printed [12].

Fig. 3 – Scheme of a bispectral UV camera, adapted from [12]

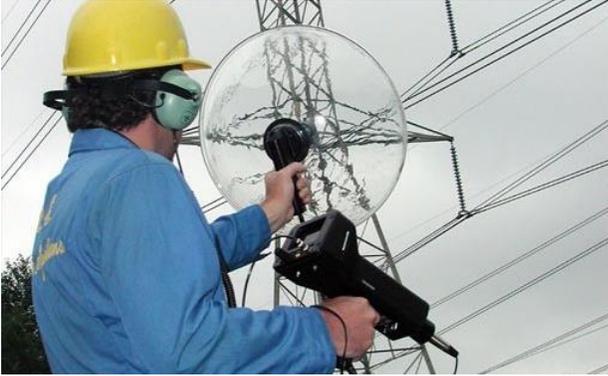
One of the limitations of this technology is that the measurements require to be carried out at short distances, with the maximum range of Ultraprobe 10,000 and 15,000 being about 10 meters, as it was possible to understand through contact with the company UE Systems. This value can be doubled using a UWC (Ultrasonic Waveform Concentrator) which is particularly useful for inspection of line insulators, as shown in Fig. 4.

Fig. 4 – Ultraprobe 10,000 equipped with UWC, extracted from [16]

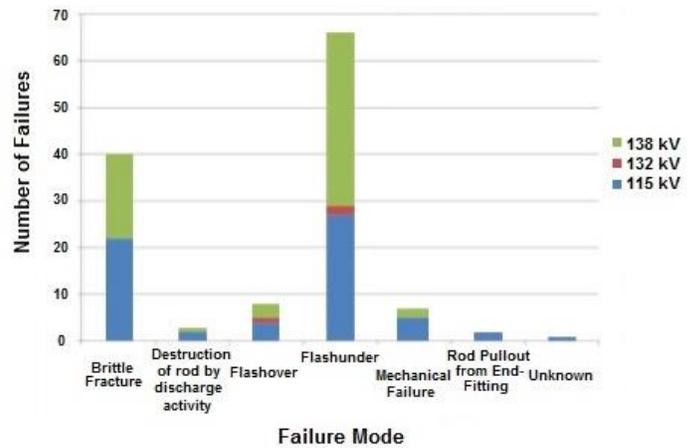
Motivated by the occurrence of failures in composite insulators in the USA, at 115, 132 and 138 kV voltage levels (Fig. 5), EPRI (Electric Power Research Institute) started in 2006 to conduct a study with the purpose of understanding them so that they could be later prevented [23].

Fig. 5 - Failure modes in composite insulators in USA, extracted from [24]

The researchers focused at the insulators of the 115 and 138 kV lines, detecting corona effect in a significant number of those. In the cases where corona effect was detected, corona rings were applied, followed by a new inspection. It was found that its application totally mitigated corona effect in all insulators [23].

Then some insulators were removed from service and subjected to visual inspection. The insulators that showed the greatest signs of ageing were the same where previously corona effect was detected [24]. For this reason, it can be concluded that this is the main cause of premature ageing, responsible for the failures in the composite insulators.

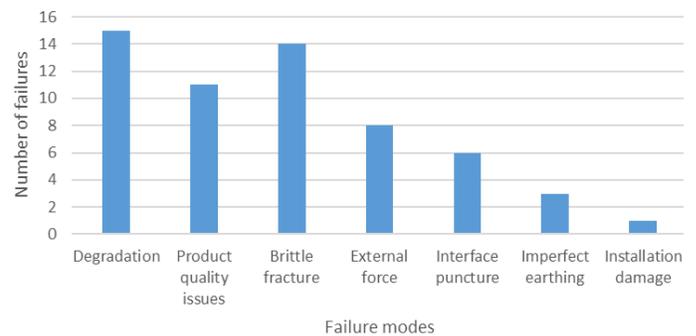
One of the studies developed in this subject, was conducted by Prof. Guan Zhicheng, from Tsinghua University. The study went through the accounting and investigation of the failures occurred between 2000 and 2006 (Fig. 6).

When analyzing the graph, it is noted that 69% of the failure modes are related to defects in the manufacture because, as previously mentioned, a brittle fracture is a failure mode that results from ageing of insulators.

Fig. 6 - Failure modes in composite insulators in China, extracted from [25]

When doing a quantitative analysis of failure modes, it can be verified that their proportion is very small, because there were failures in 58 composite insulators out of a total of 2,2 million installed. On the other hand, considering that most of these have been applied to the Chinese lines for about a decade, more accurate conclusions will require a longer service experience.

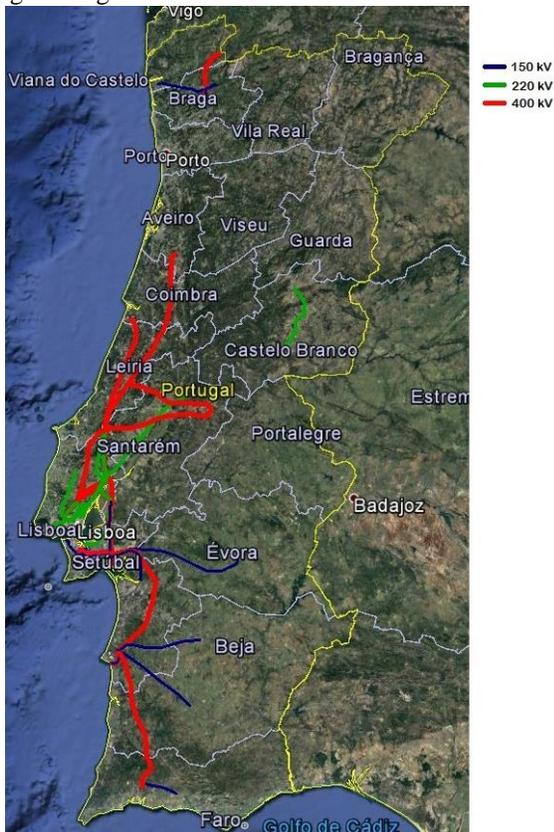
Regarding the use of line composite insulators in Portugal, these began to be used by REN in 2007 (Fig. 7), and are currently also used by EDP Distribuição, in medium, high and very high voltages.

Fig. 7 – Overhead lines with composite insulators, from REN

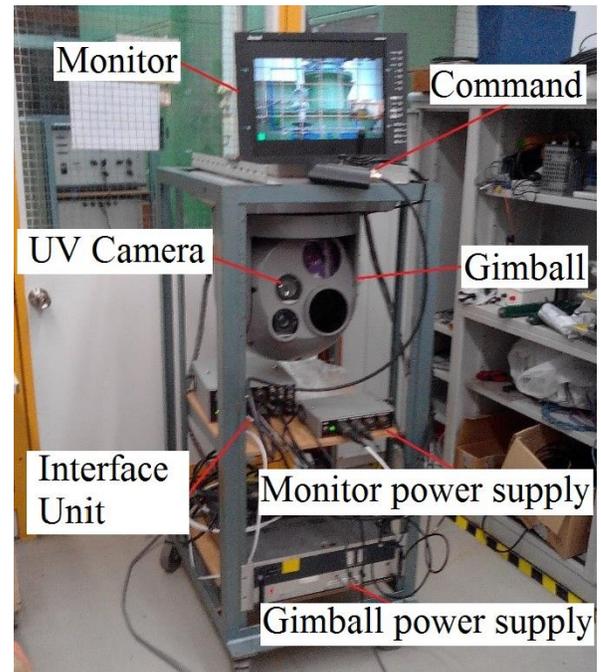
The experimental component was divided into 3 different experiments. To perform the detection of partial discharges, the ultraviolet camera SWE-400, from SweSystem, was mounted in a rack along with its power supply and a signal processing unit (Fig. 8), which grants the interface between the gimball and the monitor and computer. By using the software provided by this same company, WebcamViewer and VideoView, photos and videos can be saved, in real time, directly on the hard disk of a computer.

Fig. 8 – Apparatus used for corona detection

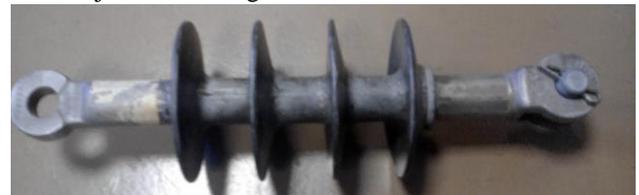
The tests were conducted with the objective of detecting corona effect on a composite insulator (Fig. 9) which was stored in Labelec facility for about 6 years and has never been used or subjected to voltage.

Fig. 9 – Composite insulator tested in experiment 1

- Test 1 - Dry insulator, no defects
- Test 2 - Dry insulator, copper string applied
- Test 3 - Wet insulator with water
- Test 4 - Dry insulator with puncture (1st shed)
- Test 5 - Dry insulator with puncture (1st shed) and cut (4th shed)
- Test 6 - Wet insulator with puncture (1st shed) and cut (4th shed)
- Test 7 - Wet insulator with puncture (1st shed) and cut (4th shed)
- Test 8 - Dry insulator with puncture (1st shed) and cropping (4th shed)
- Test 9 - Wet insulator with puncture (1st, 2nd and 3rd sheds) and cropping (4th shed)
- Test 10 - Wet insulator with puncture (1st, 2nd and 3rd sheds) and cropping (4th shed)

Based on the tests, it can be concluded that the insulator, in dry conditions, maintained high dielectric supportability when subjected to the mechanical defects. That is shown by the absence of both corona effect and electric arc in tests 4, 5, 8 and 10, for all voltages applied.

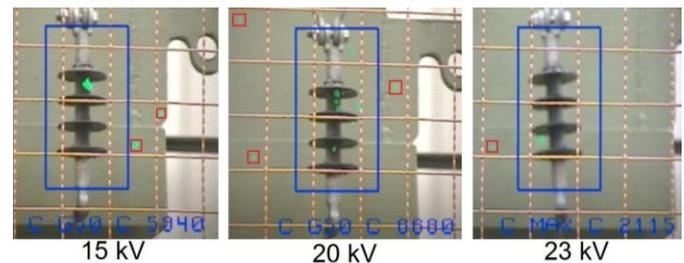
It was noted the occurrence of effluvia, indicators of the occurrence of partial discharge, in unexpected regions away from the insulator (Fig. 10). These were noted to have occurred with greater intensity and frequency in the tests on which corona effect was detected. It can be then deduced that these are only perturbations in the air molecules, caused by its partial disruption, but that have spread, instead of being circumscribed to the surface of the insulator.

Fig. 10 – Effluvia away from the insulator surface

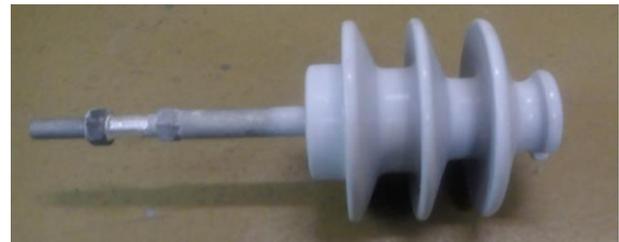
The experiment 3 was conducted to detect corona effect on a 30 kV polymeric coated ceramic insulator (Fig. 12), which was divided into 6 tests:

Fig. 12 – Polymeric coated ceramic insulator used in experiment 3

The mechanical defects that were intended to be applied to the insulator would be the removal of part of the polymeric coating and the breaking of part of the 1st shed, that that its impact could be testes in the occurrence of corona effect. However, that was not possible since such damage would be irreversible and thus not fulfilling the need to preserve the mechanical integrity of the insulator.

Based on the results of tests 2 and 3, it is found that the impact of ash applied on the surface strongly depends on the condition of the insulator, being dry or wet.

For the voltage levels applied, the ashes used in test 2, deposited on the dry insulator, did not cause corona effect, so it can be concluded that the critical voltage value is, in this case, higher than 30 kV.
