# Vierendeel mechanism on steel beams with web openings

## Experimental and numerical study

Civil Engineering Department of Instituto Superior Técnico, October 2017

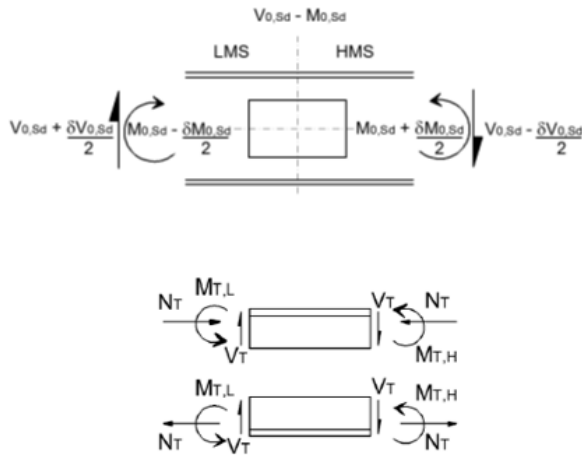
Besides supporting the bending moment and shear force acting at the centre of the opening, the corner sections are also subjected to a local bending moment, Vierendeel bending moment, represented in figure 1.

**Figure 1** Vierendeel's local bending moment. Adapted from (Chung & Ko, 2003)

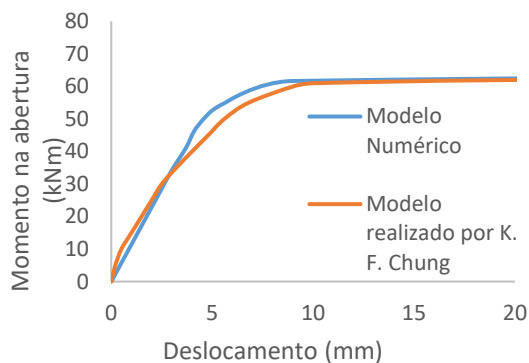
All that is missing is calibration of the model. This part is made by comparing the results obtained by the model made with results obtained by Chung & Ko [1], as shown in pictures 6 and 7. Since the results for both beams are very similar to the ones modelled by the authors, the calibration of the steel beams is completed.

Figure 5 Comparison of the results for beam 2A

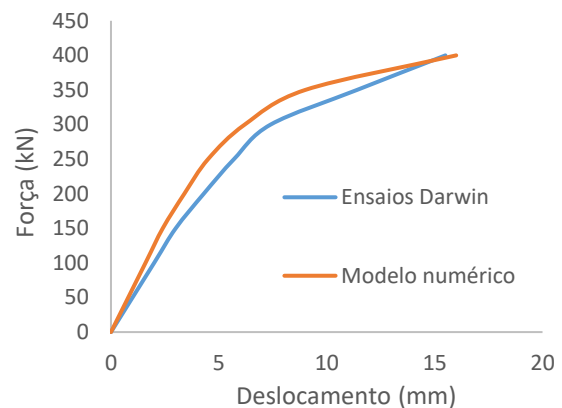
The calibration was made by comparing the obtained results with the results of one of Clawson & Darwin [5]'s experimental tests. The comparison of the results is shown in figure 9. Once again, the results obtained were very similar to the ones obtained by the authors, thus completing the model calibration.

Figure 8 Results for the calibration of the composite beams

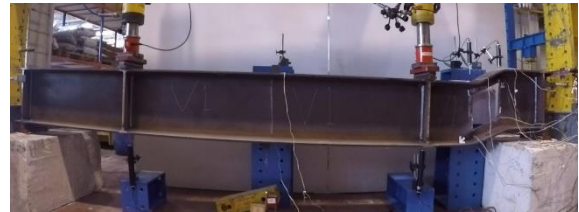
Figure 19 illustrates the deformed shape, where it is observable besides the opening, the beam's shape is completely linear.

Figura 18 Beam's final deformed shape

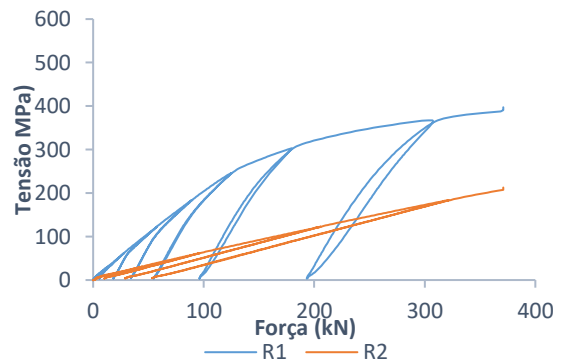
The results obtained at the rosettes are shown in figure 19. Rosette R1, placed further from the corner, has a slower growing rate than R2

Figure 19 Maximum Compression tensions at both rosettes

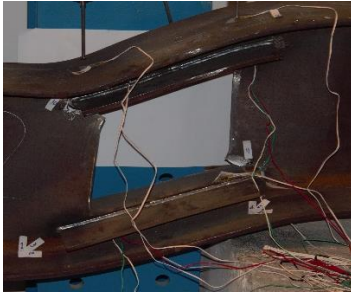
At failure, the deformations at the opening were clear. It is perceptible that the corners in which

the local bending moment induces tension, it created wide fractures.

On the other hand, the corners where the local bending moment induces compression, the web buckles outside of its plane. The deformations on the opening are shown in figure 18.

**Figure 23** Deformation at the web opening

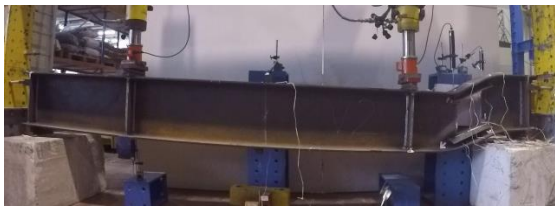
Figure 19 illustrates the deformed shape, where it is observable that besides the opening, the beam's shape is completely linear.

**Figure 24** Beam's final deformed shape

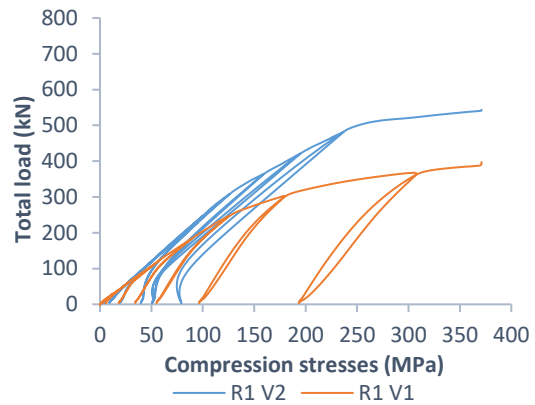
In terms of stresses, the results comparison for R1, illustrated on figure 28 show that the maximum principal compressions stresses have a faster growing rate for beam V1, which shows the effect of the reinforcements.

**Figure 27** Comparison of the results at R1 for both beams

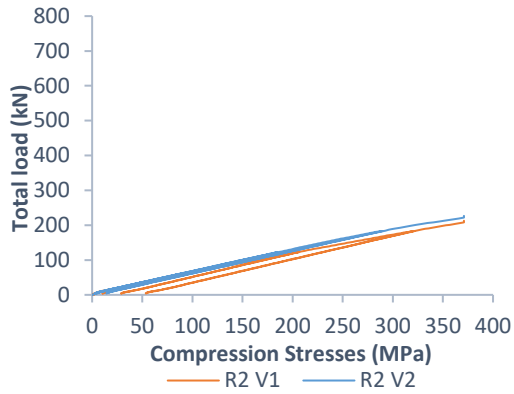
On the other hand, for rosette R2, right on the opening's corner, the results for both beams were more similar, showing that the reinforcement's influence is mostly felt between them and the flanges. The results are shown in figure 29.

**Figure 28** Comparison of the results at R2 for both beams

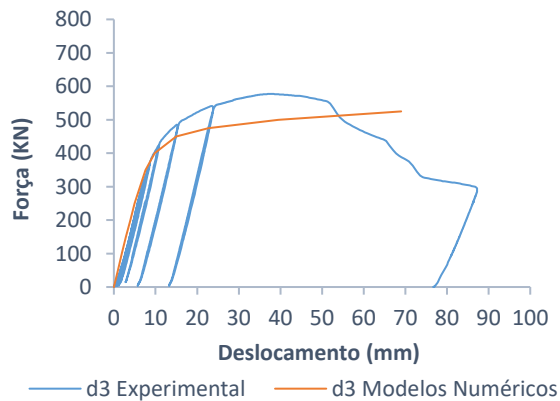
The results comparison for beam V1 show that the model is capable of reproducing the beams elastic behaviour. The comparison of the results is illustrated at figure 30.

**Figure 29** Comparison of displacement d3 for the numerical model and experimental test

It is also clear that the plastic behavior of the beam is not well reproduced by the model. The software is missing a failure criterion that considers the steel cinematic hardening.

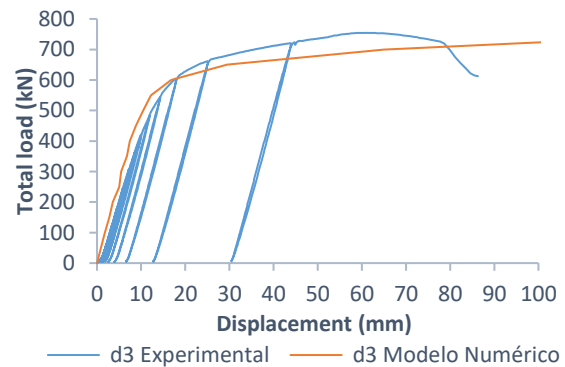
The results comparison for beam V2 show that the model is capable of reproducing the beams elastic behaviour. The comparison of the results is illustrated at figure 32.

**Figure 31** Comparison of displacement d3 for the numerical model and experimental test

It is also clear that the plastic behavior of the beam is not well reproduced by the model. The software is missing a failure criterion that considers the steel cinematic hardening.
