Damage Assessment of *Pombalino* building due to ground movements: Analysis of a *Pombalino* building in a block at Lisbon's downtown

October 2017

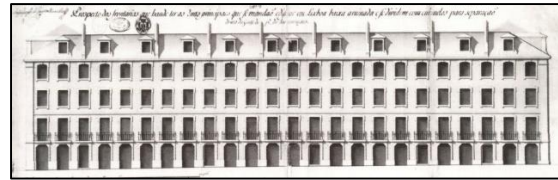
They are divided by gable walls and normally have five floors: ground floor, noble floor, two upper floors and attic, as shown in Figure 1. The height of the façades was approximately equal to the width of the main streets. They were characteristic of many repeated openings of large size.

Figure 1: Typical *Pombalino* building, courtesy of Lisbon Story Center.

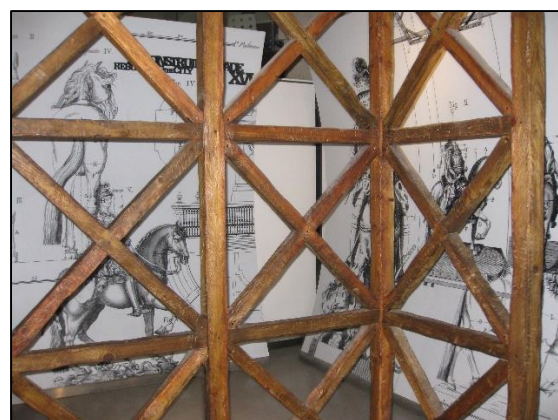
The outer walls were composed by masonry, which thickness decreased with height. The frontal walls had wooden elements arranged horizontally, vertically and diagonally, connected together to form triangles, known as the crosses of *Santo André* (very resistant to actions in their plane, (Lopes et al, 2005), represented in Figure 2). They improve the resistance to horizontal actions and constitute important elements of energy dissipation.

Figure 2: Crosses of *Santo André*, courtesy of the Lisbon Story Center.

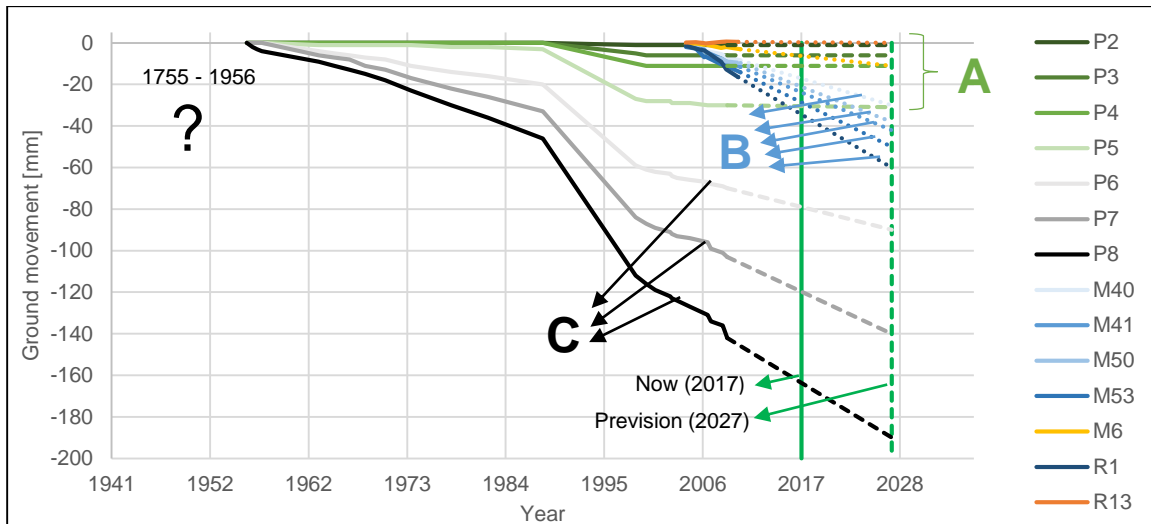
Based on the analysis of ground movements records measured by: surface marks, levelling rulers and measuring points, three different types of behavior were identified, as shown in Figure 6. Group A showed a stabilized behavior,

neither visible settlements nor visible trends of increasing settlement. Group B with a tendency to increasing settlement, but with angular distortion lower than 1/1500, and a group C with an angular distortion rate between 1/700 and 1/400 in approximately 60 years.

Figure 6: Behaviour of surface markings, levelling rulers and measuring points recorded in downtown Lisbon.

The analysis of the records of ground movement revealed the existence of three different types of movement rate: group A showed no visible trends of settlement increase, group B showed a gentle increase trend, with angular distortion values lower than 1/1500 (10 years' period) and group C which has a trend to increase settlement and angular distortion values between 1/700 and 1/400 (60 years' period).

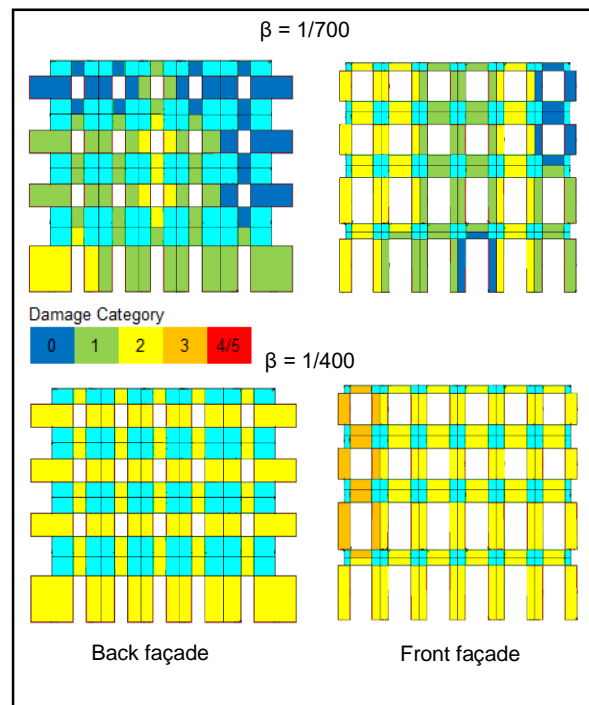
Figure 7 plots the damage categories on the front and back façade. It is based on the empirical method proposed by Boscardin and Cording (1989) to assess damage due to differential settlements.

For an angular distortion of $1/700$, the façade has three categories of damage: 0 (irrelevant), 1 (very slight) and 2 (slight). For an angular distortion of $1/400$, the back façade has only one category of damage, 2 (slight) and the front façade has two categories of damage, 2 and 3 (average).

Figure 7: Damage pattern to the back and front façades due to the methodology proposed by Boscardin and Cording for angular distortion of $1/700$ (above) and $1/400$ (below).

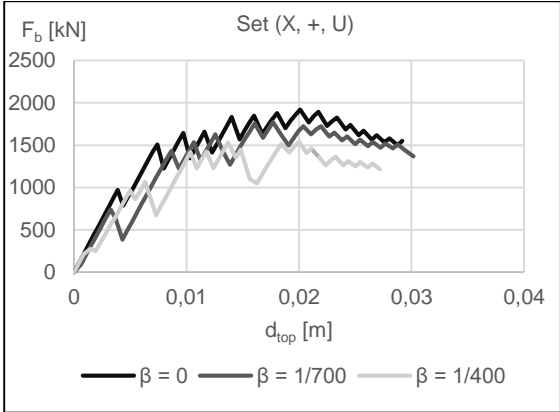
For set (X, +, U), each capacity curve with different angular distortion's values are also presented in Figure 12.

It is observed for the set (X, +, U) and $\beta = 0$, that the curve presents higher ultimate shear force and reaches bigger ultimate displacements. The rigidity of the curves for $\beta = 0$ and 1/700 is

similar, however, it is decreased for the $\beta = 1/400$ curve.

Seismic resistance and ductility are significantly affected when the structure is previously subjected to differential settlements. Especially for 1/400 angular distortion.

Figure 12: Capacity curves with different angular distortion to the set (X, +, U), (all curves stop when du is reached).

Seismic resistance and ductility are significantly affected when the structure is previously subjected to differential settlements. Especially for 1/400 angular distortion.

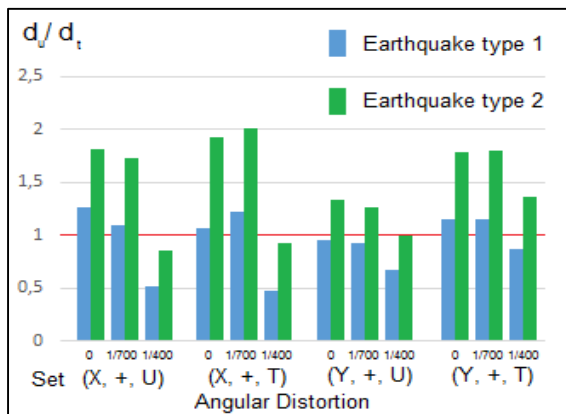
In Figure 13, it is shown the relation between ultimate displacement, d_u , and target displacement, d_t , for each value of angular distortion and set. The d_t is evaluated according N2 method (CEN, 2010). If the ratio d_u/d_t is lesser than 1, it means the structure does not verify the safety check.

Earthquake type 1 (far-field action) is more demanding than the earthquake type 2 (near-field action) for the structure under study.

For the sets which have ($\beta=0$ and 1/700) only one set does not verify the safety, for an angular distortion of 1/400, all sets do not verify the safety.

Figure 13: Ratio between the ultimate and target displacement, for earthquakes type 1 and 2 and for each set, as a function of the angular distortion values.

The seismic assessment of the building was performed by means nonlinear static analysis, N2 method, It is observed that the building does not verify the seismic safety criterion according EC8, regardless of whether or not the structure has previous settlements. The earthquake type 1 is more demanding than the earthquake type 2.
