GFRP rebars for concrete structures. Effect of elevated temperatures on the bond behavior of GFRP bars to concrete

Romeu da Costa Carvalho

IST, Technical University of Lisbon, Portugal

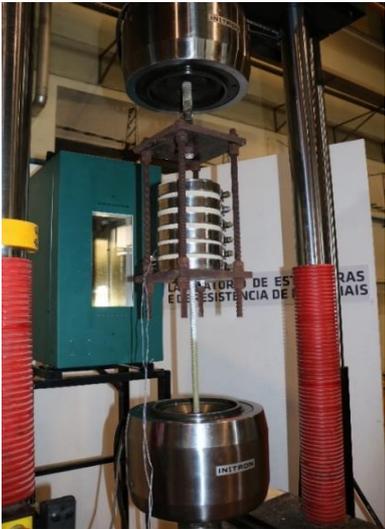
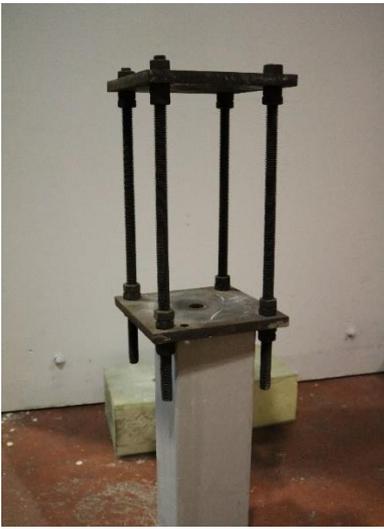
Figure 4 – Instron Universal testing machine (left); metal frame used in the pull-out tests (right).

The test setup used in the pull-out tests is illustrated in Figure 3. To perform the experimental campaign, an *Instron* universal testing machine was used with a 250 kN capability (Figure 4). To heat the specimens, a *Tinius Olsen* thermal chamber was used, with dimensions of 605 x 250 x 250 mm and a maximum heating temperature of 300 °C. To measure the temperature inside the specimens during the test, type K thermocouples with 0,25 mm diameter were used, positioned as illustrated in Figure 2, in the rebar-concrete interface; to measure the temperature inside the chamber, a third thermocouple

To place the concrete specimens inside the thermal chamber, a special metal frame was built, composed of two metal plates and connected with steel rods, with dimensions of 200 x 200 x 16 mm.

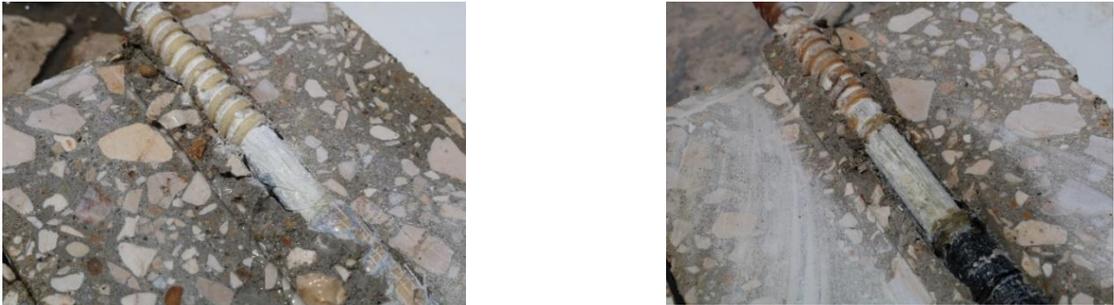
Figure 8 –(left) specimen tested at 140 °C; (right) specimen tested at 220 °C.

After all the tests, the specimens were saw cut in two parts, for a visual confirmation of the failure modes and to determine the extension of the damage underwent in the materials and in the GFRP-concrete interface. In both campaigns the damage of the rebars increased with temperature. Between 140 and 220 °C the ribs were ripped off from the surface of the rebar, with some broken fibers were observed at the rebars' surface Figure 8. At 300 °C the damages were more severe, with the ribs totally ripped off from the rebar's core, and with more broken fibers visible at the surface. Some residues of resin and fibers were also found at the concrete surface Figure 9.

2. The visual observations of the specimens allowed confirm the damage underwent by the rebars and GFRP-concrete interface. For temperatures above 120 °C the surface of the rebars was severely damage, with the ribs ripped off from the rebars core; Between 140 °C and 220 °C most of the rebar was severely damage, with fibers residues in the concrete. At 300 °C the core of the GFRP rebar was damage with fibers exposed along the rebar

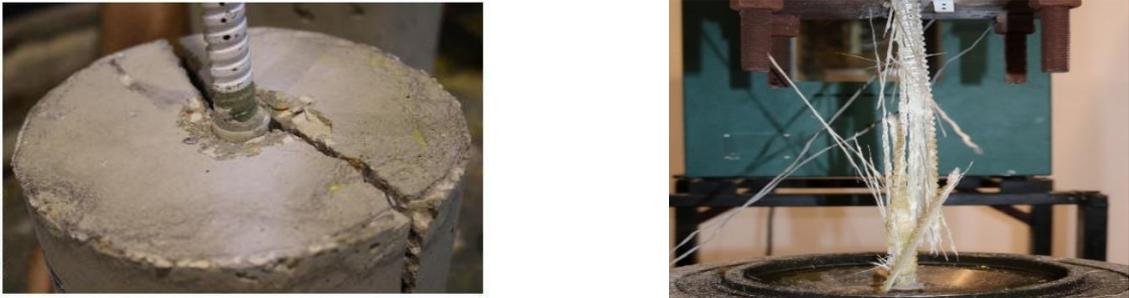
Figure 9 – Failure modes observed during the pull-out tests performed: (left) splitting failure in the straight rebars at 100 °C; (right) bent rebar at room temperature.

out of the GFRP rebar. In the straight rebars at 100 °C the failure mode occurred by concrete splitting - in this case the confinement provided by the metal brackets was not enough to prevent this premature failure mode.

For the pull-out tests with bent rebars at ambient temperature, tensile failure of the rebars were observed in two of the specimens, while for the remaining two specimen the detachment of the concrete above the bent portion of the rebar was observed. At elevated temperatures two failure modes were observed: i) the detachment of the concrete above the bent portion of the rebar and ii) pull-out of the rebars. For the higher testing temperatures, only the failure mode ii) was observed.
