Study of seismic behaviour of a "Gaioleiro" building

André João Silva Ferreira

October 2019

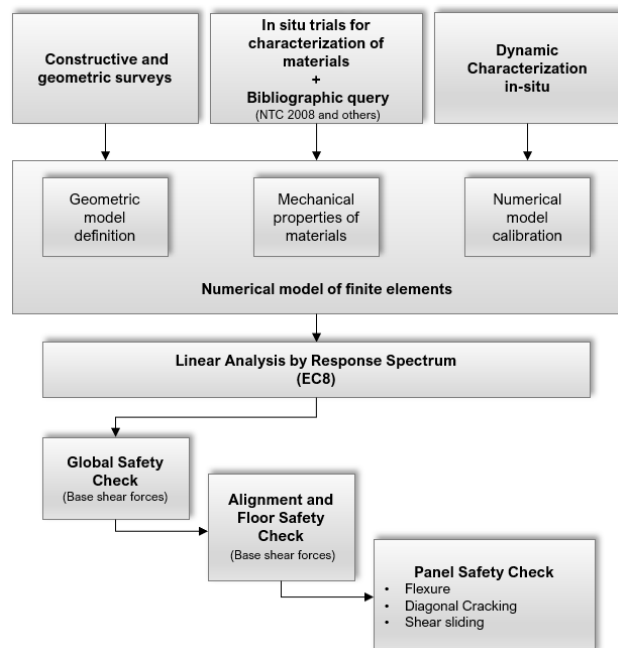
Figure 2 Applied methodology.

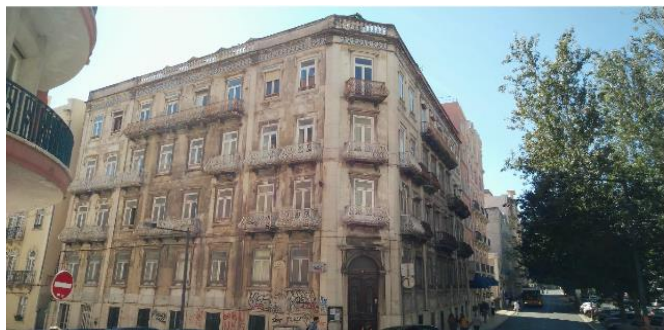
Completed in 1906, the building under study is located in the Coração de Jesus parish. It measures approximately 22 m in length and 24 m in height (figure 3). The building has six floors: one of which consists of a semibasement, a ground floor, three high floors and an attic. On the first five floors, the right foot is constant of 3.5 m, except in the meekness that presents 3 m.

Figure 3 Main building façade

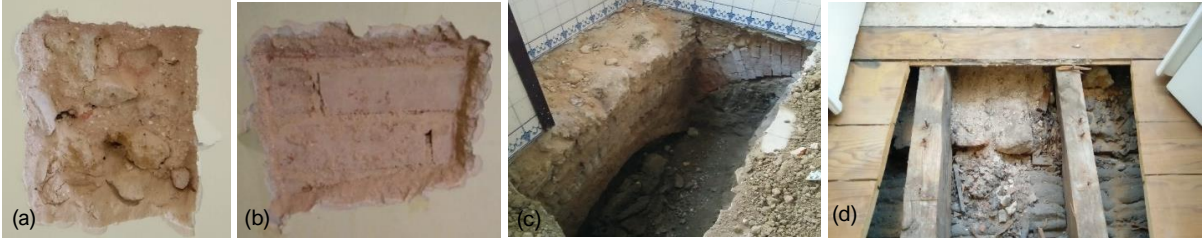
with viewing windows on walls and slabs on the third floor. As well as of probing wells in the foundations of the building. Figure 6 shows in the plant the location of the viewing windows performed and in Figure 4 depicts some of the samples obtained. The figures (a) and (b) represent samples of JI3 (façade wall) and JI13 (inner wall). The probing well in Figure 4 (c) was carried out on the ground floor, located in Figure 6. In this well it was possible to verify that the walls are seated on brick masonry arches. In Figure 4 (d) it is possible to observe that the floor beams seats on the wall of the PEF 1 façade.

Figure 4 Viewing windows carried out: (a) JI 3 - Irregular stone masonry; (b) JI 13 - Brick masonry; (c) Probing well (PS); (d) Wood floor (IP B)

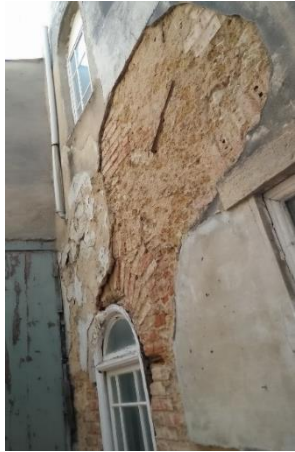
Often one can also find in this type of buildings brick masonry arches in the upper area of the of windows designed to forward the loads to the adjacent zone (figure 5). Usually this type of buildings has undergone severe changes in the original layout of structural elements (Simões, et al., 2017). In this case of study, there were two major interventions that undermined the seismic behaviour of the building. The first took place somewhere between the conclusion of the building and its first intervention (1944), the lobby underwent a significant intervention as it doubled its original size. Later, between 1944 and 1955, to improve the commercial space in the semibasement, it was decided to open large spans both on the right and left side of the building (in relation to the axis of symmetry).

Figure 5 Masonry arch over window (orange)

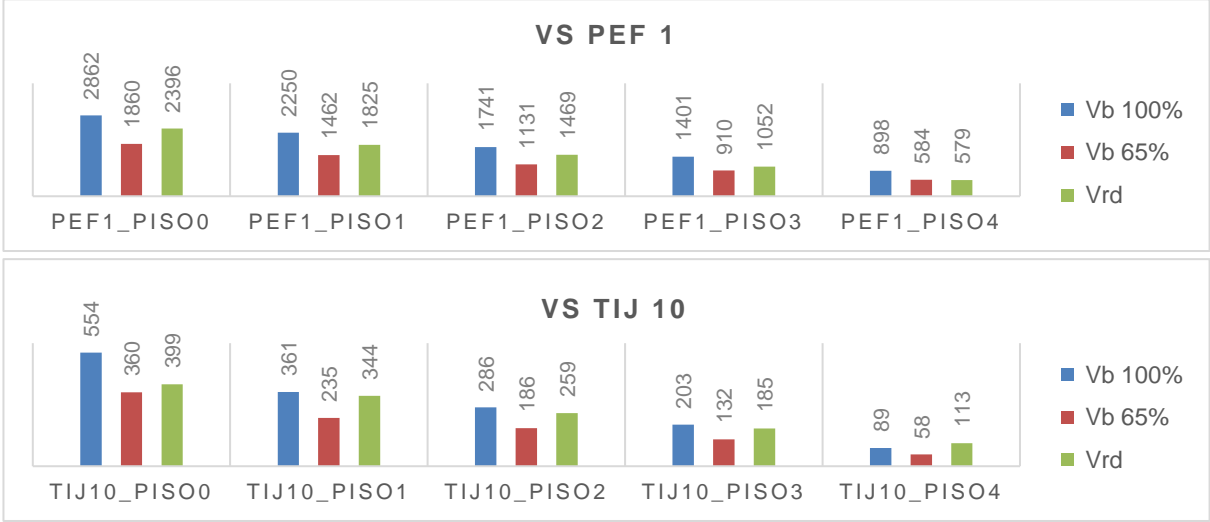
To match a global and a more detailed analysis (per panel), an alignment and floor verification will be put forward in order to understand which ones are the most conditioning. This analysis will be performed for the shear rupture with the same method on 5.1. Figure 9 shows the seismic analysis performed in the load-bearing walls, PEF1 and TIJ10.

Figure 9 Representative graph of the safety check of the PEF 1 and TIJ 10 alignments (100% and 65% of seismic action).

Among all checks carried out in each alignment of the building, the safety check on the ground floor was achieved on the 65% mark, in opposition to the 100% mark when it didn't occur. It is also possible to understand that on the upper floors, both for the 65% and 100% of seismic action, the probability of this type of collapse mechanism to take place is higher. This is mainly due to the existence of lower compression and shear.

Compared to the analysis on 5.1, there is some inconsistency in the overall security check of the structure. This is due to the sensitivity that this mode of rupture presents in the face of the weight of the building introduced in the second portion of the shear resistance (V_{Rd}). In the verification by alignment and floor, it is shown a greater coherence with reality due to better detailing of the attributed forces, as well as the consideration of mechanical properties.
