# Inspection, evaluation and rehabilitation of steel bridges

Mariana Cardoso Marques  
marianacardmarq@gmail.com  
IST - Technical University of Lisbon, Portugal  
October 2019

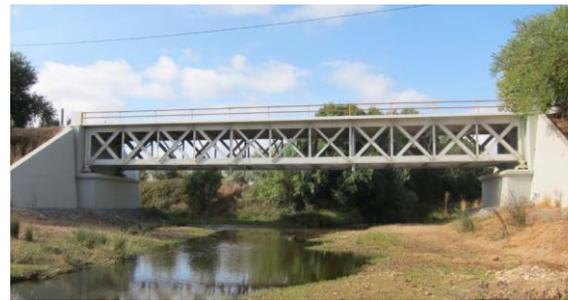
The bridge in question is a small span bridge with a metal frame solution and reinforced concrete deck that is simply supported (figure 1) [22].

Figure 1: Bridge over Ribeira do Garvão [23].

It has a free span of 31,0m and 6,8m of board width, and the lattice metal structure is composed of two main beams with height of 3,0m (upstream and downstream) braced crosswise by transverse girder (with constant spacing of 2,86m) made of vertical flat trusses and horizontally by two braces, one at the level of the lower flanges of the main beams and another at the level of the concrete slab. The metal structure is made up of metal bars and angles of various sizes and flanges, solidified by rivets, resulting in composite profiles ("U", "I" and "T") [23].

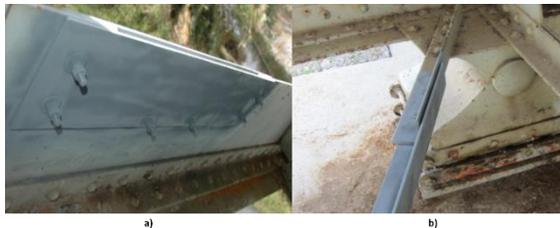
**Figure 2:** Places of sampling: (a) lower truss rope core plate; (b) diagonal of lower bracing [22].

One of the works in the specifications was to characterize the materials of the structure. For this purpose, tensile, chemical composition and fatigue tests were performed. The two samples were extracted near the right support, one from the lower rope core web of the upstream main truss and the other from one of the lower bracing diagonals. Four specimens were taken from each sample, two being tested for traction, one for fatigue and the other subjected to chemical analysis. In the areas where the samples were taken, the cross sections were replaced. To the core plate were added two plates which were placed laterally to the existing core plate and connected with screws, as shown in figure 2(a). The angle of the bracing, consisting of an angle, was completely cut and the continuity of the existing element was restored by placing a bolt-on angle section, figure 2(b).

From the tests performed the average yield strength obtained was 265MPa and the minimum value 237MPa, while for the breaking stress the average value was 353MPa and the minimum value 329 MPa. Based on these results, the safety structure of the bridge was considered for the strength class S235 for steel of the steel frame elements. From the two fatigue-tested specimens, it was found that both resisted until the end of the  $2 \times 10^6$  cycles application, showing no cracks or breaking. From the chemical analysis it was concluded that it must be a wrought iron. The metal has a high amount of impurities, particularly phosphorus and lead, so it is not advisable to use welded joints and riveted or bolted joints should be used. In view of the results of the tests mentioned above and, based on the analysis of the structure submitted to the defined regulatory actions, a safety check was performed using calculation programs. Safety is not verified in the compressed diagonals of the main trusses in all modules. These situations result mainly from the reduction of the resistant capacity of the profiles due to the lower inertia buckling effect. In addition to these cases, the metal structure shows signs of degradation due to the widespread corrosion of the various constituent elements. Thus, the measures taken to rehabilitate this structure included replacing the fixing screws of the supporting devices, cleaning, painting and lubricating the supporting devices, reinforcing the main trusses, replacing

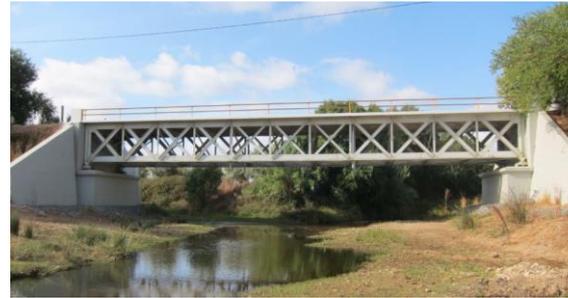
The structure shown in the figure 3 is a road bridge with a steel structure solution with reinforced concrete tray that allows the passage of EN122 over Ribeira do Vascão, whose flow in the area of the artwork has approximately the South-North direction [24].

**Figure 3:** Bridge over Ribeira do Vascão [24].

This bridge from an old decommissioned railway bridge has a 65m span between the extreme supports, consisting of 3 spans with 20m, 25m e 20m. The deck consists of a continuous lattice beam supporting a 23cm reinforced concrete slab. The main trusses are distributed in two planes that are about 6,4m apart and the slab rests on the upper sleepers spaced 2,5m apart. In addition to the two upper and lower ropes, each of the trusses consists of vertical mullions with a 2,5m pattern, each module having two diagonals. The trusses are linked together by horizontal locking and triangular ridges. The latter are formed by diagonal bars and exist in the plane of each of the mullions. In general, the entire metal structure is made up of composite section profiles, consisting of angle or U-shaped profiles and plates with riveted connections. Between the two trusses there is a lower walkway allowing longitudinal access along the entire length of the work [25]. The test plan consisted of tensile and fatigue tests of structural steel and chemical analysis of steel. Three steel samples were taken, one from the lower rope core web of the upstream main truss near the right abutment and two from the diagonal angles of the lower horizontal brace next to each abutment. From each sample were taken three specimens, in which one was tested for traction, one for fatigue and another subjected to chemical analysis. To the core plate were added two plates that were placed laterally to the existing core plate and connected with screws, as shown in figure 4(a). The angle of the bracing, consisting of an angle, was completely cut and the continuity of the existing element was restored by placing a bolt-on angle section, figure 4(b).

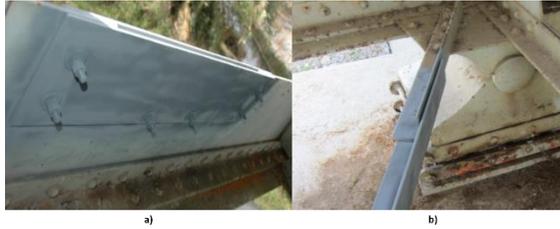
**Figure 4:** Places of sampling: (a) lower truss rope core plate; (b) diagonal of lower bracing near the right abutment [25].

The average yield strength obtained was 247MPa and the minimum value 235MPa, while for the breaking stress the average value is 336MPa and the minimum value is 319MPa. Based on these results, the safety assessment of the bridge structure considered the strength class S235 with  $f_u$  of 320MPa for the steel of the steel structure elements. From the three fatigue tested specimens, it was found that the Fa1 and Fa3 specimens resisted until the end of the  $4 \times 10^6$  cycles, while the Fa2 specimen reached failure in the first cycle. Failure of test piece Fa2 resulted from the fact that in the section where the failure occurred there was corrosion of the material as shown in figure. After rupture of the sample, it was found that in the section of rupture approximately 2/3 of the section area showed corrosion. It should be noted that upon prior observation of the test specimen this behavior was not to be expected as only a small surface corrosion stain was visible with no loss of section.

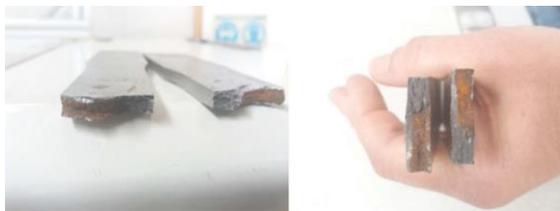
**Figure 5:** Sampling Fa2 after the rupture [25]

The chemical analysis and the information obtained through microscopic observation concluded that it is a wrought iron, material used in the early twentieth century. Steel has a significant amount of impurities, phosphorus and lead. Wrought iron is not recommended for welding and should be bonded through rivets or screws.

In the case of the bridge over Ribeira do Vascão, after the rupture of the specimen subjected to the first cycle of fatigue, the analysis of the state of conservation fell on the suspicion that the entire metal structure was compromised, which led to the decision to replace the entire tray. In this case, further testing could have been carried out in other areas of the structure in order to verify whether that non-visible cracking situation was representative of the overall condition of the structure. The inspection process developed for the two structures was similar and consistent with the systematized process, however it should be emphasized that no *in situ* evaluation methods were used. Inspection actions were based essentially on the visual observation of the various components of the metal bridges, verifying that the most recurrent anomalies explained in chapter 4 are consistent with those identified in the two cases analyzed. However, the need to begin introducing the use of analytical methods complementary to observation is emphasized, as some methods are relatively simple and economical and provide more information and complement visual data on the condition of the structure. It is considered that, in actual reality, these methods are not employed due to economic constraints as, as identified in section 4, some of these NDT tests imply the purchase or rental of expensive equipment. In order to achieve a cost-effective compromise, it is suggested to use less expensive tests such as the penetrating liquids method, magnetoscopy and the use of a hammer on
