**Risk assessment of ground movements: application to a  
case study in Lisbon**

Thesis to obtain the Master of Science Degree in

**Civil Engineering**

**December 2020**

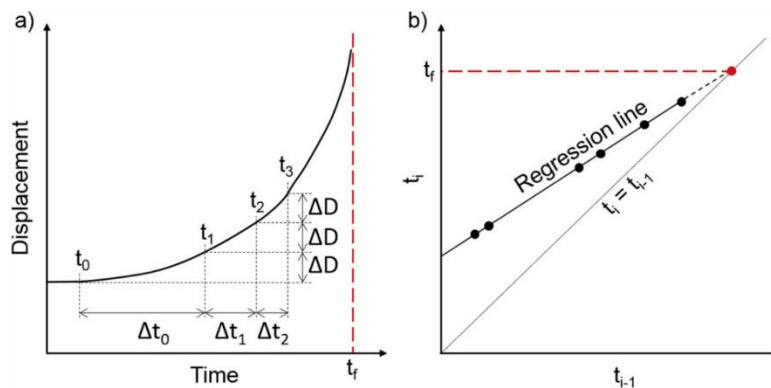
Figure 3.5. Graphical method by Azimi et al. (1988): (a) displacement curve before rupture; (b) variations between  $t_i$  and  $t_{i-1}$  (Intrieri et al., 2019)

Also presenting a graphical method, Azimi et al. (1988) developed Asaoka's (1978) approach to assess the final settlement in an oedometer test, by plotting displacement versus time and individualizing segments of equal displacement,  $\Delta D$ . As velocity,  $v$ , increases the time intervals,  $\Delta t$ , will shorten until  $\Delta t \rightarrow 0$  (Figure 3.5.a), meaning that the final and initial instant of the final time interval,  $t_i$  and  $t_{i-1}$ , respectively, tend to be equal. In tertiary stage, plotting  $t_i$  versus  $t_{i-1}$  will align in a straight line and the time of failure,  $t_f$ , will correspond to the interception of that line with the line that represents the identity ( $t_i = t_{i-1}$ ), that can be extrapolated (Figure 3.5.b).

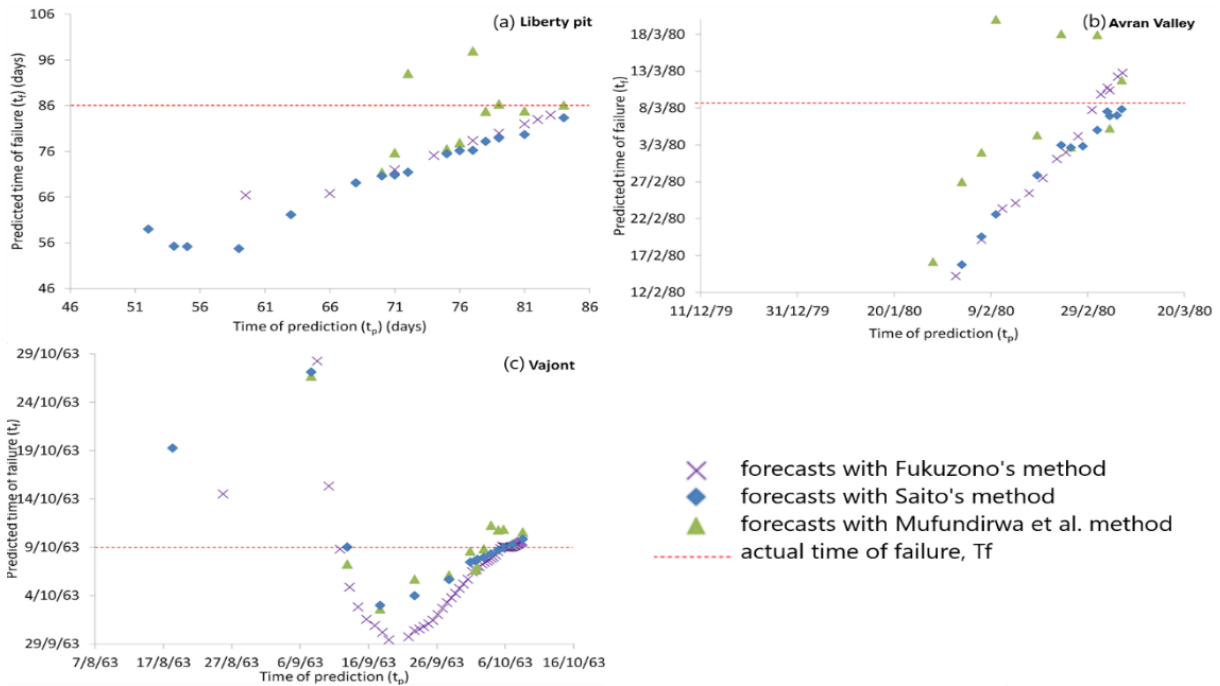
Figure 3.8. Prediction plots of the (a) Liberty pit, (b) Avran Valley and (c) Vajont landslides (adapted from Intrieri & Gigli, 2016)

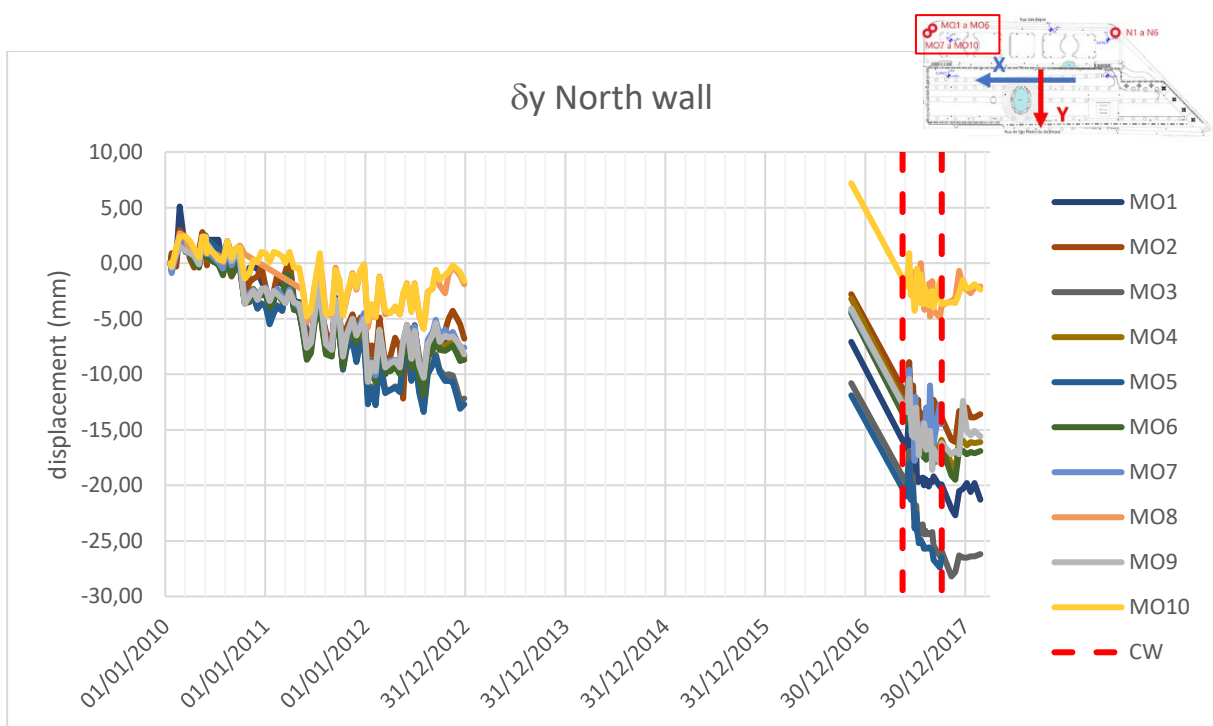
Figure 5.7. Transversal ( $\delta y$ ) cumulative displacements of the North wall (adapted from Teixeira Duarte, S.A., 2017a)

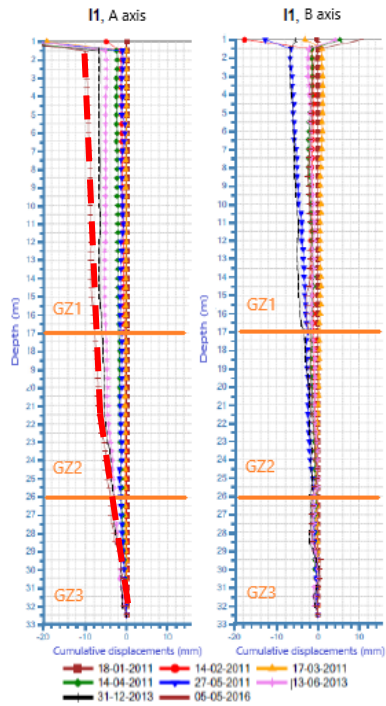
Figure 5.20. Transversal (A axis,  $\delta y$ ) and longitudinal (B axis,  $\delta x$ ) cumulative displacements of I1 from 2011 to 2016 (adapted from Geotest, 2016)

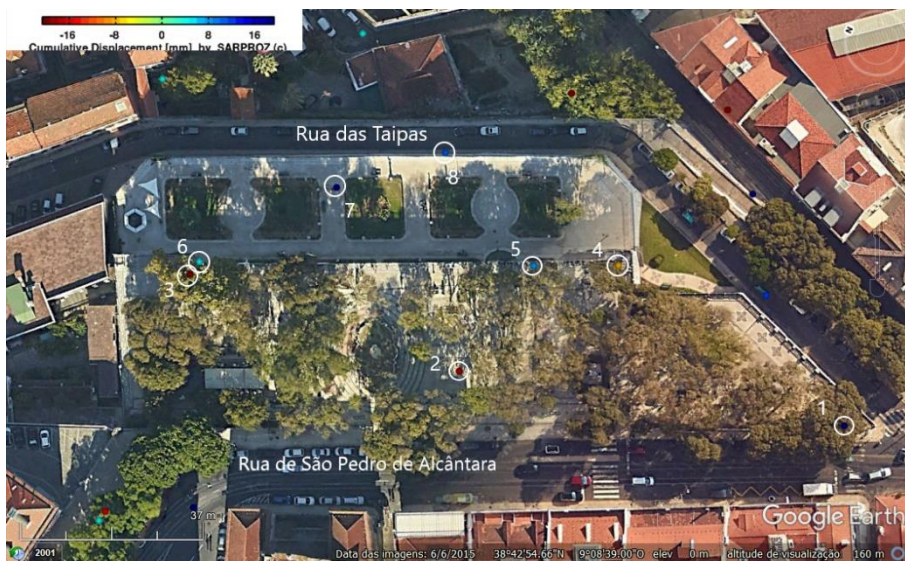
Figure 5.29. InSAR points of displacement measurement in the MSPA (adapted from Roque, 2020)

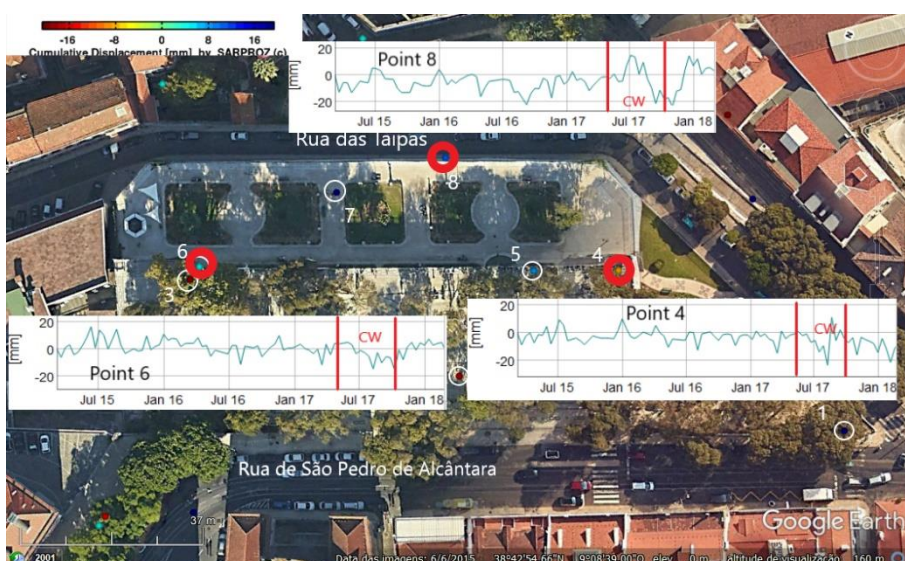
Figure 5.30. InSAR points of stable displacement (adapted from Roque, 2020)

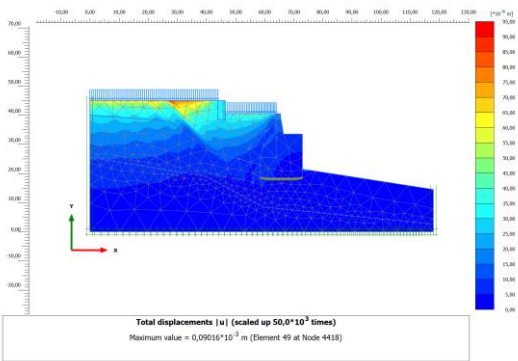
Figure 6.31. Case B - calculated total displacements for drained behaviour and  $R_{inter} = 0,5$
