Accessibility on building maintenance actions

Diogo de Campos Almeida e Melim Mendes

Extended Abstract

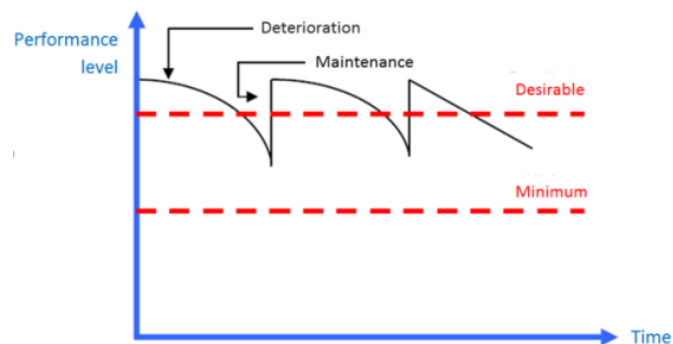
Figure 1 – Performance level of a constructive element (Barbosa, 2009)

Figure 1 illustrates the minimum and desirable levels required by building users, while showing the performance level of a constructive element and the periodic maintenance actions over time, represented by the vertical lines. Therefore, the absence of regular maintenance actions can lead to the building's degradation with the consequent reduction of its performance level.

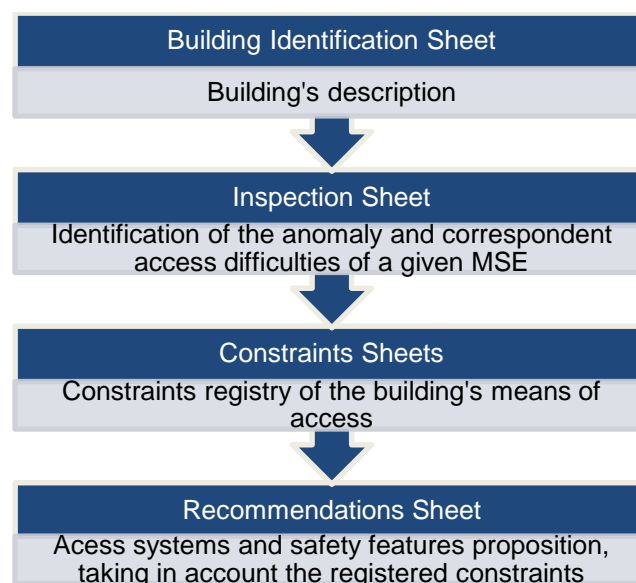
Figure 2 – Flowchart of the methodological sequence

To ensure this goal, it is essential to define technical documents, namely, the Building Identification Sheet, the Inspection Sheet, the Constraints Sheets and the Recommendations Sheet, in four stages, as pictured in the flowchart in Figure 2.

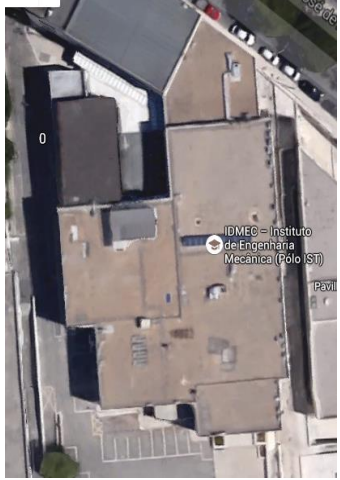
Table 1 - Building Identification Sheet

Building Identification Sheet			
Building's name	Mechanical II Pavilion

Location	Alameda Campus IST		
Purpose	Housing		
	Commerce		
	Business	×	
	Others		
Year of construction	-		
Number of floors above ground	3		
Number of floors below ground	0		
Type of surrounding	Rural		
	Urban	×	
	Marine		
Terrain's coverage	-		
Implantation area	1950 m2

First of all, it is required to proceed with the building detailed description, through the building Identification Sheet, adapted from Nogueira (2013) and shown in Table 1, filled with a case study which is explained in chapter 4.

This case study regards the replacement operation of the Heating, Ventilating and Air Conditioning (HVAC) equipment located on the roof, as well as its adjacent tubes on the exterior facade, of the Mechanics II Pavilion, located in Instituto Superior Técnico Campus University. The replacement operation, which took place between the 14th and 16th of September 2015, involved various activities, in particular, the prior assembly of the access scaffold, the HVAC equipment and tubes replacement and, finally, the scaffold's dismantling after the operation's completion.

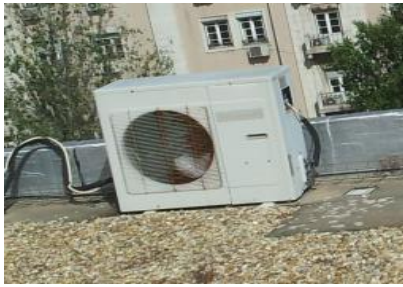
Table 2 - Inspection Sheet

Inspection Sheet	
Anomaly A20 – Not functioning (inoperational)	
Anomaly's location Roof's terrace	Image/Picture

Group of MSE affected HVAC installations	
Anomaly description Equipment no longer performs the function for which it was designed for	
Intervention Level Bad	
Possible causes End of equipment lifespan	Access difficulties/observations Working at height
Inspection Method Visual inspection	Inspection date 11/09/2015

For an accurate anomaly identification and its access difficulties of a given MSE, an Inspection Sheet was developed, shown in Table 2, already filled with the support of the anomalies list, the MSE list and the intervention level list.

The field dedicated to the anomaly identification should be filled in the first place, indicating its name and code, according to the anomalies list. The anomaly localization field should include the place where the MSE is located, in this case, on the roof. The sections referring to the Group of MSE affected should also be filled, using the MSE list, as well as the possible causes of the anomaly insurgence, the date the inspection occurred and the inspection method used. A schematic photograph should also be included.
