# Solutions for Excavation, Earth and Facade Retaining Structures

## Case Study – Building Liberdade 203

**Luís Pedro Costa Marques**

*Department of Civil Engineering, Instituto Superior Técnico, Universidade Técnica de Lisboa – PORTUGAL*

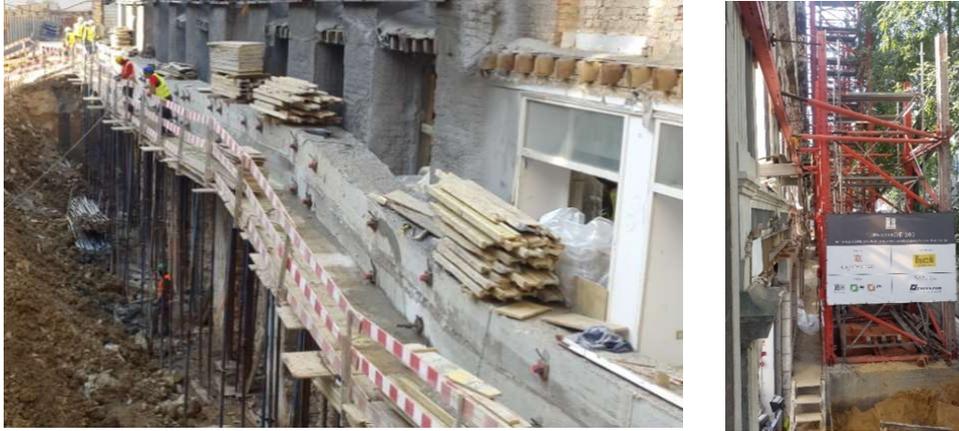
**Figure 3 - Interior support beam (left) and metallic support structures of the main facade (right)**

For the support of the main facade, near Rua Rosa Araújo, it was foreseen the realization of two support beams founded by vertical micropiles. The connection system between these three elements (interior and exterior beam, plus facade) would be achieved by the application of a sewing mechanism composed of

stressed bars of the Gewi-Dywidag type. It was also predicted the execution of three temporary metallic structures, fixed to the existing wall through connections in previously defined places and with recourse to bolts embedded in the facade. These structures would be supported by reinforced concrete elements, also based on vertical micropiles.

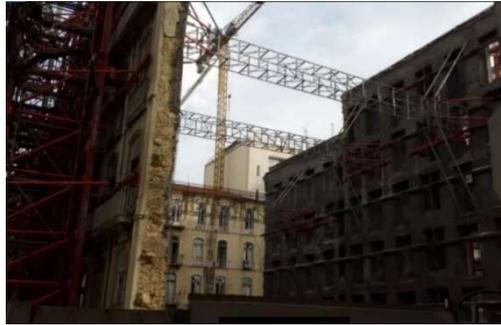
**Figure 7 - Horizontal shoring system at the top of the facades**

In the following campaigns, values began to be obtained in both facades that showed horizontal displacements into the excavation area with special incidence in the targets on the upper levels. This behavior coincided with the drilling in the foundation of the main facade for the realization of the micropiles. The trend in the interior movements continued in the readings that followed, and it was

decided to implement a horizontal shoring system located in the upper third of the facades. This structure was completed in mid-November, when excavation and execution of king post walls were under way.
