COMPARISON OF TRADITIONAL AND INDUSTRIAL MULTILAYERED PLASTERS AGAINST THE SALT CRYSTALLIZATION ACTION

Daniel Pinto

Instituto Superior Técnico, Universidade de Lisboa, Portugal, 2018

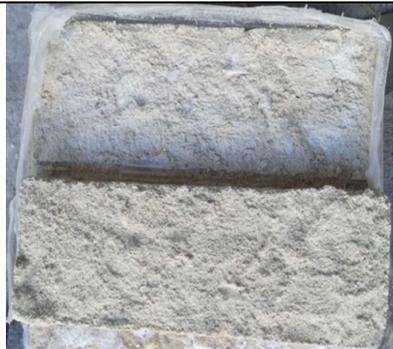
| Plaster | Visual Aspect | Description |
|---|---|--|
| Double Layer USL6+TSL3 | | Complete detachment of plaster in stage E3-B1. The rupture occurred by the interface between the regularization plaster and the support. |

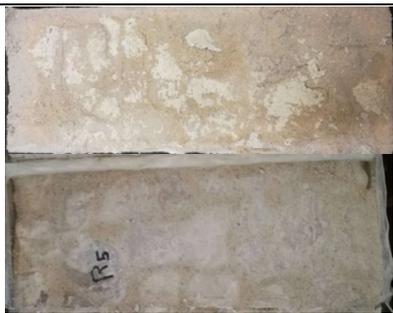
| Plaster | Visual Aspect | Description |
|---|---|--|
| Single Layer R1 | | Complete detachment of plaster in stage E3-B1. The surface of the plaster was with localized losses of material (in small amounts). Adhesive breakage between the plaster mortar and the stone elements of the support and cohesive between the plaster and the mortar of the joints between the stone elements of the masonry base. |

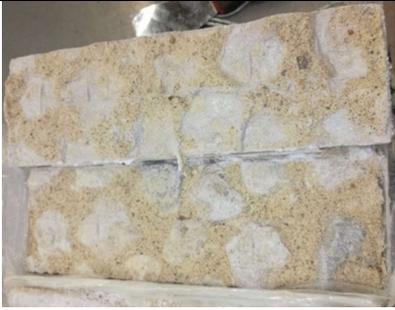
| <p>Single Layer R2</p> | | <p>Complete detachment of plaster in E4-A phase. The surface of the plaster did not exhibit any presence of crystallized salts. Adhesive breakage between the plaster mortar and the stone elements of the support and cohesive between the plaster and the mortar of the joints between the stone elements of the masonry base.</p> |

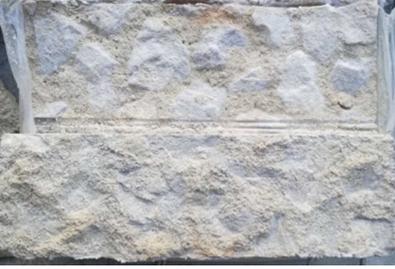
| <p>Double Layer R2+A1</p> | | <p>Complete detachment of plaster in E4-A phase. The surface of the plaster with localized losses of material (in small quantities). Adhesive breakage between the plaster mortar and the stone elements of the support and cohesive between the plaster and the mortar of the joints between the stone elements of the masonry base.</p> |
