THE INFRASTRUCTURE OF ACTIVE MOBILITY – EVALUATION OF A SURFACE PAVEMENT SOLUTION

1. INTRODUCTION

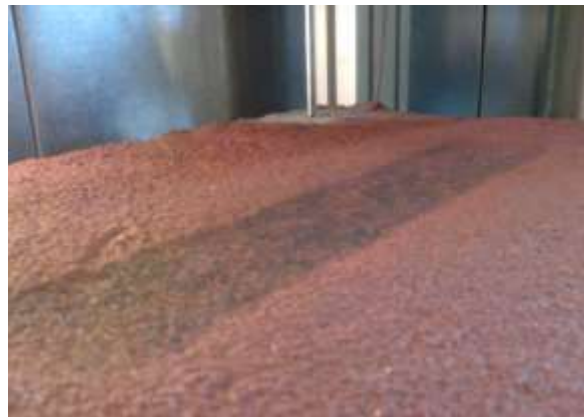
The simulation was done with a traffic simulator used in the Wheel Tracking Test (Figure 1) that performs the EN 12697-22 2013 [6] and whose objective is evaluate the susceptibility of deformation of the bituminous mixtures with the passage of moving loads – representing in a simplified manner the successive passages of the wheelsets (Figure 2).

FIGURE 2 - SURFACE APPEARANCE AFTER THE ACCELERATED WEAR TEST

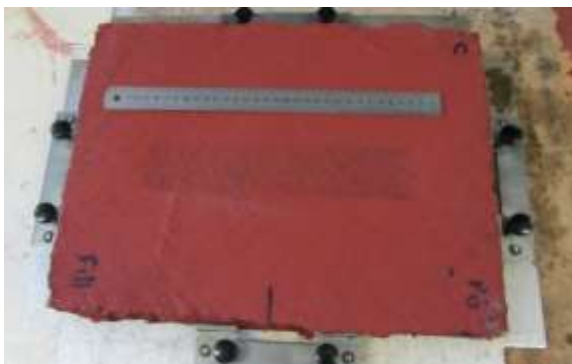
In slab C (Figure 3) we see that after 10 000 cycles the degradation in the portion corresponding to the stone powder is higher than the portion in which was placed the filler.

FIGURE 3 – SLAB C AFTER 10 000 CYCLES

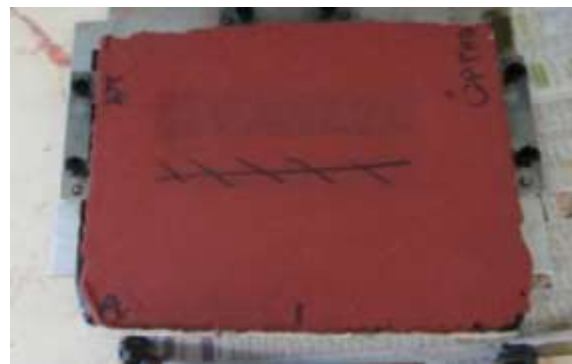
In slab D (Figure 4), we see that the rutting is more pronounced in the area where the application of the primer was made before the two coatings of covering product. However, in the rutting of the portion where only 2 coats were made (Classified as “Optima” in the slab) we can see a place where there is greater disaggregation of material (bottom right of the rutting).

FIGURE 4 - SLAB D AFTER 10 000 CYCLES

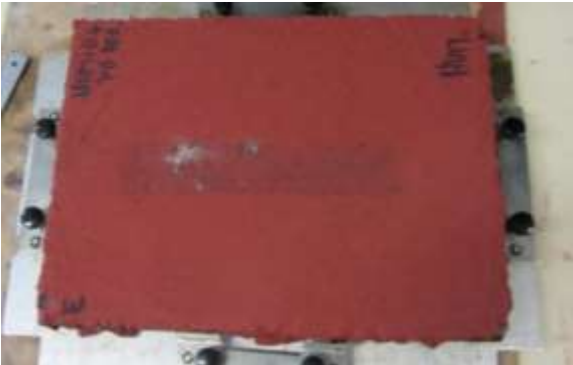
In turn in slab E (Figure 5) it's obvious the degradation of the damp and with stone dust portion. Indeed, the visible degradation is higher than in any other cases. Nevertheless, we can see in the damp portion a general breakdown of the lining material noticeable by the sharp black shading in the slab- that matches the colour of the bituminous mixture used as a base.

FIGURE 5- SLAB E AFTER 10 000 CYCLES

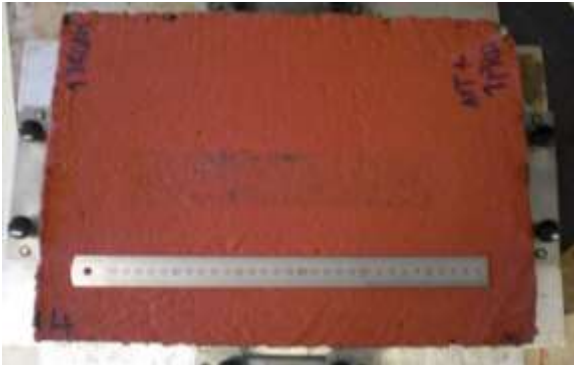
Finally, in slab F (Figure 6) there is a further deterioration in the portion where it was applied only one coat, in which the black shading is superior to any of the other visible portions of any slab.

FIGURE 6- SLAB F AFTER 10 000 CYCLES

Generally speaking, we can consider that the worst way of applying the covering is over a wet and dusty surface and that the best results happen with the application of two coatings over a clean and dry surface. Besides that, it is more resistant to breakdown a surface with primer application than without, especially in cases in where only one coat of the coating product is applied.

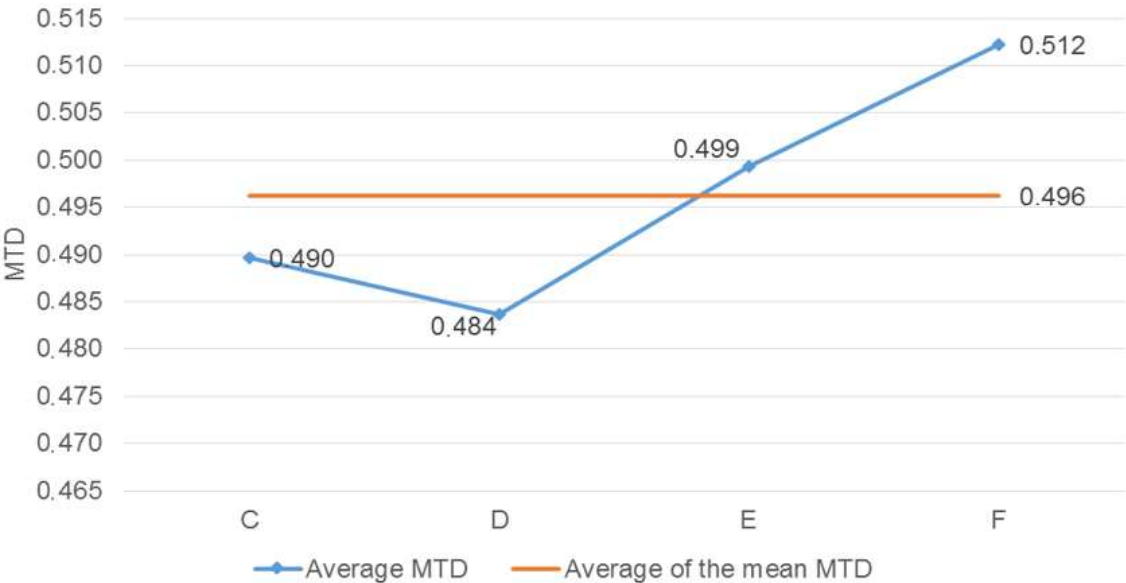
The results obtained in laboratory following the stain's volumetric technique show what can be seen in the Figure 7:

FIGURE 7- AVERAGE MTD OF EACH SLAB

From the laboratory trial's point of view, we verified that the stain's volumetric technique is very much influenced by the covering's thickness.

Indeed, the slab with thinner covering (where only a coating of product) it matched the highest value of MTD and the slab that used two coatings which is considered to be the correct procedure corresponded to the lowest MTD value (0,484).

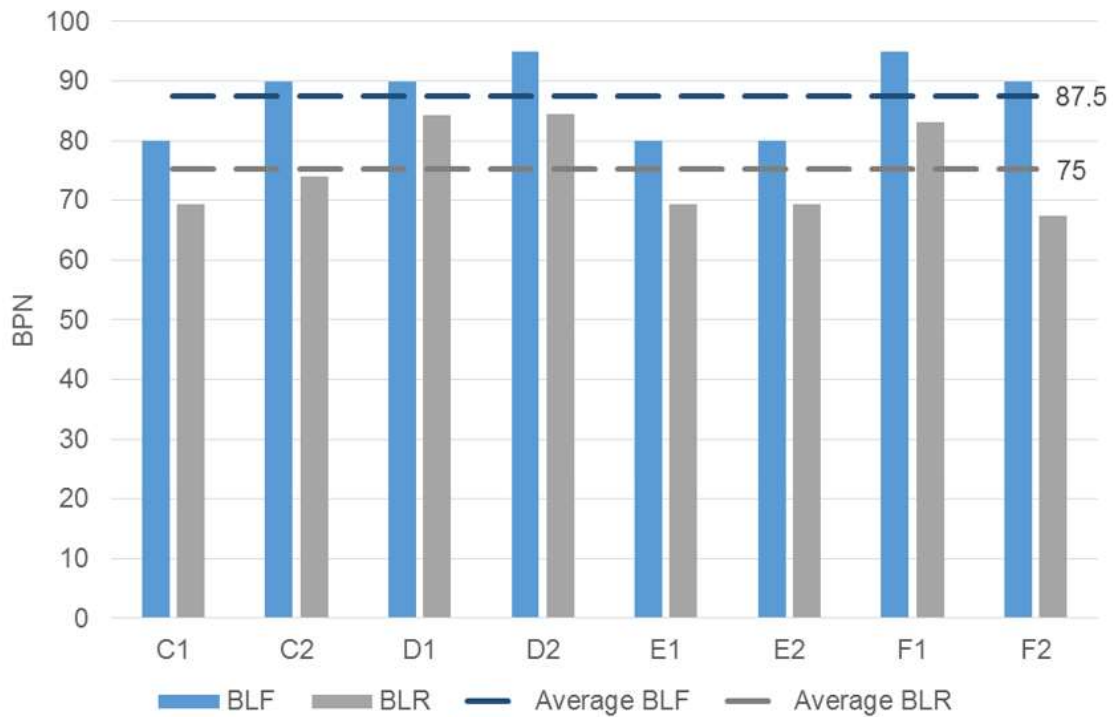
FIGURE 8- FINAL BPN RESULTS IN THE BRITISH PENDULUM TEST

It should be noted that the BLF values correspond to tests carried out with the standard rubber out of the rutting and the BLR values are related to the ones carried out with short rubber in the rutting which were later extrapolated values for the standard rubber by calculating a factor K corresponding to the ratio between the average test values out of the rutting with short and long standard rubbers.

Comparing the values inside and out of the rutting it can be seen that the values outside of the rutting – where the BPN value refers to more friction surface in a surface point- they are higher than the trial values in the rutting, this is consistent with the fact that the wear and tear of the surface decreases its friction.

Only D1, D2 and F1 present both values higher than average, thus the ones that best retain the friction despite wear. It should be noted that the fact that only one coat of product is used gets good results because the mixture used to make the tiles have aggregate of granite origin which is very resistant to wear.

Now C1 and E1 both present exhibit both higher than average values so that either before or after the degradation their occasional friction is reduced. And so we can determine that the best solutions are the use of two coatings of covering product, as predicted in the product catalogue. It is also observed that the primer has a significant effect on product durability since D2 is the one that has the highest values.

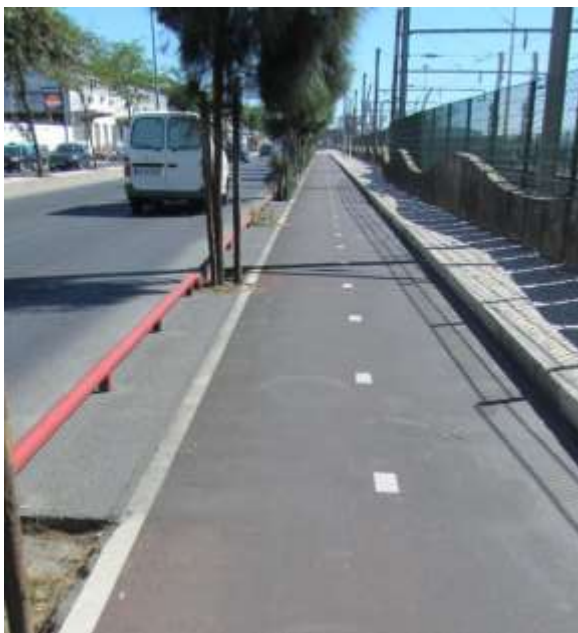
In cycle path A because of its appearance it was possible to identify 2 parts with different characteristics and so two trial spots were considered, A1 and A2.

FIGURE 9- CYCLE PATH A

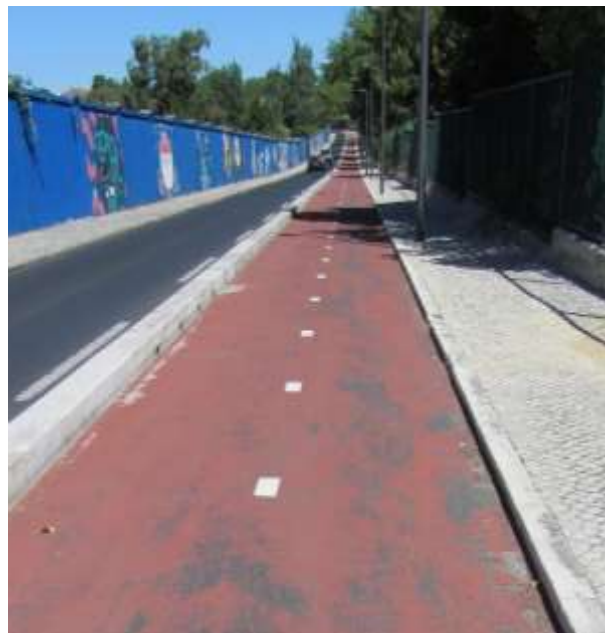
FIGURE 10- CYCLE PATH B

As a result, 4 cycle paths that present the characteristics above were tested: Cycle Path A (Figure 9), Cycle Path B (Figure 10), Cycle Path C (Figure 11) and Cycle Path D (Figure 12).

It is observed the cycle path B is the one that has the most material degradation, the MTD value is the lowest, while cycle path D that was visually in better condition has a higher MTD.

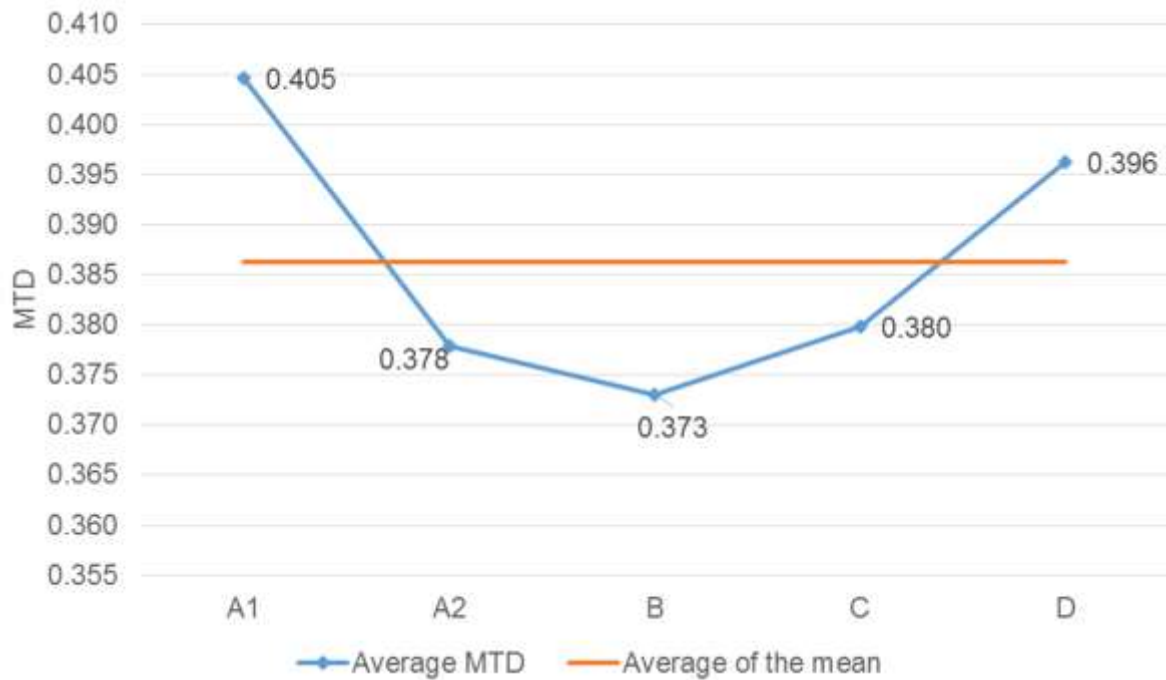
In the cycle paths the acquired results for stain's volumetric technique were (Figure 13):

FIGURE 13- AVERAGE MTD OF EACH CYCLE PATH

According to the field trials, the corresponding stretch with the best roughness characteristics corroborates what was verified during laboratory tests.

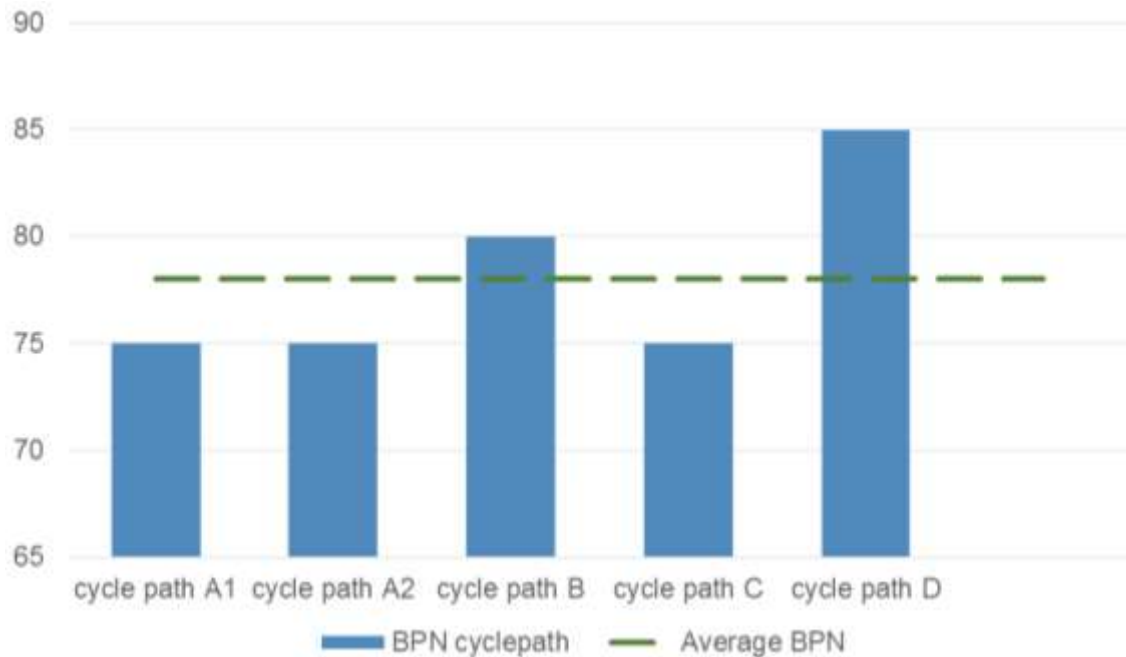
For the pendulum trial the results were (Figure 14):

FIGURE 14- RESULTS OBTAINED IN THE BRITISH PENDULUM TEST

As can be seen, both parts analysed in cycle path A got the same BPN values, just like the part analysed in cycle path C. On the other hand, the trials done to cycle paths B and D obtained the higher values of 80 and 85, respectively. That means these two cycle paths have more friction than the other parts analysed.

We also discovered that the point relative friction is not as sensitive to the covering's condition since the two parts in different conditions from the same cycle path had the same BPN value in the 10 made trials (5 in each).

According to the British Pendulum test we saw that the BPN values to which corresponds the best solution is 85. Watching the analysed parts, the cycle path that was clearly in a better condition was the one that got the closest value to the one verified in the laboratory.
