NEW WELDING PROCEDURES FOR REPAIRING H13 AND P20 TOOL STEELS

The aim of the present paper is to investigate TIG welding in this particular application, the metallurgical behaviour of AISI P20 and H13 tool steels during welding thermal cycles, and to define welding procedures to repair these tool steels.

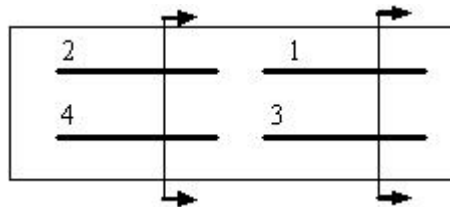
Figure 1 shows the sequence of bead on pates adopted in this study.

Figure 1– Illustration of the single welds welding procedure

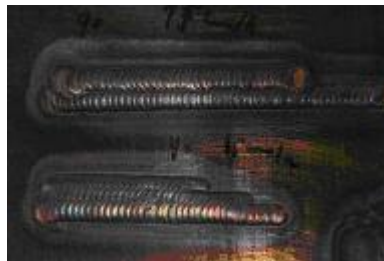
Multipass welds were also made with the purpose of investigating the effects of repeated welding thermal cycles in the hardness and microstructure of the welds, using two levels of welding current, 90, and 120A, and two welding speeds, 7 and 15cm/min, as shown in figure 2.

Figure 2 – Illustration of Multipass welding

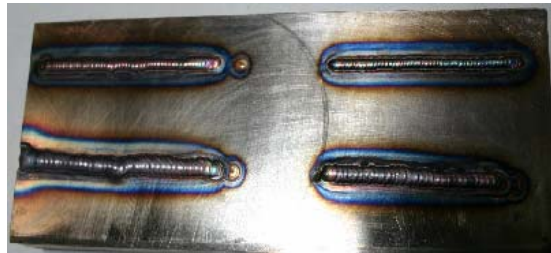
TIG weld deposits made with H13 and P20 tool steels show good superficial homogeneity, without detectable superficial defects, as shown in fig 4. The weld dimensions of TIG deposits width varied between 3.3mm and 6.3mm, while the depth varied between 0.8 mm and 1.9mm, being the higher values associated to higher heat inputs.

Figure 4 - TIG weld deposits.

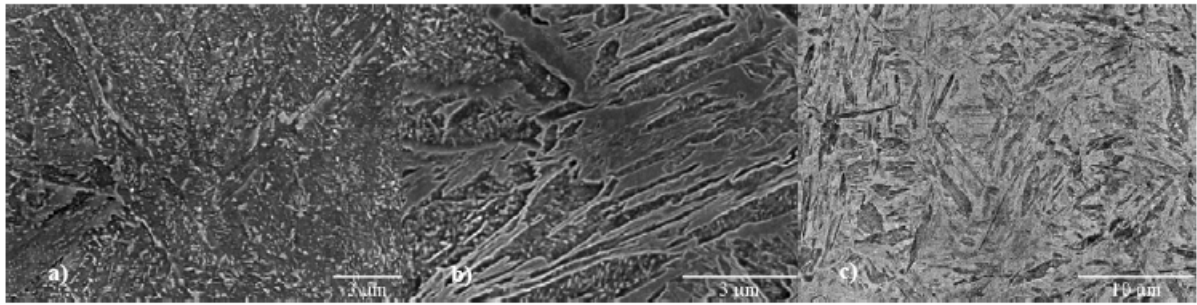
Microstructural observations and hardness evolution of the samples show that for single weld TIG deposits the Base Metal (BM) has a tempered martensite microstructure, the weld metal (WM) and the Heated affected zone (HAZ) are constituted by martensite with high hardness levels, as shown in fig 5.

Figure 5 - SEM photomicrography of a P20 TIG Weld, showing: a) Base metal, b) Weld metal and c) heated affected zone.

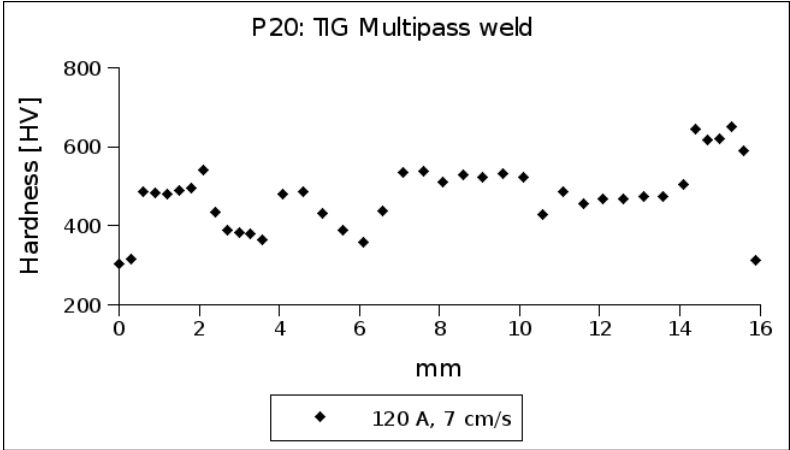
Figure 7 illustrates the hardness profiles, measured in a horizontal line parallel to the surface, in multipass welds, at one millimeter from the surface. It is observed that the average hardness values measured in the weld metal multipass samples were significantly lower than those of the single pass deposit, due to the tempering of the martensite by subsequent stress relieve effects.

Figure 7 - Hardness profile multi pass TIG welds, measured in a horizontal line parallel to the surface, at 1mm from the surface.

However, it is worth to mention that in order to produce a uniform hardness profile it is necessary to make a post-weld heat treatment, as these results indicate that the effect of multipass welding is not sufficient to lower the harness to values correspondent to the hardness of the base metal (300 HV). For the welds which were post-weld heat treated (tempered), it was possible to obtain a mean hardness of 300 HV in both weld metal and heated affected zone, as observed in fig. 8.

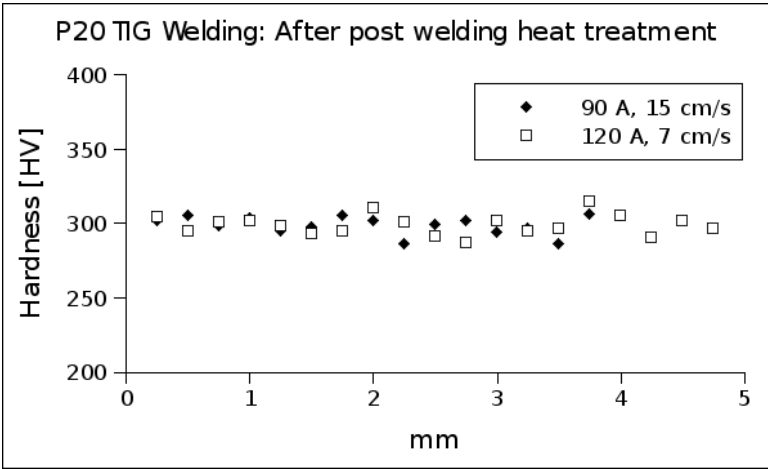
Figure 8 - Hardness profile of single, P20 TIG welds after post-weld heat treatment.

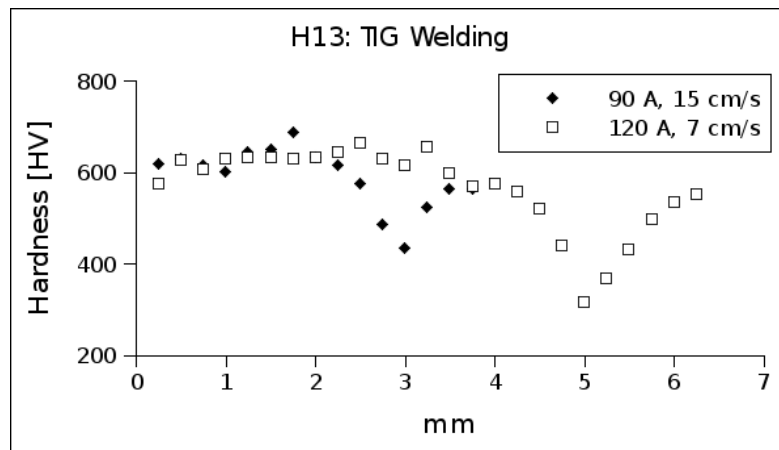
In H13 tool steel similar results were observed, indicating the presence of martensite in the heated affected zone and weld metal. However, as far as H13 is concerned the hardness profile shows a region in the heated affected zone, with lower hardness comparatively to the base metal, as shown in fig. 9. This is the result of an over-tempering effect. Unlike P20 tool steel, where cracking can arise in regions of high hardness in the heated affected zone, that could be reduced to values equal to the base metal by a tempering treatment after welding, for H13 tool steel the only way to reduced the hardness is through a complete post-heat treatment of quenching and temper.

Figure 9 - Mean hardness of H13 TIG single pass welds, for two welding conditions.

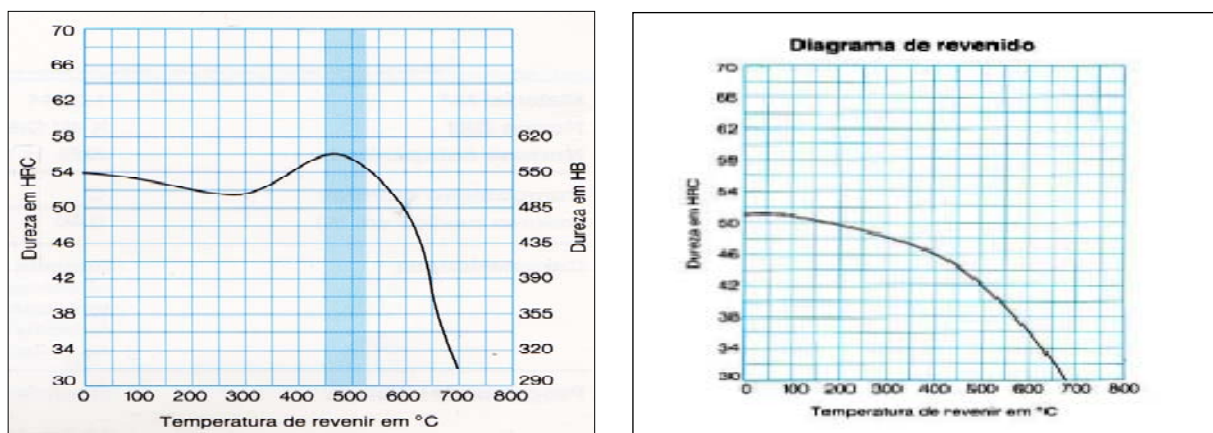
In order to explain the regions of lower hardness in the heated affected zone of the H13 tool steel, the tempering diagrams from the steels manufactures, as shown in fig. 10, were used. After the quenching and tempering treatment, H13 tool steel presents a range of hardness between 50 and 52 HRC (base metal hardness), which, according to the diagram indicates a tempering at around 550-600°C. Therefore, material regions that during welding reach a temperature higher than the above mentioned and lower than the austenitization temperature, will suffer an over-tempering, with an inherent decrease in hardness.

Figure 10 - Tempering diagrams a) H13; b) P20 [8]

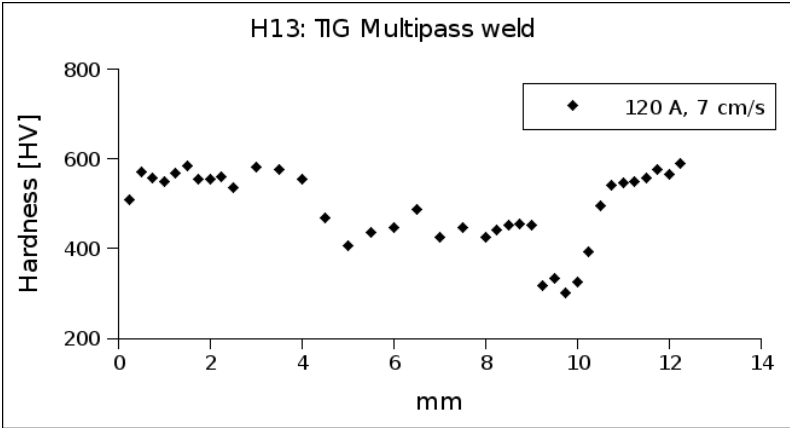
Relatively to the multipass welds, similar results were obtained, where the tempering effects give rise to areas with lower hardness comparatively to the base metal, which can affect the structural integrity of the mould, as illustrated in fig 11.

Figure 11 - Mean hardness of H13 TIG multipass welds, made with a 350°C preheating.

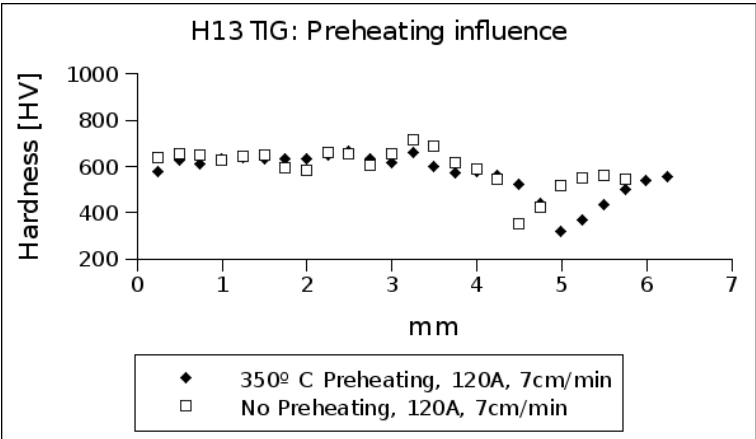
Figure 12 represents the evolution of hardness for TIG welds made with no pre-heating and with a 350°C preheating. It can be seen that pre heating has little influence on the hardness profile, being the average hardness slightly lower for the samples that were pre-heated. However, preheating has a beneficial effect in service lifetime since it reduces residual stresses and prevents cracking in service.

Figure 12 - Mean hardness of H13 TIG single pass welds, with no pre heating and 350°C preheating, for 120A and 7cm/min

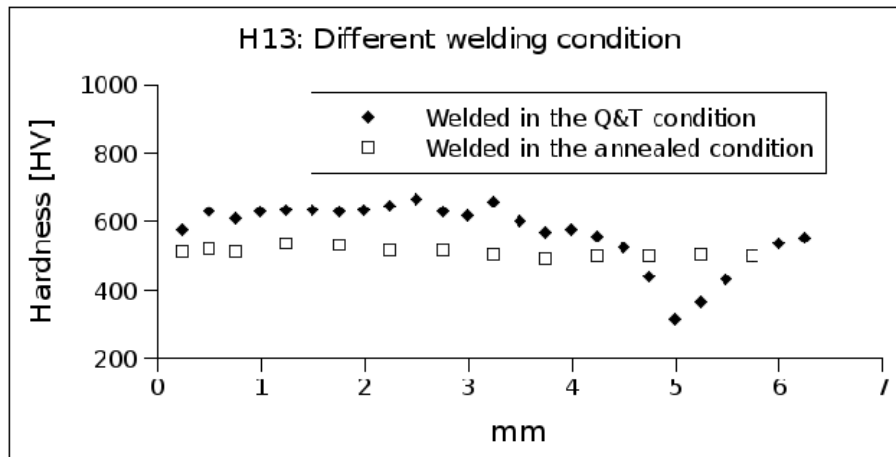
Some welding trials were also made in the annealed conditions followed by a quenched and tempered treatment. From the results obtained it can be observed from fig 13, a uniform hardness distribution along the weld metal, heated affected zone and base metal, with a value similar to the base metal. This result indicates that when welding the H13 steel in the annealed state it is possible to obtain after quenching and tempering a similar structure to the base metal. Despite the composition of the filler material being slightly different, its behaviour to heat treatments was similar.

Figure 13 - Mean hardness of TIG single pass welds, made in the annealed condition, which were than quenched and tempered and welds made in the quenched and tempered state.
