# Characterization of defects in *Liceu* school buildings in Portugal

## Analytical methods for the study of constructive anomalies

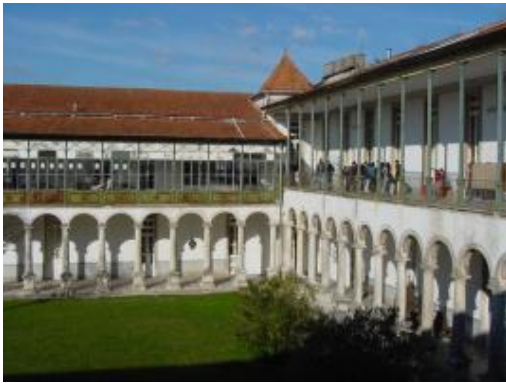
Fig. 7 – *Colégio das Artes* patio, in Coimbra.

In the *Liceu* school buildings of this period, the structural materials used in the bearing walls were irregular stone masonry. Their coating was chosen to meet the hygienist requirements, to ensure easy cleaning and greater sanitation quality of the interior spaces, and ranged from limestone or cementitious renders with water-based paint (in the exterior) to hydraulic or ceramic tiles. The original pavements and stair structures were in timber and have been replaced or added in some specific areas by reinforced concrete slabs built some decades after the initial construction, during restoration actions.

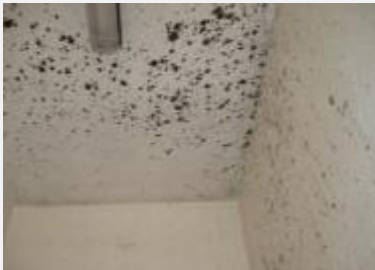
<b>A3</b>	<b>Discoloration or stains (A3)</b>  This anomaly is characterized by the expression of discolorations or stains defined by contrast with the surface, including efflorescence ( <i>D. Luísa de Gusmão</i> School, in Lisboa).

Fig. 12 - Example of an anomaly description, according to the list of anomalies adopted.

The identification of the type of anomaly is an essential step for its characterization. However, the increasing complexity of existing buildings, materials and systems over time and the increasingly rigorous requirements for performance, together with the lack of maintenance and intensive use of schools, leads to a high level of degradation, triggering the presence of performance defects in increasingly complex anomaly chains (Azzalin 2005). In order to support the identification of the type of anomalies and their matching description, a comprehensive list of anomalies was prepared (Fig. 12).

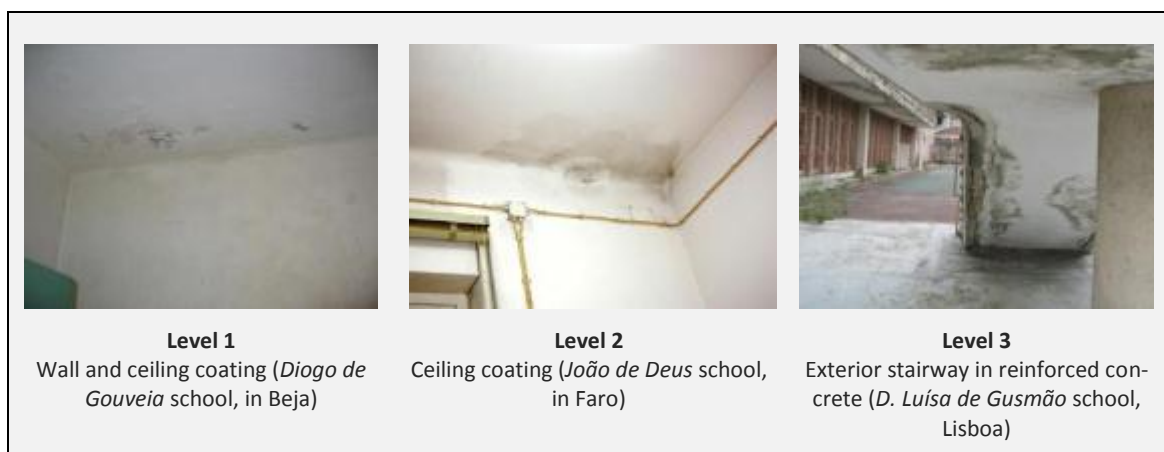
Fig. 13 - Example of a comparative visual evaluation for the A3 defect (discolorations or stains).

For the assignment of the severity levels within each type of defect, this methodology proposes a comparative visual evaluation as presented in Fig. 13. This analysis is based on the use of images of the same type of anomaly from which a comparison is made, and also based on the definition of criteria that support the input of relevant information.

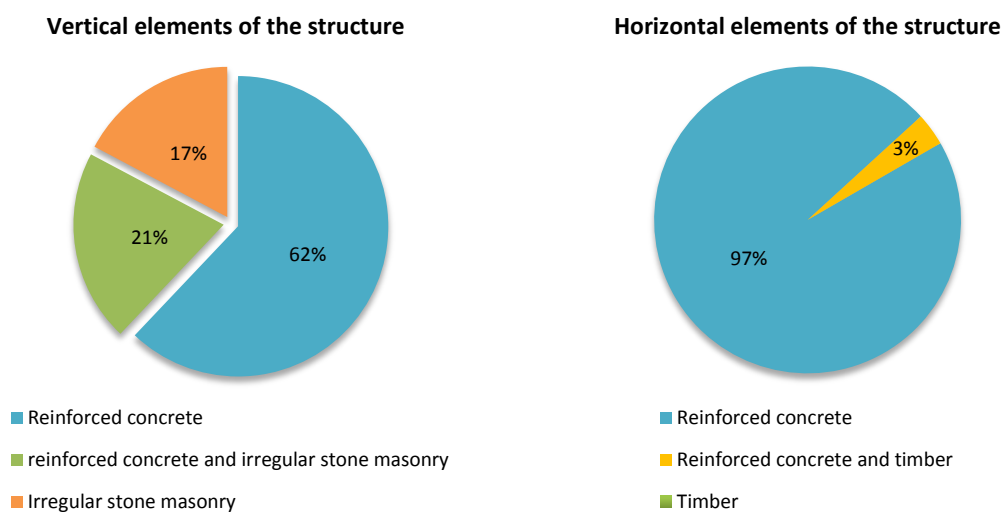
Fig. 15 - Relative frequencies of the structural elements.

Therefore, the age average of these school buildings is about 60 years. Consequently, they present a specific type of construction, generally using reinforced concrete in the horizontal and vertical structural elements (Fig. 15). In older buildings irregular stone masonry and timber elements would be found instead. Throughout the twentieth century these school buildings underwent some remodelling actions that consisted frequently of replacing these timber structural elements with reinforced concrete ones.
