**EXTEND ABSTRACT****1. Abstract**

This dissertation aims to identify structural reinforcement techniques used in schools intervened in the secondary school modernisation programme: “*PMEES*”. The programme was carried out by the company “Parque Escolar”.

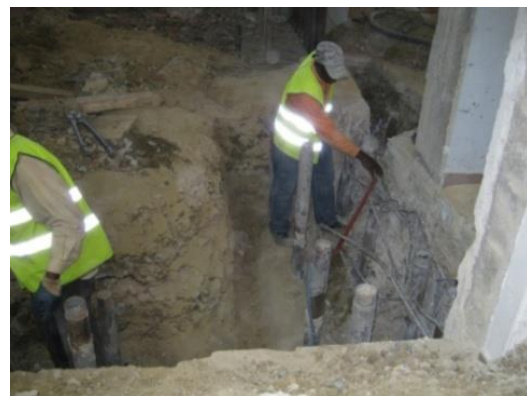
Figure 2 – Reinforced footings with micropiles  
(photo taken in 2010-10-19 by author)

The foundations for the concrete walls had a complicated compatibility with the existing footings. Thus, we chose to build independent foundations for new walls, reinforced with micropiles to solve the problem of high eccentricities.

Normally, with the introduction of these walls, the existing foundations must be strengthened or new ones must be create. This foundation reinforcement can be achieved by micropiles that are characterized by presenting a high load capacity and a small size. This type of indirect foundations is decisive for the wall overturning resistance, because it's practically not subject to the stabilizing effect of the vertical load.

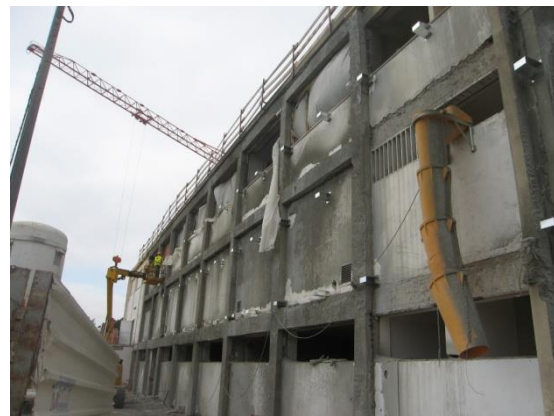
Figure 4 – Gym's seismic strengthening (photo taken in 2010-08-18) – (Laranjeira, 2008-2010)

In this building we applied the seismic reinforcement from outside using the same system of Body A. The gym floor was replaced because it presented deteriorated areas due to the wall moistures.

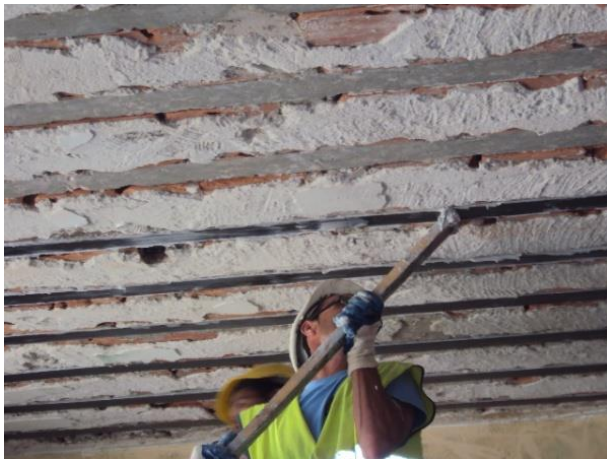
Figure 5 – Applying laminate of CFRP in Santa Isabel School (Jacinto, 2008-2010)

The slab for reinforcing belongs to the gym's building. It had signs of deterioration such as infiltrations, biological colonization and excessive flexural deformation.

In order to correct the problem of excessive buckling slab it was applied an epoxy adhesive and a laminate of carbon fibre reinforced polymers (CFRP) on underside of its beams.

Lastly, the reinforcement of beams in slabs is achieved with a carbon fibre composite. This technique is used to increase the load capacity of the structures.

The composite material is relatively recent and only resists tensile. It presents a very high resistance for a low density. In this process we have to ensure a good connection between its

three elements: the composite material, the epoxy resin and the existent substrate (Cóias, 2007).

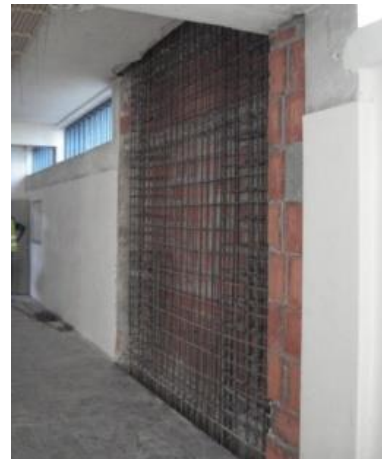
Figure 6 – Addition of shear walls in Leonor School (photo taken in 2010-10-25 by author)

- addition of reinforced concrete shear walls

The existing buildings (Blocks 4 and 5) were structurally divided into 7 modules. The modules were separated by expansion joints executed by duplicating structural elements.

The addition of resistant walls in concrete is an effective method for the control of horizontal forces, allowing reduction efforts in existing elements (Proença, *et al.*, 2011).

It can be performed using it to insulated walls or to end frames in shotcrete. These frames may waive the use of form-work, it has a higher execution speed and ensures a better grip of the new concrete to the existing substrate, presenting a monolithic behaviour.
