Inspection of reinforced and prestressed concrete structures through an ultrasonic technique performed by ultrasound tomograph - Mira

By Maria Roque; November, 2014

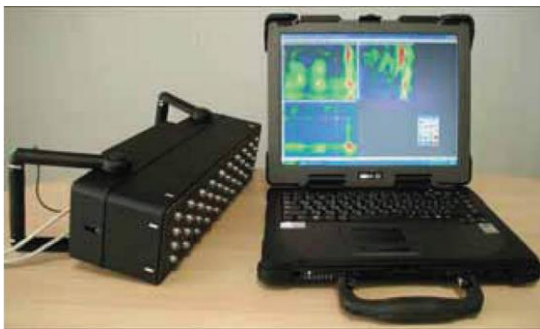
Figure 3.6 - Antenna and laptop with control and analysis program. [Catalog NDT, 2010]

The device used to obtain images of the interior of the concrete was the ultrasonic tomograph Mira, developed by Germann Instruments. It works based on detection of contrast and density system through ultrasound. The main parts of the equipment are the antenna array and the laptop with a monitoring and data program installed (Figure 3.6). The antenna array has 40 shear wave low frequency transducers, disposed in a 10 x 4 (10 rows, 4 columns) matrix. The transducers are spring-loaded to conform to an irregular surface, dry-point contact piezoelectric sensors with a center frequency of 50 kHz. Each transducer is built with a wear-resistant ceramic tip, which allows testing even on very rough surfaces. In operation, the transducers act as transmitters and receivers in a sequential mode. In summary, the control unit within the antenna excites one row of transducers and the other rows of transducers act as receivers [Catalog NDT, 2010]. Figure 3.7 shows the 45 rays paths involved in each of the four columns of transducers. It takes less than 3 seconds to complete data acquisition, data processing, and data transfer for a test at one single antenna location. The program installed on the laptop allows, through the wireless connection to the antenna, receiving signals obtained by the antenna, process and archive them as data [Catalog NDT, 2010].

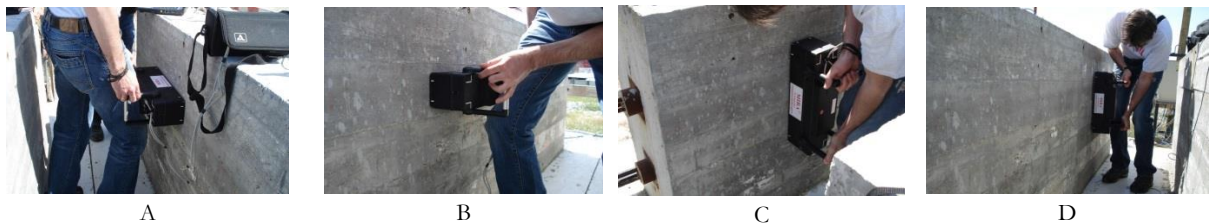
Figure 3.11 - A - Calibration. B - Explorer mode test. C, D - Scan mode test.

for performing scans; **viii)** testing in explore mode in 1 or 2 different positions to confirm configuration of the device (Figure 3.11 B); **ix)** scan mode (multiple scanning), performing the 1st scan. At each antenna location change, take care seeing if all transducers are snug against the face (Figures 3.11 C and 3.11 D); **x)** select review mode where there are recorded and processed data acquired during the scan performed. Record this data in another directory and another file name. Recording JPEG images obtained is also performed in this mode (Figure 3.9); **xi)** analyze obtained

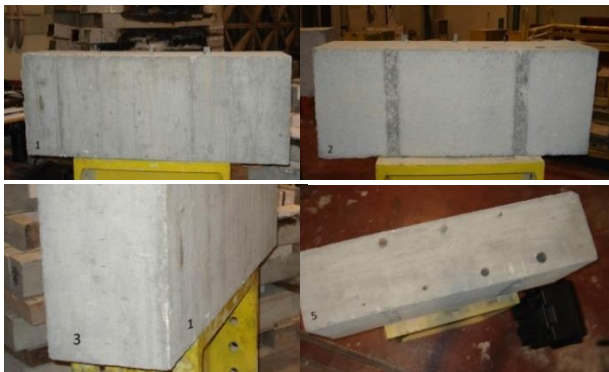
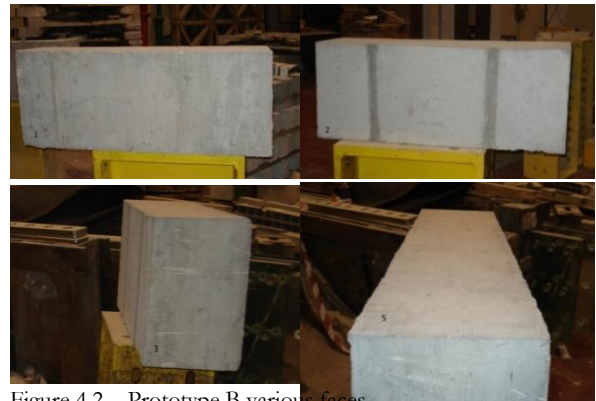
Figure 4.1 - Prototype A various faces

Figure 4.2 - Prototype B various faces

The faces of the beams A and B were inspected to assess the surface's flatness and roughness. As observed in Figures 4.1 and 4.2, the faces are apparently flat. The sides 1, 3 and 4 are less rough when comparing with side 2, which has a higher roughness (free face during the concreting process).

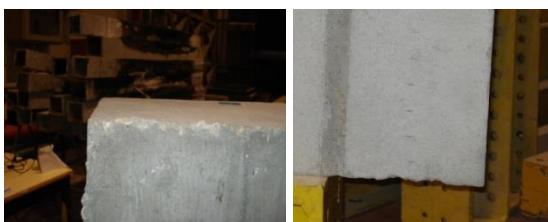
Figure 4.3 - Peeling and delamination in the prototypes

Some few vertices and edges of both beams were peeled or delaminated at various locations (Figure 4.3).

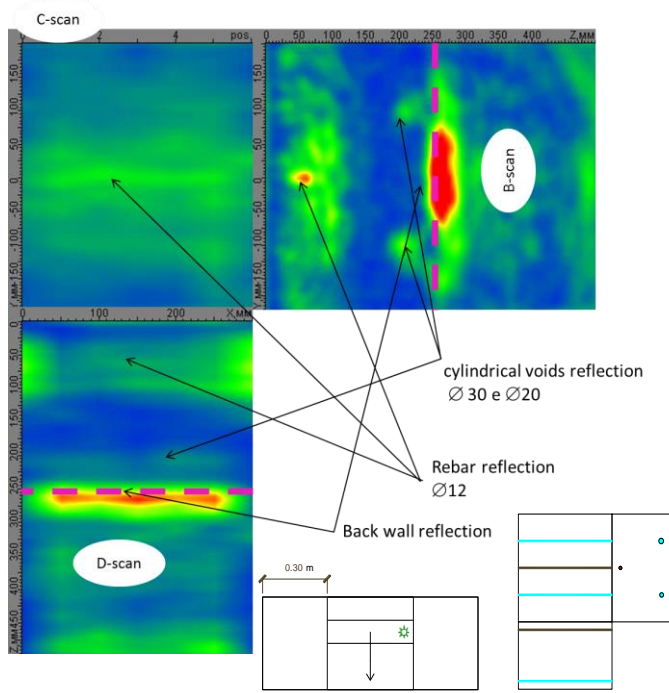
Figure 4.4 - Images from test VAF1H5Y30

In test VAF1H5Y30 (figure 4.4) performed on beam A, face 1 with a scan step of 5 cm, on B-scan, rebar and voids are perfectly clear. Image shows location of both rebar and voids but it is not possible to be accurate in their dimensions. In the D-scan is also possible to identify the development of voids and rebar.

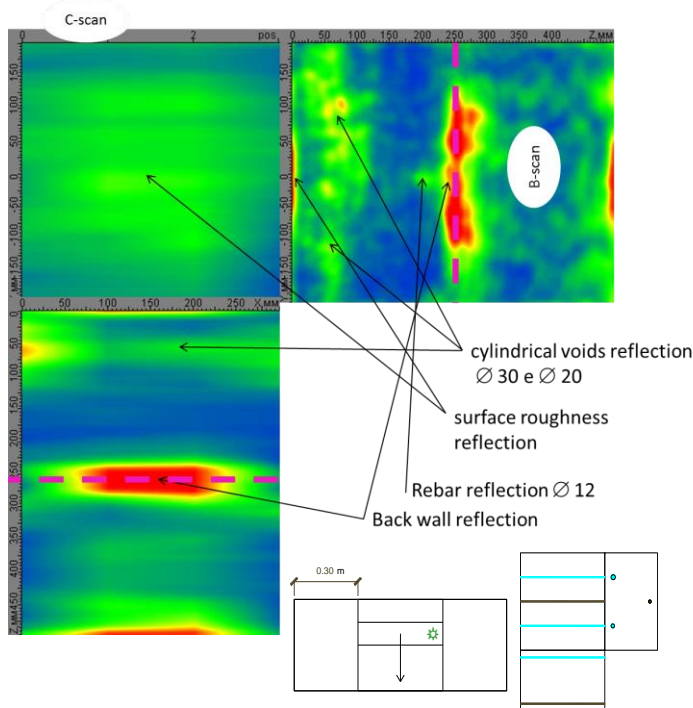
Figure 4.5 - Images from test VAF2H10Y30

Test VAF2H10Y30 (Figure 4.5) was carried out on beam A, face 2 with a scan step of 10 cm (opposite face of previous test, which has a higher roughness). On B-scan, rebar and voids are visible but are not as clear as in the previous test (VAF1H5Y30), which seems to be due to surface roughness in contact with the tomograph. This roughness translates into the loss of image sharpness of C-scan and visible reflections on B-scan, as seen in Figure 4.5. In the D-scan it is also possible to identify the development of voids quite clearly.

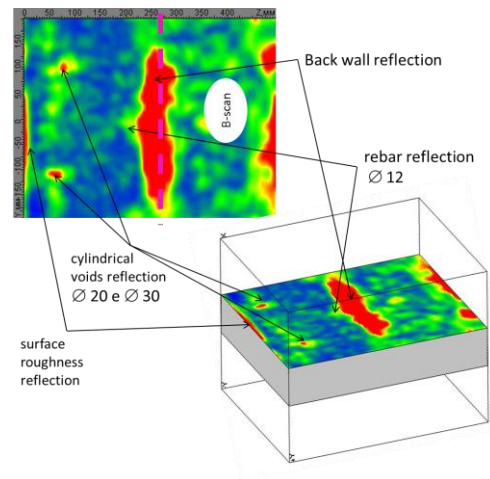
Figure 4.6- Images from test VAF2H10Y30 roughly half the height of the prototype A

Due to the lack of sharpness in the initial test VAF2H10Y30 a 3D model is presented (option given by the software program) in cutting B-scan roughly at half the height of the beam prototype A (Figure 4.6). This was,

in the present test, the sharpest image. The location of the rebar and the voids still were not as well defined as in the tests carried out on face 1.

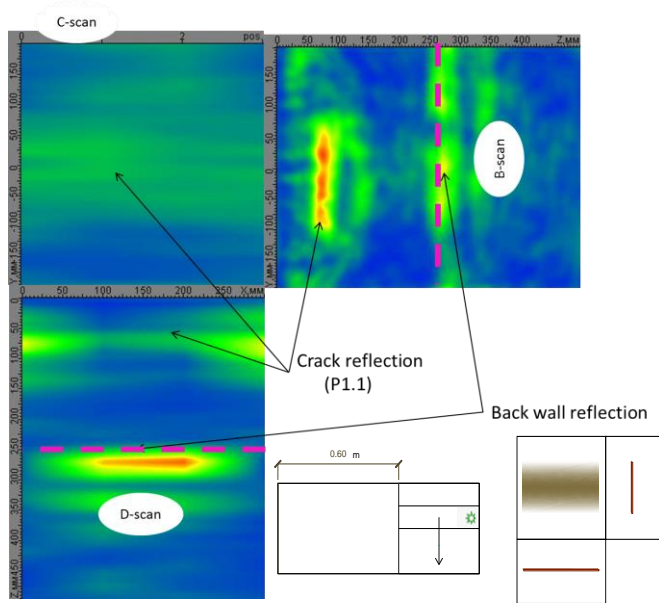
Figure 4.7 - Images from test VBF1H10Y60

In test VBF1H10Y60 (figure 4.7) performed on beam B, face 1 with a scan step of 10 cm, on B-scan crack (P1.1) is identified and located and it is possible to measure approximately its length (approximately 20 cm). On C-scan the crack appears in parallel plane to the image, being recognized by the roughly diffuse green spot.

When identified in a perpendicular plane to the crack itself (B-scan and D-scan), the expression of the crack shows a high thickness, which does not correspond to reality. On C-scan and on D-scan it is understood that the crack is nearly over the entire height of the beam.

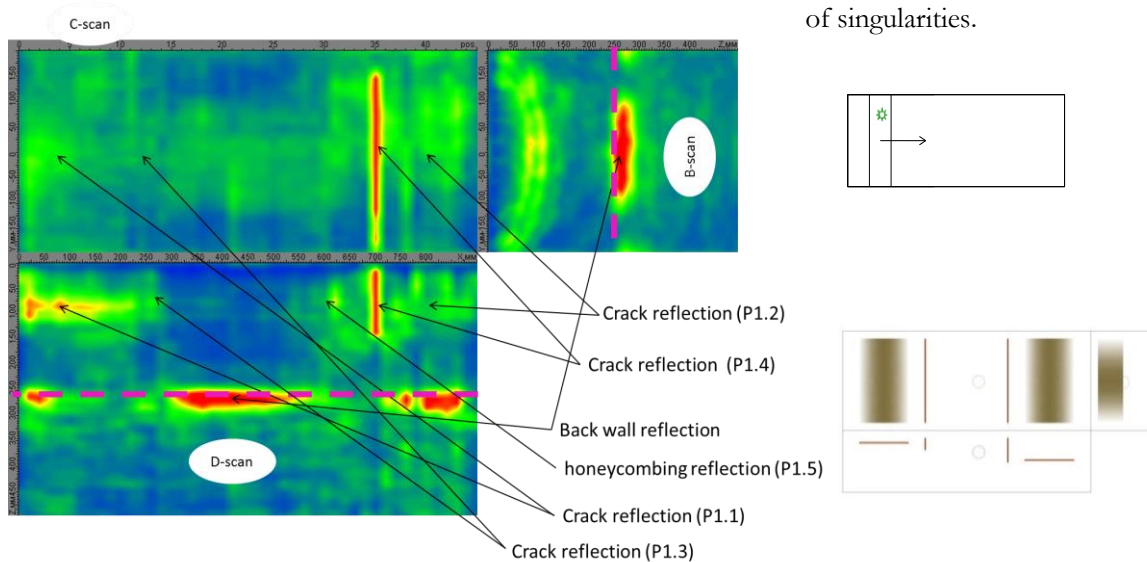
Figure 4.8 - Images from test VBF1V2X0

Finally, in test VBF1V2X0 (figure 4.8), carried on beam B, face 1, it is possible to identify and locate virtually any existing cracks on C-scan and on D-scan. The identification of honeycombing is less obvious, although this singularity appears to have visible expression on D-scan, as indicated in the figure. This test was performed with smaller scan step, equal to 2 cm, to enable to identify the vertical cracks (P1.3 and P1.4), which appears to have resulted in better identification and definition of singularities.

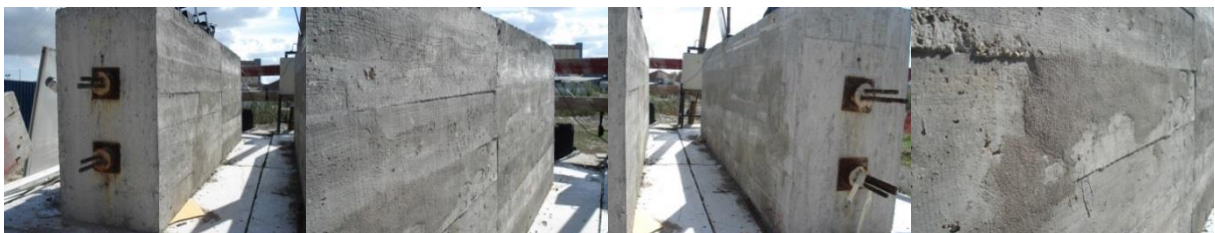
Figure 4.9 - Prototypes 1 and 2 faces

Tests for reinforced and prestressed concrete beams (prototype 1 and prototype 2) were performed in the Operational Polo of the building company Teixeira Duarte in Montijo, outdoors. Visual inspection of the faces, showed that they are not quite flat and there is significant roughness (figure 4.9), even in formwork faces.
