# **Solutions for Excavation, Earth Retaining Structures and Columns Underpinning**

Case Study – Av. Infante Santo – Building B – IS76

**Tomás Rodrigues de Almeida**

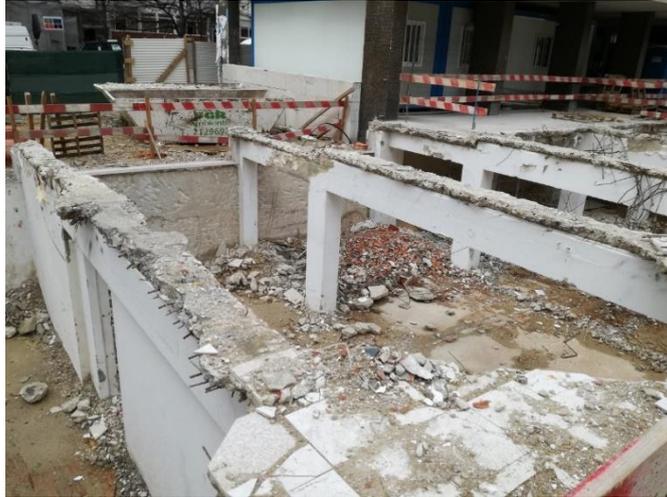
Figure 2: Remaining framed structure after the first demolition works.

In a first phase, the building was partially demolished, with the framed structure and existing peripheral walls temporarily remaining, as well as some sections of the ground floor slab.

This decision was due not only to the enormous lack of space in the yard, but also to the awareness of the structural weaknesses and previous careless execution that led to a conservative approach. The building itself has a construction area of 351 m<sup>2</sup> with an implantation area of 300 m<sup>2</sup>.

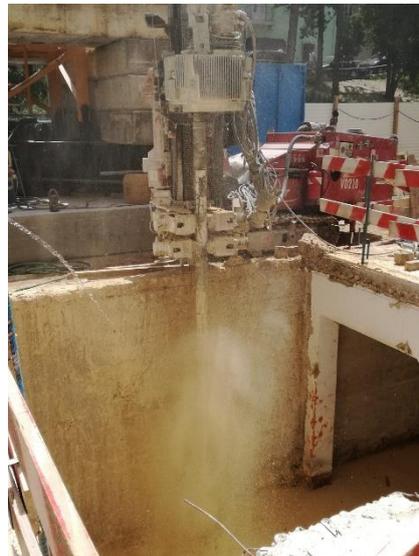
Figure 3: Drilling with roto-percussion with rods and bit.

It should be noted that the stability of the hole through this drilling method was ensured by the high cohesion of the soil, without the need for a coating tube. The sealing injection of the micropiles was performed using the IRS system.

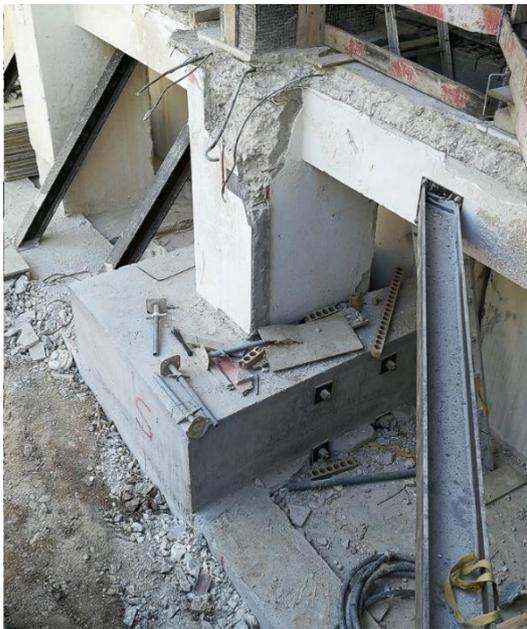
Figure 4: Underpinned column in this case study.

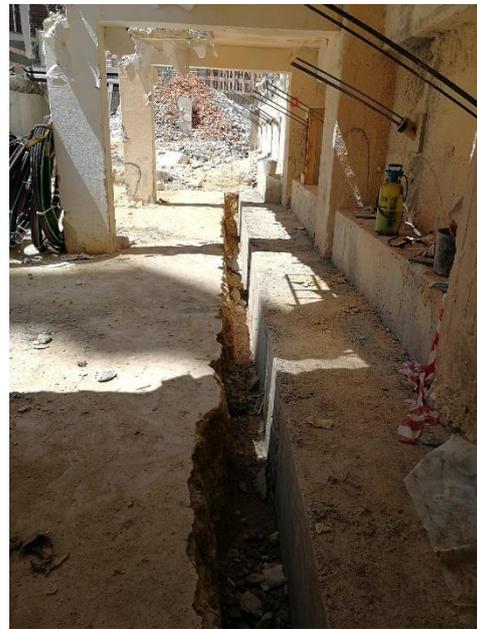
Figure 5: Executed underpinning beam.

After the micropiles were executed, an underpinning beam was constructed in order to support the vertical elements and the panels constituting the peripheral earth retaining. The beam was coffered and cast against the existing wall.
