SLOPE STABILITY

LANDSLIDE AT S. PEDRO DE MOEL

FILIPA RAMALHO RODRIGUES

May 2019

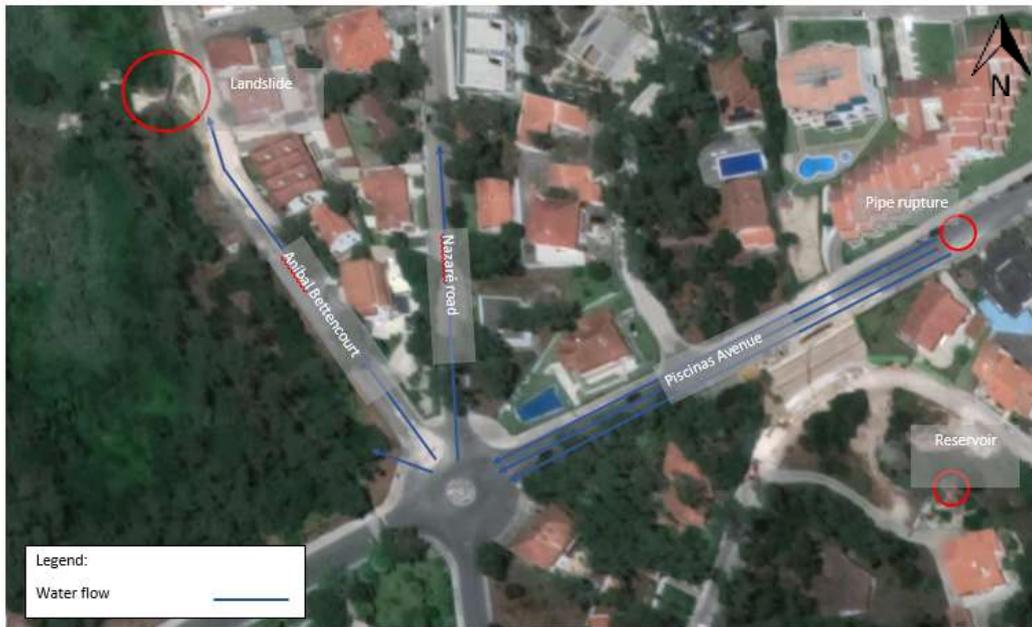
On December 10, 2017, the pipeline that supplies the water reservoir of S. Pedro de Moel collapse, this pipeline had a diameter of 20 centimeters and a pressure of 7 bar, which upon burst caused the area to flood. The accumulation of water at the top of the slope, together with the speed of the water, caused it to rise up the road and seep through the hillside (Ferreira, et al., 2018).

FIGURE 1- WATER FLOW WITH LOCATION OF LANDSLIDE, WATER RESERVOIR AND RUPTURED PIPELINE (FERREIRA, ET AL., 2018)

The flow of water led to the erosion and transport of the sand layer, since the pipeline was active until the next morning, the erosion process became worse until discovered the next day, when there was already a ravine of 30 meters wide and 9 meters deep. The result of the erosion is visible along the water course where there are several wrecks of the road, the walkway and the walls, these follow along the valley of S. Pedro where two accumulation cones of material, next to the existing water line were formed

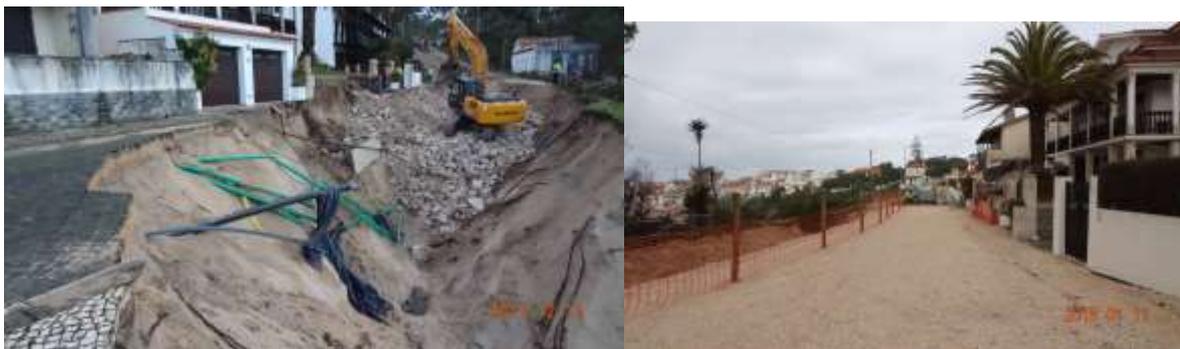
The town Hall of Marinha Grande started on the morning of December 11, provisional stabilization works for the slope. The solution consisted in filling the sidehill with pebbles and by a surface of compacted of granular material.

The embankment was protected by a network also to interdict the passage of vehicles, the essential infrastructure like the sewage pipes, the water and electricity supply were reestablished.

FIGURE 2- EXECUTION OF THE TEMPORARY WORKS AND THE FINAL RESULT (FERREIRA, ET AL., 2018)

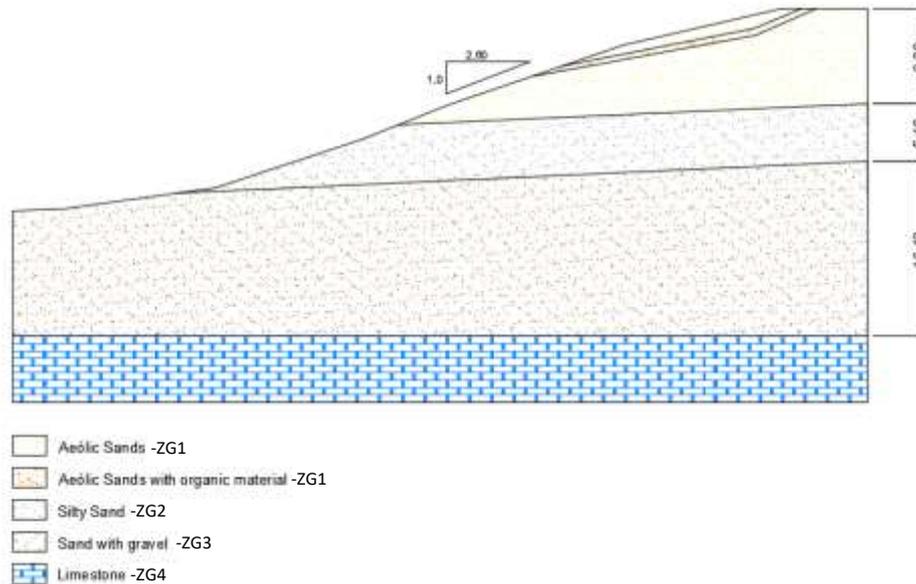
A geotechnical study was requested from the University of Coimbra, which carried out two distinct test trials, one DPSH test and one georadar test. Through these two, and the information provided through the geological map and altimetric maps it was possible to build a geotechnical model and assign resistant parameters to the various layers.

FIGURE 3- SLOPE CROSS SECTION AND GEOLOGICAL PROFILE

Since the movement of the soil occurred mainly in the transversal direction of the slope, and considering that the longitudinal dimension of the slope is much bigger than the transversal dimensions, the cross-section represents a transversal profile with a layer distribution similar to Figure 3

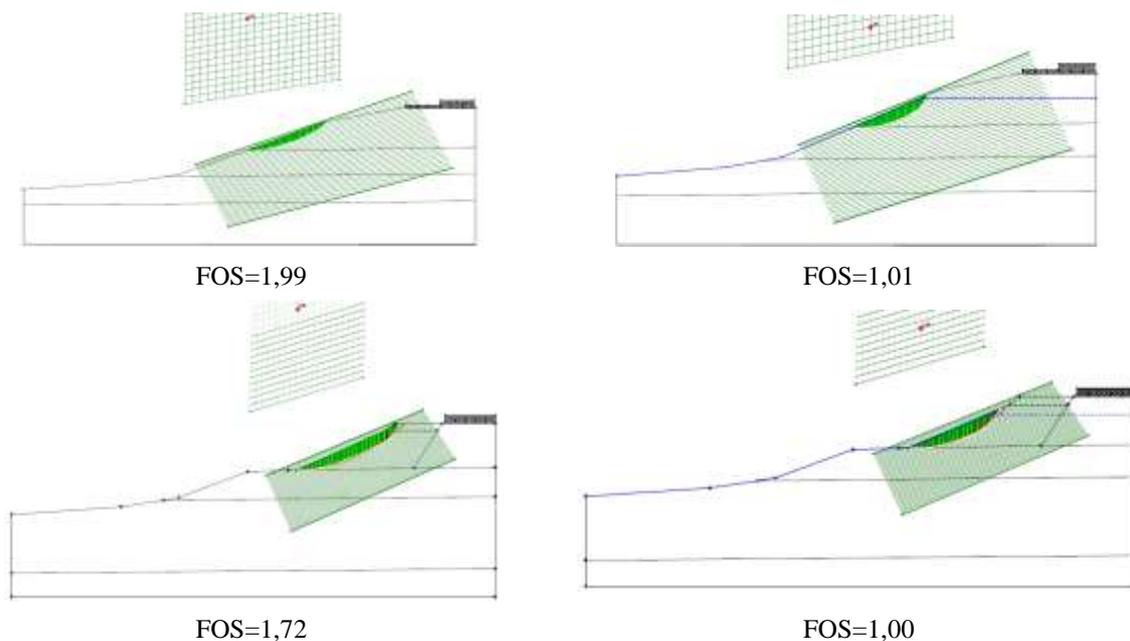
Once established the soil parameters, several stability analyses were carried out, two for the natural slope, with a high-groundwater level and a low groundwater level, and then the emergency intervention was analyzed for the same conditions. The values of the overall factor of overall safety and the sliding surface are showed in Figure 4.

FIGURE 4- FACTOR OF OVERALL SAFETY OBTAINED WITH GEOSLOPE\W

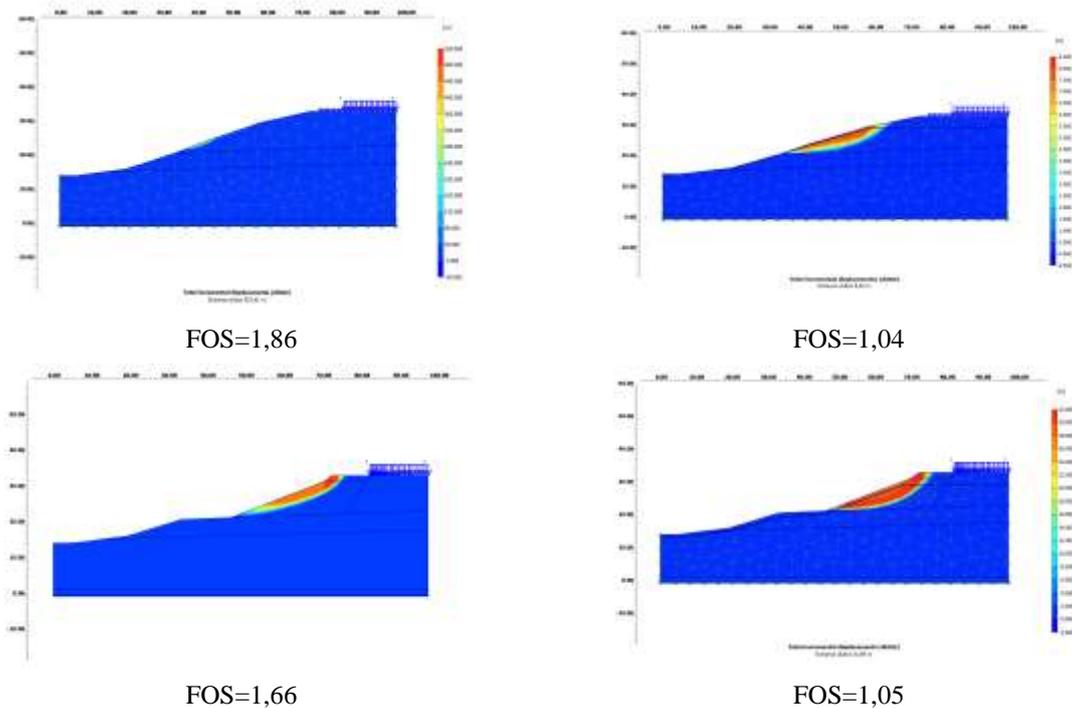
As for the LEM analysis, the slope was studied before collapse and as it is currently found, both for different groundwater level situations. The sliding surface is shown in Figure 5, as it's the FoS.

FIGURE 5- FACTOR OF OVERALL SAFETY ACCORDING TO PLAXIS

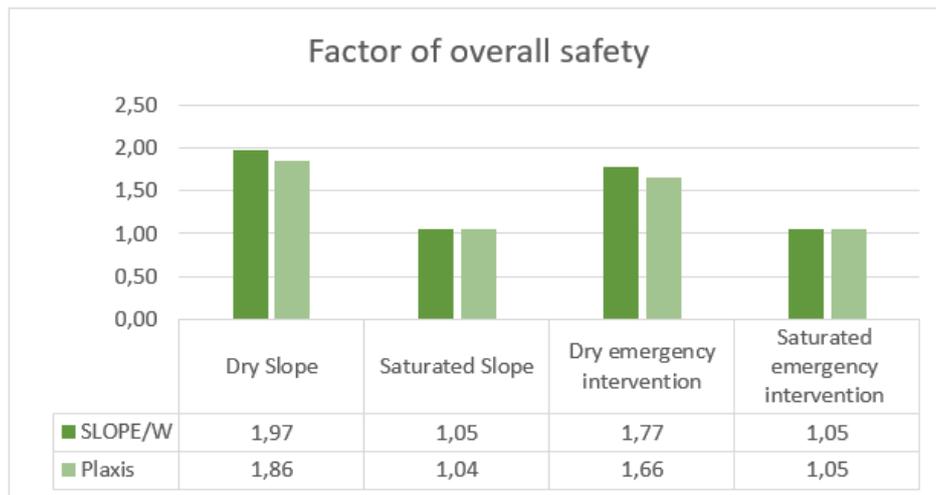
The main difference between the two methods is that the LEM is a static analysis, while the finite element method uses a constitutive relation that relates stress-strain. Since the FEM has the capacity to reproduce the soil behavior, the parameters obtained through the backanalysis in FEM are used in the LEM so that a viable comparison between the methods can be made. The results obtained are in Figure 6.

FIGURE 6-FACTOR OF OVERALL SAFETY COMPARISON BETWEEN THE TWO METHODS

It is noteworthy that during the various simulations, the soil parameters obtained were higher than expected, especially the value of cohesion for materials such as gravel and eolic sand. It is also important to note that a FoS equal to 1 in this simulation is not a value that indicates slope safety, since the FoS equal to one indicates less prone to collapse when the safety factors according to EC7 are applied, which has not happened in this case. So that conclude that it will be necessary to design an alternative solution to the existing one in order to restore the safety of the slope.

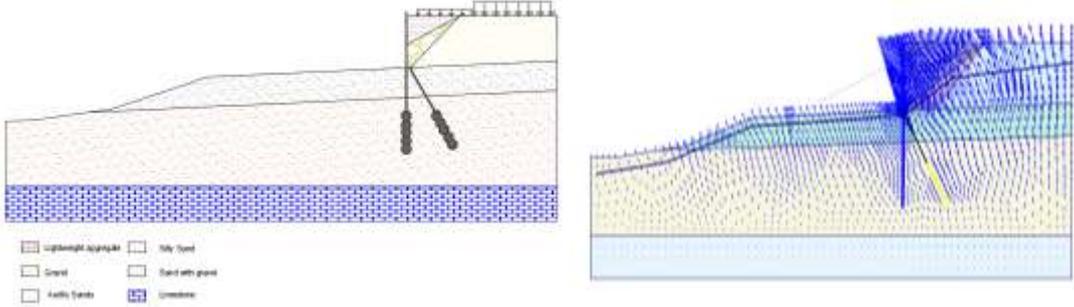
For the simulation of this solution, it was necessary to characterize the materials used according to the models in Plaxis software and to define the various calculation steps. The materials used in this solution were the micropiles, the lightweight aggregates and the concrete wall, the geometry of the solution as shown in Figure 7.

During the calculation phases, the lowest FoS value was obtained when the landfill was removed, $FoS = 1.17$, however, when the solution was complete it presents a FoS higher than 3,50 for a high-water table.

FIGURE 7- GEOMETRY OF THE CONCRETE WALL AND MICROPILES SOLUTION AND DEFORMATION FOR HIGH GROUND WATER LEVEL

Since safety coefficients were not applied to the soil parameters or applied loads, it is assumed that FoS above 1.5 will ensure the allowable safety of the solution.

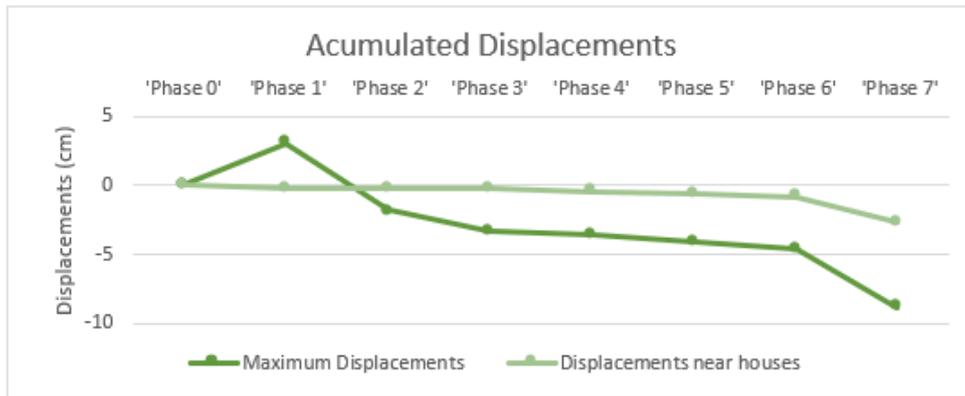
Considering the surrounding constructions, it was important that the displacements didn't exceed the 50mm in that area. In this solution, the maximum accumulated displacement was inferior to 10cm and near the construction it didn't exceed the 2,50cm. The development of the deformations during the several phases are presented in Figure 8.

FIGURE 8- SETTLEMENTS EVOLUTION THROUGH MAIN CALCULATION PHASES

According to the obtained results it is proved that the solution meets the safety and the deformation criteria.

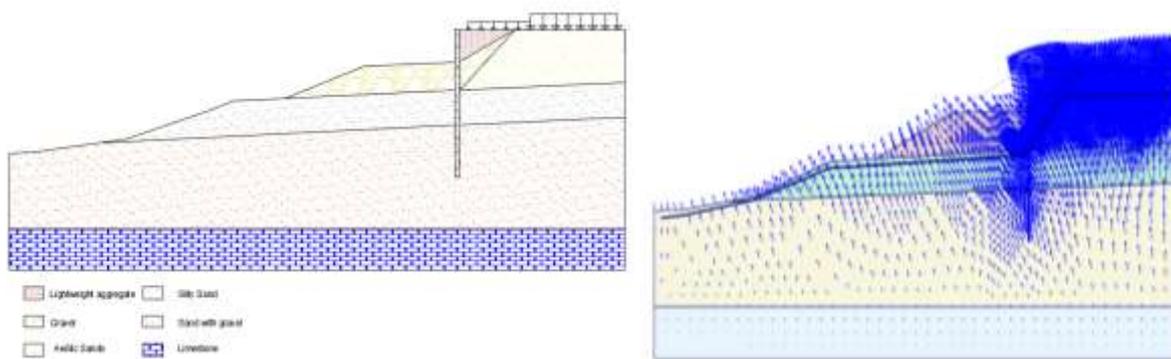
The constructive process of this solution begins with execution of the bored piles, excavation of the existing landfill and later filling it with lightweight aggregates. In each calculation phase, the factor of overall safety and the soil deformations suffered by the soil were analyzed.

FIGURE 9- GEOMETRY OF THE PILEWALL AND DEFORMATIONS FOR HIGH GROUND WATER LEVEL

During the construction process the minimum FoS obtained was 1,66 during the execution of the piles and when the water table rises the FoS is 1.88. This concludes that the construction of the pile curtain ensures the safety of workers and users of the road and houses.

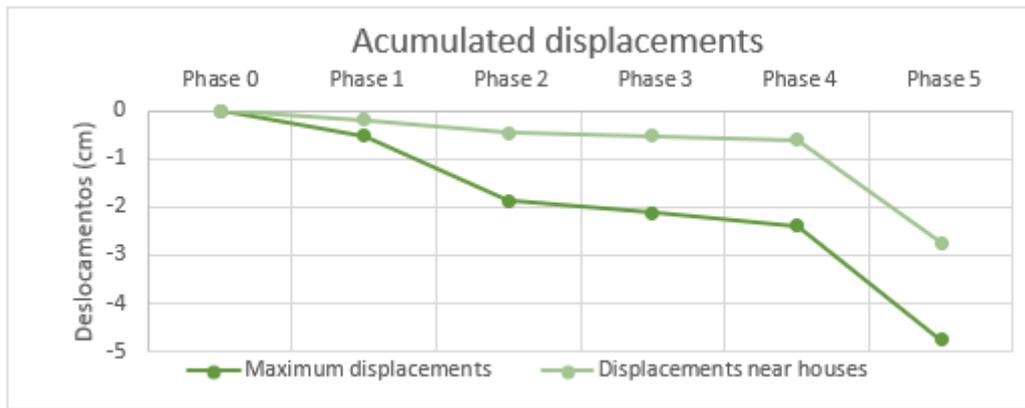
Nevertheless, it was still necessary to analyze the soil deformations, during the execution of this solution, which, by analyzing the Figure 10, guarantees the integrity of the buildings. In comparison with the solution presented before, this one induces less deformations.

FIGURE 10- SETTLEMENTS EVOLUTION THROUGH MAIN CALCULATION PHASES
