# Dynamic characterization and seismic evaluation of masonry buildings in Lisbon.

## Realization of ambient vibration and numerical modeling tests.

Bruno Daniel Torres da Silva

Instituto Superior Técnico, Universidade de Lisboa

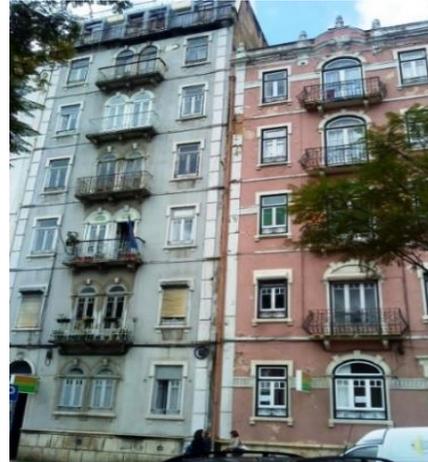
Figure 1 - "Gaioleiro" buildings front façade

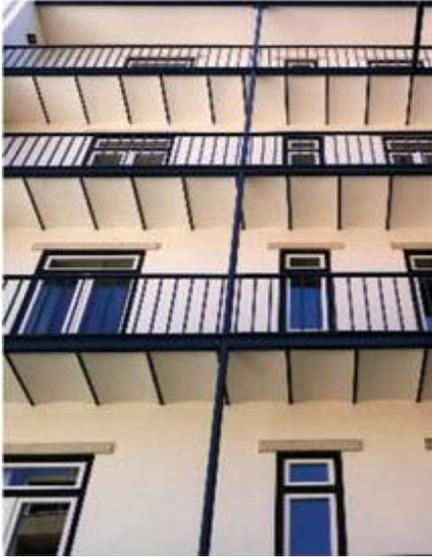
*Figure 2 - Back façade balconies.*

There are two sets of stairs, one inside and the others outside. The first is located approximately half-way from the building next to one of the gables, being executed in wood, while the latter is located in the back facade connected to the balconies, generally constituted by metallic elements.

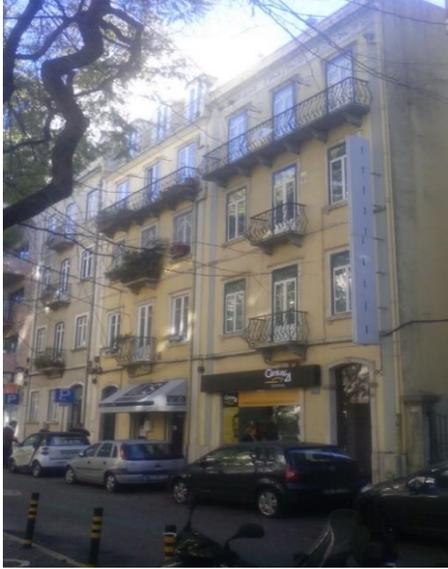
All the buildings selected for the tests belong to the type I (Simões, 2018), two of them neighbours, located on Avenida Elias Garcia (nº89 and nº91) - Figure 3, in the neighbourhood of Avenidas Novas and the other on Travessa de Santa Marta (nº4) - Figure 4, located in Santo António. All the buildings have widths around 7-8 meters and depths around 19 meters.

The buildings of Av. Elias Garcia have 3 floors above the ground floor and an habitable attic and are situated between a building of reinforced concrete and another “gaioleiro” of the same type with the opposite gable free. On the other hand, the building Travessa Santa Marta nº4 has 4 floors above the ground floor and an habitable attic, located at the end of a series of buildings, though only the adjacent one is totally parallel.

Figure 3 - Buildings 89, 91 e 93 of Av. Elias Garcia.

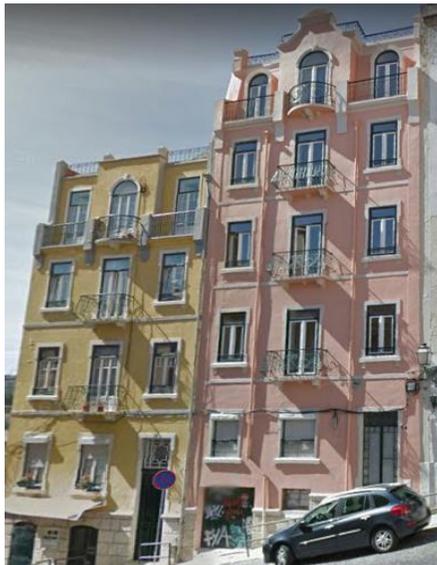
Figure 4 - Travessa Santa Marta nº4.

In the building Travessa Santa Marta nº4 the conditions available for the accomplishment of the tests were quite satisfactory, which facilitated the access to the dwellings of all the floors. The tests were performed in ascending order of height, with the two free seismographs placed successively in the southwest and northeast corners of each floor. The reference seismograph was placed in the southwest corner of the top floor (attic) - Figure 6.

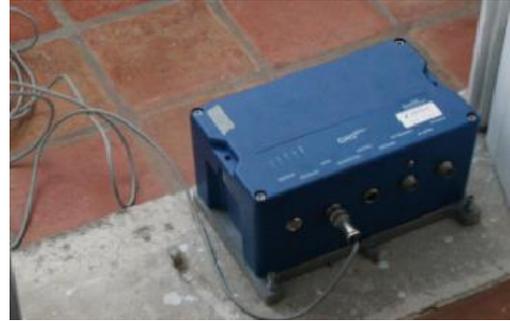
The measurement units used for the ambient vibration tests were GeoSig branded macro-seismographs, model GSR-24 - Figure 5, programmed to start and end the test simultaneously by a portable computer through software, which later collects and allows the reading of signals collected from all channels.

Figure 5 - Seismograph used in the tests.

The procedure started with the programming of each of the seismographs for the measurement, inserting parameters such as the start time, measurement duration and frequency of record acquisition, through the QuickTalk™ program. After the setup was completed, the seismographs were placed at the designated locations for each measurement. In all measurements, one of the seismographs is held at a fixed point, desirably at the top and at one corner of the building, to ensure the homogeneity of the records, while the other two are free and varying their locations between measurements. The duration chosen for the tests (twenty to thirty minutes) should be enough to ensure a sufficiently representative sample of accelerations.
