“Rising damp in masonry walls of old buildings”

Rui Jorge de Moraes Monteiro Torres

Extended abstract

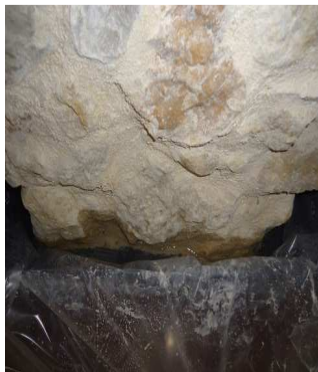
Fig. 3 – After 1 hour.

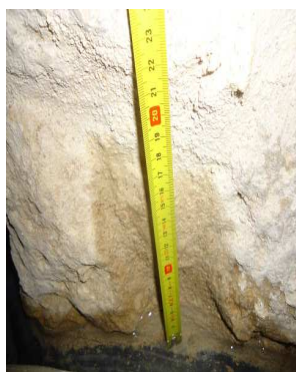
Fig. 4 – After 5 hours.

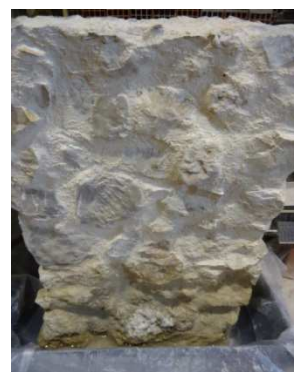
Fig. 5 – After 15 days.

Most likely the sample reached a balance between the amount of water absorbed and the amount of water evaporated daily, preventing the maximum height of rising damp to arrive at higher levels. The highest level of rising damp in natural environment corresponded to 49,0 cm.

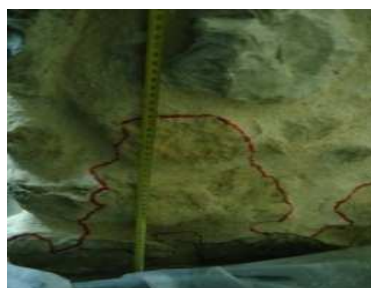
Fig. 6 – After 1 day.

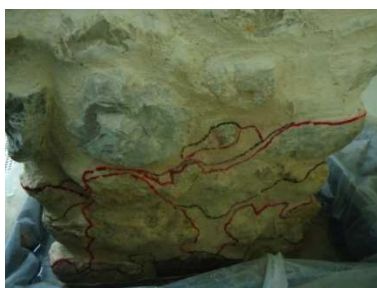
Fig. 7 – After 1 days.

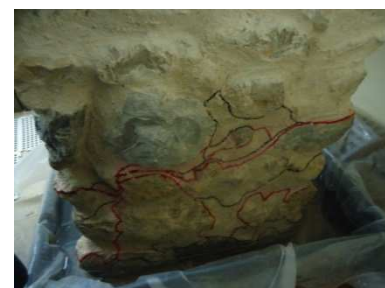
Fig. 8 – After 19 days.

The heterogeneity of the material explains the existence of an intermediate step (5 days). The highest level of rising damp in a controlled environment corresponded to 60,0 cm.

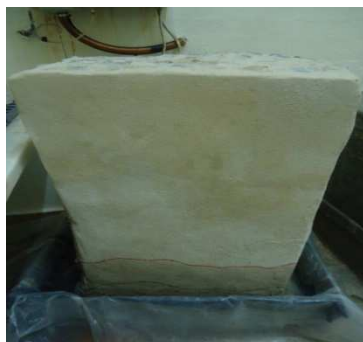
Fig. 9 – After 1 day.

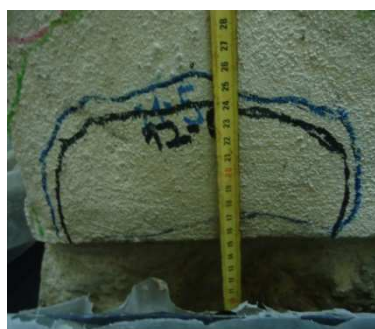
Fig. 12 – After 1 day.

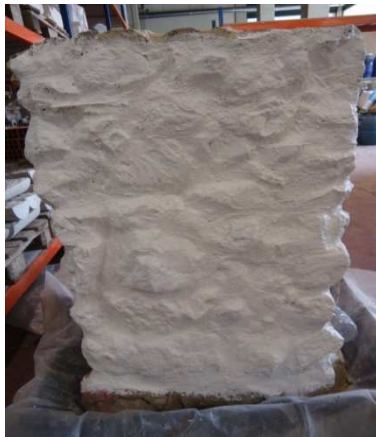
In surface "B" two layers of rubber paint were applied directly on the old lime mortar rendering. (Fig. 15)

Fig. 15 – Rubber paint applied to the Surface "B".

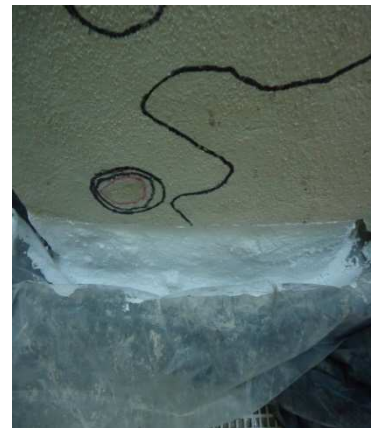
Fig. 16 – After 1 day.

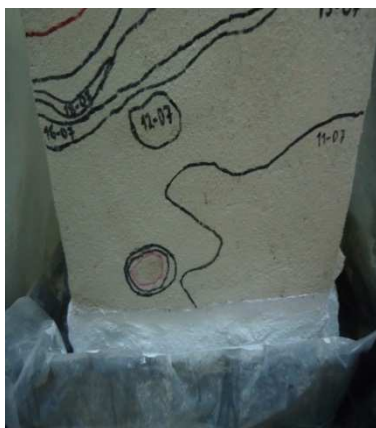
Fig. 17 – After 4 days.

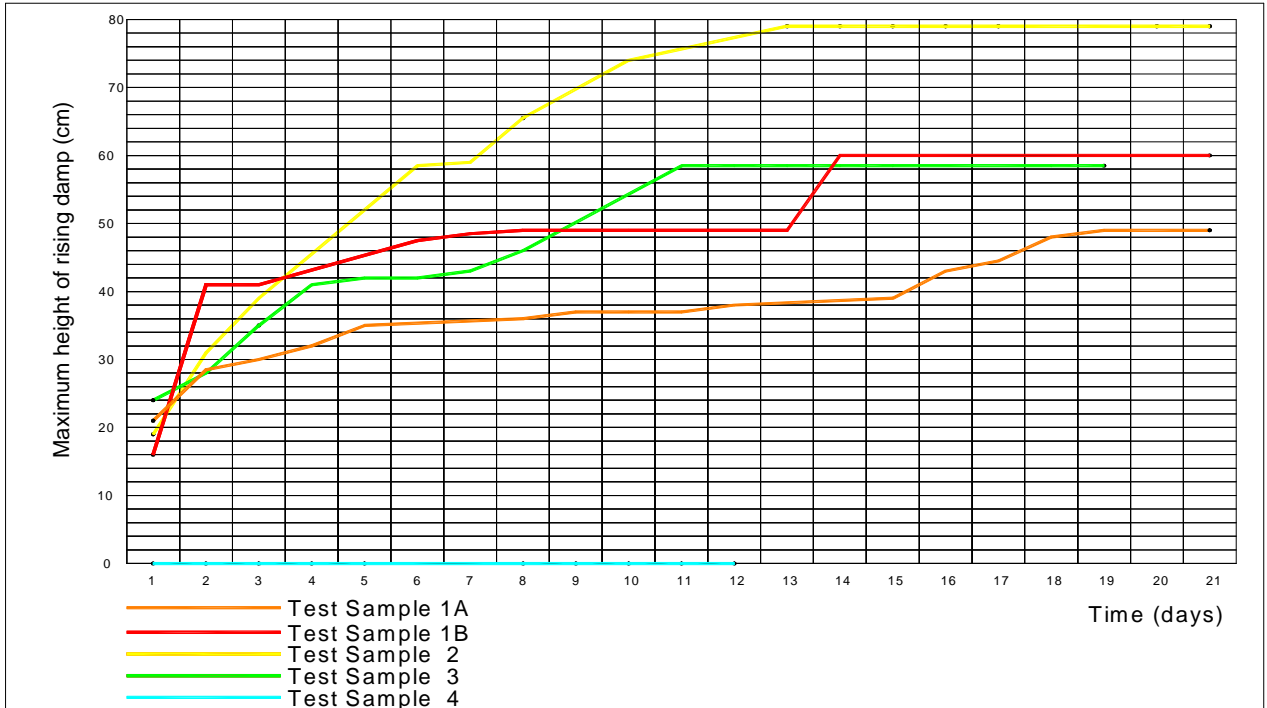
Figure 19 – Maximum height of rising damp in stone masonry with hydraulic lime mortar

The results rise from 60,0 cm (Sample 1.b) – Experiment 2) to 79,5 cm (Sample 2 – Experiment 3).

The lime mortar rendering was maintained but the 15 cm bottom was removed, preventing direct contact with water. So the maximum height of rising damp was significantly reduced in 26.4%, moving from 79.5 cm (Sample 2 – Experiment 3) to 58,5 cm (Sample 3 – Experiment 4).
