Solutions of Excavation and Peripheral Earth Containing Walls with Preservation of Historical Façades

Paulo Alexandre Van Den Broeke Costa

Instituto Superior Técnico, University of Lisbon, Lisbon, Portugal

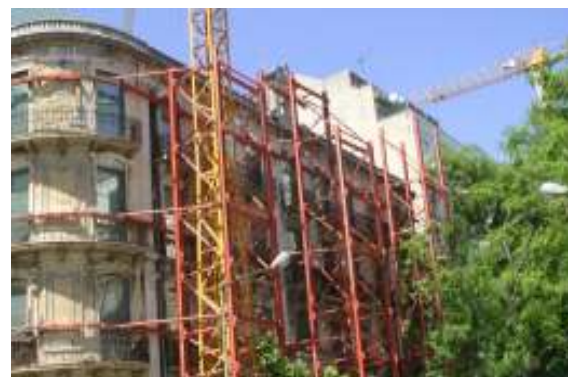
Figure 1 – Temporary steel structure

Knowing the conditions just referred, the initial proposed solution included a temporary steel structure to retain the façades (Figure 1).

This steel structure had pinned joints, making its setup relatively fast. It was supported on a concrete shallow footing founded in micropiles. In order to vertically stabilize the façade, two beams were executed (one on the exterior side and one on the interior), compressed against the façades by a pre-stressed bar of the *Gewy-Dywidag* type (Figure 2).

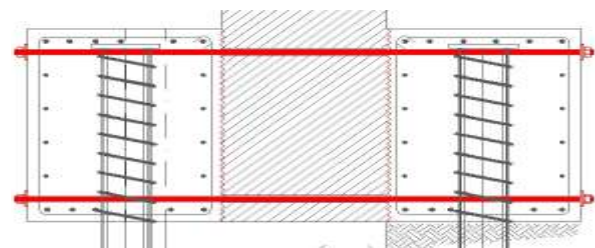
Figure 2 – Beams stabilizing the façade with the pre-stressed bar guaranteeing a better mobilization of the vertical loads (red) (adapted from [4])

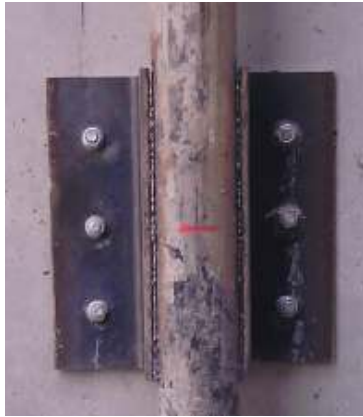
Figure 3 – Steel section guarantying the vertical forces mobilization between the retaining wall and the micropile.

beforehand in the ground. Due to physical incompatibility, these micropiles were not embedded on the concrete that formed the containing walls, but executed in its outside. The forces were then transferred through steel cantilevers melded to the micropiles (Figure 3).

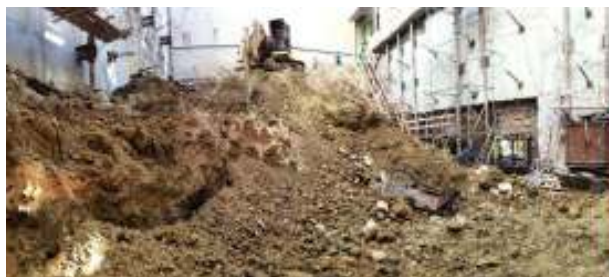
Figure 6 – Figure that illustrates the parallel execution of different levels of panels. The most delayed part of the excavation is near the entrance, in order to give access to materials and equipment.

King Post walls were made in different levels simultaneously depending on its location due to the fills treatment. This allows the works to have a good efficiency, increasing the production (Figure 6).

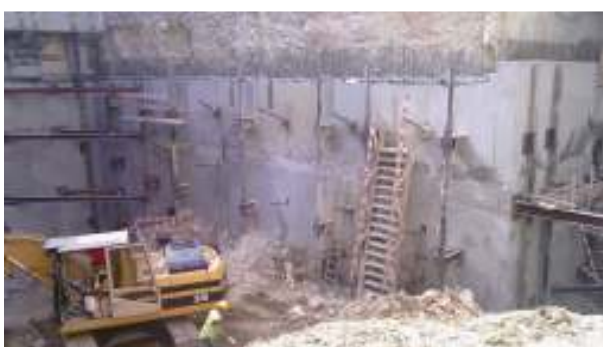
Figure 7 – Retaining walls.

In Figure 7 we can see can observe a picture of the retaining walls and both ground anchors and shorings that horizontally stabilize it.

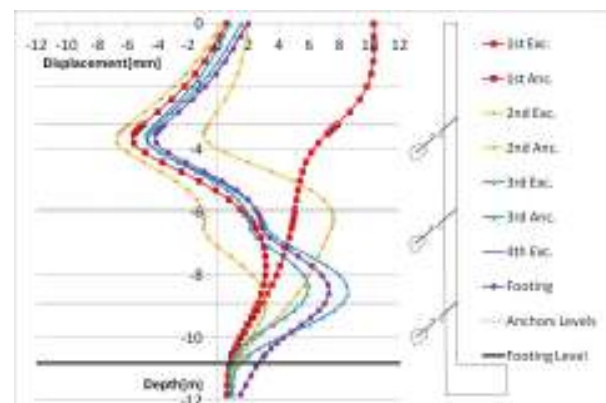
Figure 11 – Horizontal displacement of the wall by construction phase.

In Figure 11, it is shown the horizontal displacements by construction phase. The biggest displacement occurs in the excavation of the first panel level, where it registers 10,2mm towards the interior of the excavation. The little cohesion and stiffness that characterizes the superficial levels of this soil makes it very sensitive to the decompression that is associated with the excavation.
