Investigation of the Flexural Fatigue Behavior of Stone-Faced Cork Agglomerate Sandwich Composite

Ilaria Andreazza

Instituto Superior Técnico, Universidade de Lisboa, Portugal

September 2017

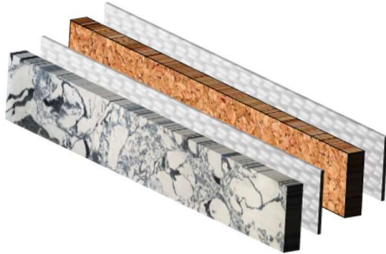
Figure 1.1 Exploded view of the material layers of the composite

cladding, it brings advantages in terms of cost, design, safety, and stability. These advantages are a direct consequence of its lower weight compared to natural stone. Its structure comprises of a first stone layer, a layer of glass fiber reinforced-resin (GFRE), a cork agglomerate layer, and a last layer of GFRE.

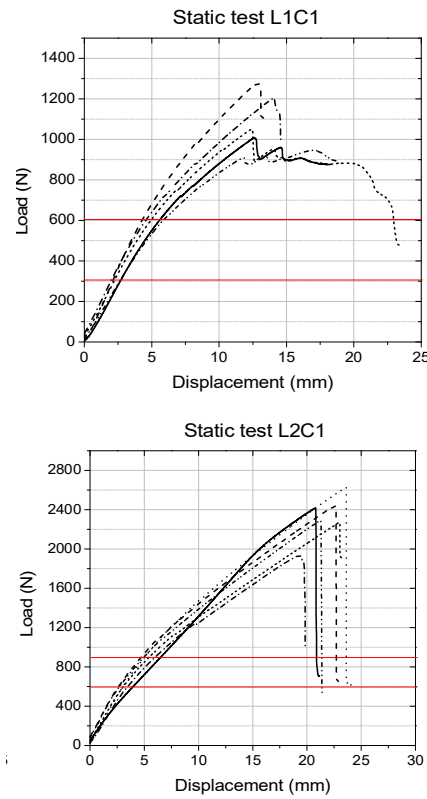
Figure 3.2 Load-displacement curves for the static tests L1C1 and L2C1

The results of the static tests are shown in Figure 3.2; the red lines indicate the limits between which stiffness is calculated in the cyclic tests.

The unevenness of specimen thickness, t , influences the failure load of L1C1, which can be described by:

$$t = 0.0026 F_{UF} + 17.635 .$$

As for L2C1, there has been no identified dependence $F_{UF}(t)$ both because a) the standard deviations of the thickness measurements on the same specimen are lower than in L1C1, and b) the variability of the average of the thicknesses is low.

It has been therefore concluded that F_{UF} of L2C1 can be taken as the average of the failure loads: 2409 N.

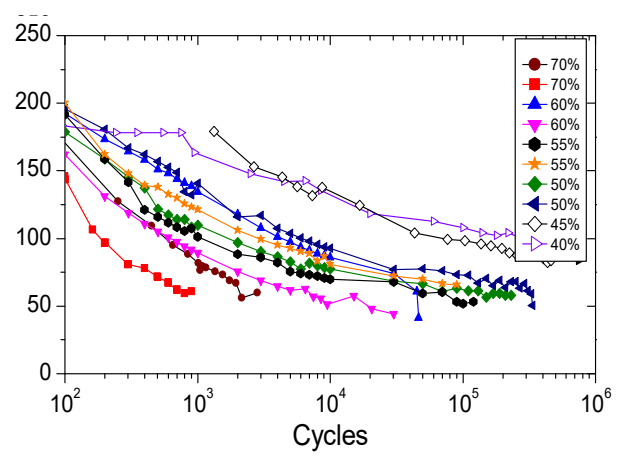
Figure 3.3 Trend of the quantities 1) accumulated deformation, 2) relative stiffness, 3) absolute stiffness, 4) dissipated energy, and 5) cumulative energy along the cycles for L1C1 and L2C1

The maximum force (F_{MAX}) of the fatigue cycle is always calculated as a percentage of the static failure load. The results of the two materials tested are summarized in Figure 3.3.

For both materials, d_{acc} shows a linear trend in logarithmic x-scale, meaning that there is a rapid increase until about 10^4 cycles, after which, unless the material fails shortly after, it stabilizes to a plateau. Curves tend to have higher stabilization deformation for increased load percentages, although for L1C1 a curve at (theoretical) load percentage of 80% has lower d_{acc} than the one at 70%. Material L2C1 shows a more regular behavior, with linear curves and approximately decreasing slope for decreasing load percentage.

The fact that all curves for the two materials have a linear trend, or logarithmic trend in linear scale, means that there always is an initial period during which the material loses part of its stiffness. The number of cycles until stabilization is, for both materials, 10^4 cycles. As shown by the test with stops, the loss in stiffness is permanent, and could be associated to a damage in the cork layer.

Overall, the d_{acc} at failure for L2C1 is set at higher values than for the other configuration (3 to 4 mm versus 1 to 3 mm); the cause could be found in the higher compressive resistance of the stone L2. The increase in d_{acc} is due to the viscoelastic nature of the cork layer; cork is microscopically made of cells with elastic walls which corrugate under stress. When stress is released, the corrugation is also recovered, but recovery has a time delay. Since the frequency of the cyclic loading is higher than the time needed for recovery, cork does not recover all its deformation, and the remaining is accounted for in d_{acc} .

The trend of d_{acc} at failure in L1C1 seems to be inferring that lower load percentages have higher accumulated deflection at failure, although the penetration of the rollers on the cork is not considered. The same happens for L2C1, although the data are more scattered.

L1C1 always shows an initial decrease until stabilization at a constant value, which is maintained until before failure. Materials showing infinite life have a curve with slope zero and similar value of relative stiffness (145-150 N/mm): this is a confirmation of the homogeneity of the stone composition. Failure might have different causes: at low

The initial decrease of D_{rel} (until 10^3 cycles) is shown both for L1C1 and L2C1, and can be attributed to a damage of the cork layer. Instead, a faster decrease in stiffness for load percentages above 60 in L2C1 could indicate another damage mechanism, probably on the stone, since it is the stone that fails due to crushing. At higher loads the damage happens faster; before the 100^{th} cycles shown on the graphs, the cork already lost its initial stiffness, increasing the bending deflection. Higher deflections at constant frequency, and slow recovery of deformation induce the composite to be loaded abruptly, until the repeated impact of the loading pin on the stone generates failure.

The graphs of dissipated energy per cycle show whether there is or not a variation in the shape of the hysteretic loops, which in turn is an indication of occurrence of energy dissipating processes. Specimens with the highest absorbed energy per cycle fail at the lowest number of cycles, for both materials. L2C1 graph indicates that the energy absorbed per cycle increases for higher maximum loads, as it is expected, because they are associated to increasing values of F_{MAX} . Moreover, in all cases the plateau energy value is constant until failure, following the same trend as the relative stiffness. This confirms that there are not additional relevant damage processes before failure.

The curves for cumulative energy showed a predictable trend: looking at L2C1, specimens tested at lower load percentages absorb less energy per cycles, therefore accumulate energy more slowly, and their slope is lower than for specimens which fail sooner. Overall, the cumulated energy at break is not constant, but higher for specimens that last longer. This means that the mechanisms inducing energy dissipation in infinite-life specimens do not degrade the properties of the material, because of an equilibrium between energy dissipation – probably in the form of heat – and thermal exchange with the environment.

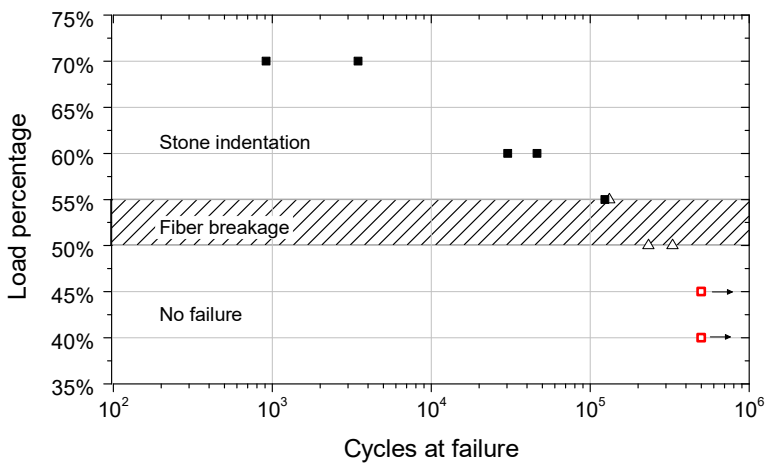
Figure 3.4 Failure mode map for L2C1

In all cases, L1C1 failure occurred due to crushing of the stone layer; L1C2 instead showed different modes of failure according to the applied load percentage (Figure 3.4):

- For $F_{MAX} > 60\% F_{UF}$ failure occurred due to indentation of the limestone, as was in L1C1.
- For $45\% F_{UF} < F_{MAX} < 55\% F_{UF}$, we observed a change in failure mode: failure occurred because of breakage of the lower layer fibers, and crack propagation in the cork layer in the direction of maximum shear stress.
- For $F_{MAX} < 45\% F_{UF}$, no fracture was observed.

For L2C1, the situation is different; although for load percentages of 60 and above, the impact of the loading pin causes failure, at 55%, the failure mode shifts. Here, due to the permanent deformation increasing slowly, the stone does not suffer from the previous effect, and the life increases considerably (from 10^4 to 10^5 cycles). This additional cycles therefore damage the layer which sustains the second highest stresses: the bottom glass-fiber layer. Damage is initiated where defects are: fabric cross-overs, undulations, or bubbles in the resin. This type of fracture is not present in L1C1 because the stone crushing occurs at lower stresses, nor it is visible in L2C1 above 55%.

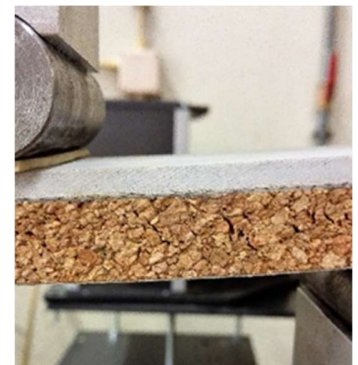
Figure 3.5 Macro-cracks on the cork layer on the fatigue tests with resting time

instead failed showing a common feature: multiple macrocracks at 45° orientation on the cork layer located at the right- and at the left-side of the left and right roller, respectively (Figure 3.5). The resulting number of cycle at failure for the various percentages are given in

Interestingly, failure of the lower fibers did not occur in the specimens tested with resting time. Here, the specimens showed typical shear failure modes of symmetric sandwich

composites tested in static or fatigue (Zenkert & Burman 2009).

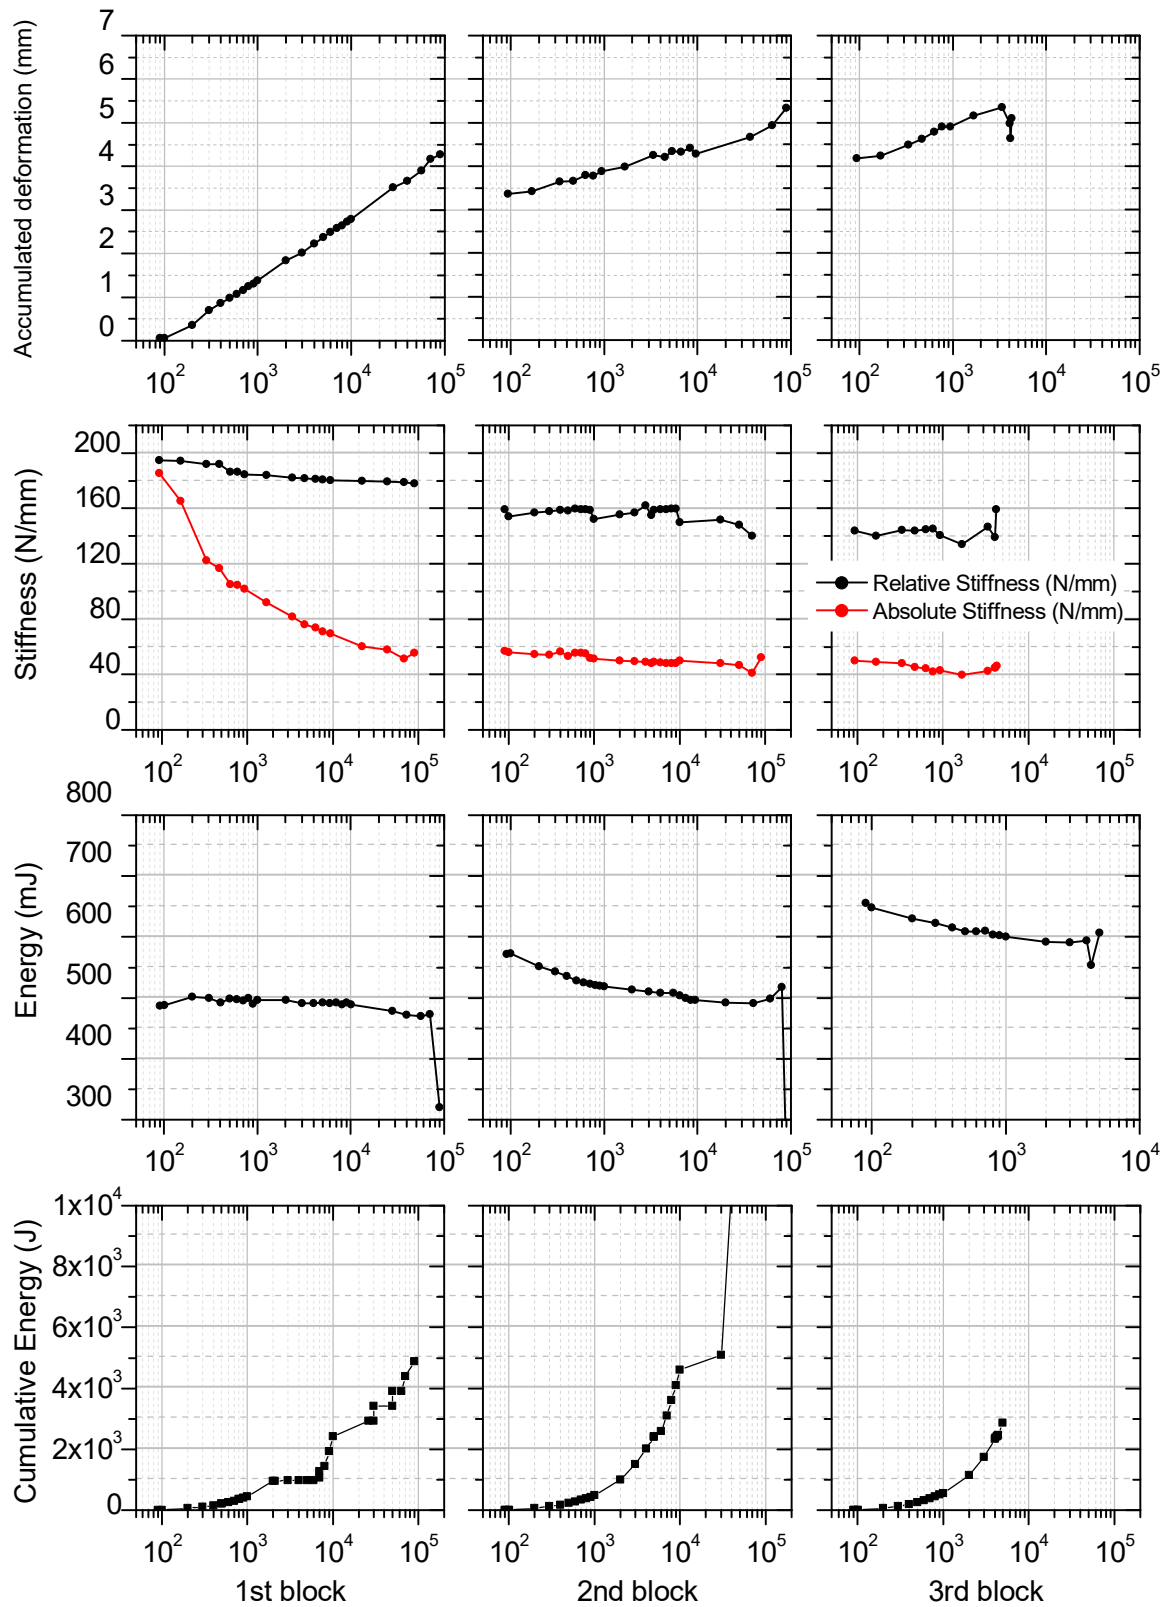
Figure 3.6 Trend of the quantities 1) accumulated deformation, 2) relative stiffness & absolute stiffness, 3) dissipated energy, and 4) cumulative energy along the cycles for LIC1; tests with resting time of 24 hours between blocks.

Tests with resting time were carried out for L1C1, at the load percentages already mentioned; only the results of 55% will be reported here, the others showing similar trends. The test at 45% did not show any sign of failure after two blocks of 500'000 cycles. The tests at 55, 60, and 60%

- Table 3.1).
- There is permanent cork damage, as can be deduced by a) the relative stiffness not going back to the initial value, and b) the d_{acc} rapidly reassuming the value it had before the resting time.
- The cork suffers from fatigue. More precisely, it is the resin used as adhesive of the granules that fails due to cyclic effect, and the mechanical resistance of the cork is degraded

The motivation underlying the first point is not clear. It is assumed that, besides the permanent damage on the cork suffered in the first cycles, there is a damage component which is recovered during the resting time, probably related to the architecture of the cork cells. Regarding the second point, the resin is the weakest link of the agglomerate, the cell walls do not fail. This is in agreement with previous tensile and shear tests done on the cork only.

The graphs of absorbed energy along cycles are also peculiar: for 55, 60, and 65 % the energy dissipated in blocks other than the first has a high initial value, then decreases. The resting induces recovery of some viscoelastic deformations, recovery which is lost again at the beginning of each new block. It is unclear whether the recovery is in the cork, in the stone, or in the fibers.
