Investigation of the Flexural Fatigue Behavior of Stone-Faced Cork Agglomerate Sandwich Composite

Thesis to obtain the Master's Degree in

Materials Engineering

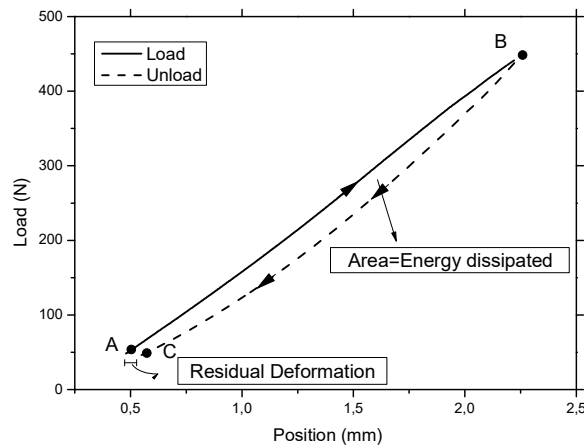
Figure 2.1 Sample hysteresis loop

between A and C). At this point, one fatigue cycle has been performed, and it is defined a hysteresis loop. Figure 2.2 pictures three cycles at increasing maximum load. The area under the curves represents the dissipated energy. After a number of cycles at the same maximum load, the hysteresis loop stabilizes.

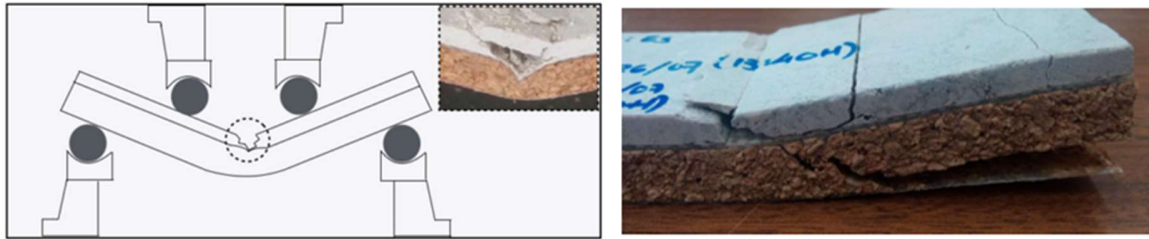
Figure 2.6 Left: Failure of specimen in 4-point bending (Gomes 2016). Right: Failure of specimen in cyclic 4-point bending

Failure in the **monotonic** bending test (of the non-optimized composite) occurred because of a crack initiated on the stress concentration points below the loading pins on the hard (and fragile) plate (Figure 2.6 left). After failure of the stone component, the layer of resin-fiber in the interface skin-core wrinkles and the cork agglomerate follows this deformation without delamination. Also, no delamination occurs between stone and fiber which indicates a good adherence between different layers of different materials.

In **cyclic** test, the damage is visible both in the hard plate as well as in the core (Figure 2.6 right). It is again assumed that cracks initiate below the point of load application on the stone. When the whole transversal section of the stone has failed, there can be an effect of penetration of the stone edges inside the cork during the cycle. This cutting effect ultimately leads to a 45° crack throughout the core.

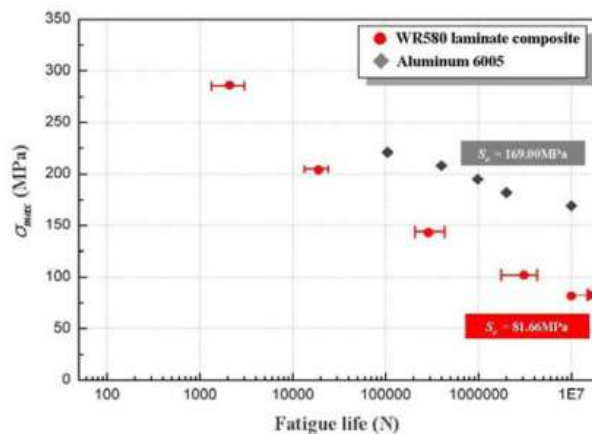
Figure 3.9 The S-N curves of woven fabric glass/epoxy laminate composites compared to Al 6005 in accordance with the maximum stress; R= 0.1 (from (Jeon et al. 2011)).

The endurance limit of GFRP in tension-tension fatigue, as tested by (Jeon et al. 2011), is 20% at stress ratio 0.1 (Figure 3.9 The S-N curves of woven fabric glass/epoxy laminate composites compared to Al 6005 in accordance with the maximum stress; R= 0.1 (from (Jeon et al. 2011))). In tension-compression with stress ratio of -1, endurance limit of the tested laminate was found at 20% stress percentage in the warp direction, and 20% in the fill direction. Additional information on literature on fatigue of unidirectional composites was given in §2.2.

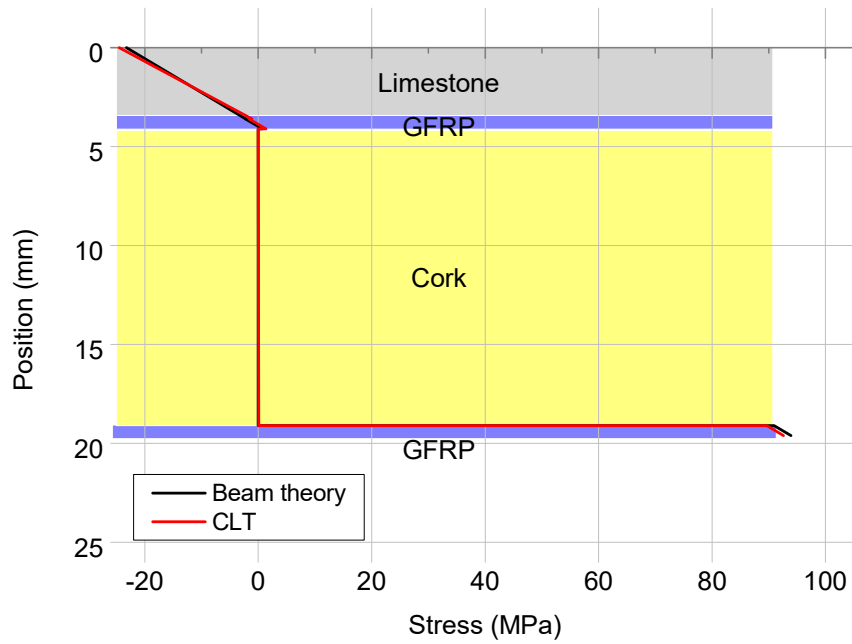
Figure 3.12 Graphical representation of the normal stress distribution according to the classical beam theory and the classical lamination theory (CLT).

Normal stresses (MPa)			
	Stone	GFRP	Cork	GFRP
Top	-19.8	-5.35	0	116
Bottom	-5.13	-3.23	0.00165	119

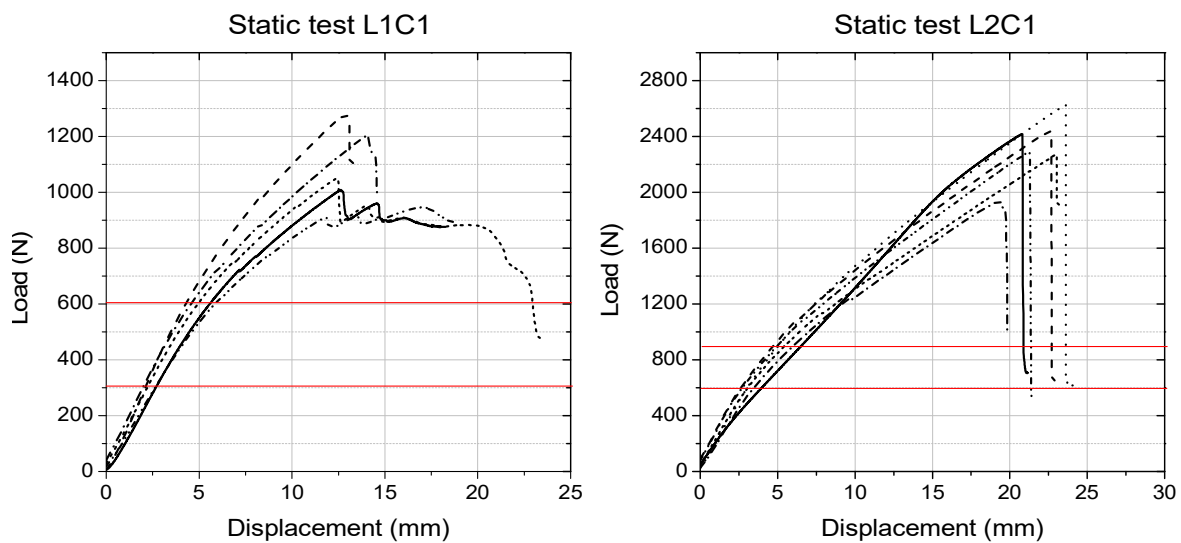
Figure 5.1 Load-displacement curves for the static tests L1C1 and L2C1

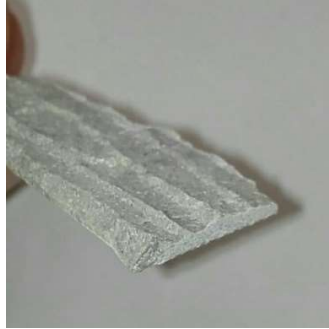
Figure 5.5 Example of stone chip detached (phase III)

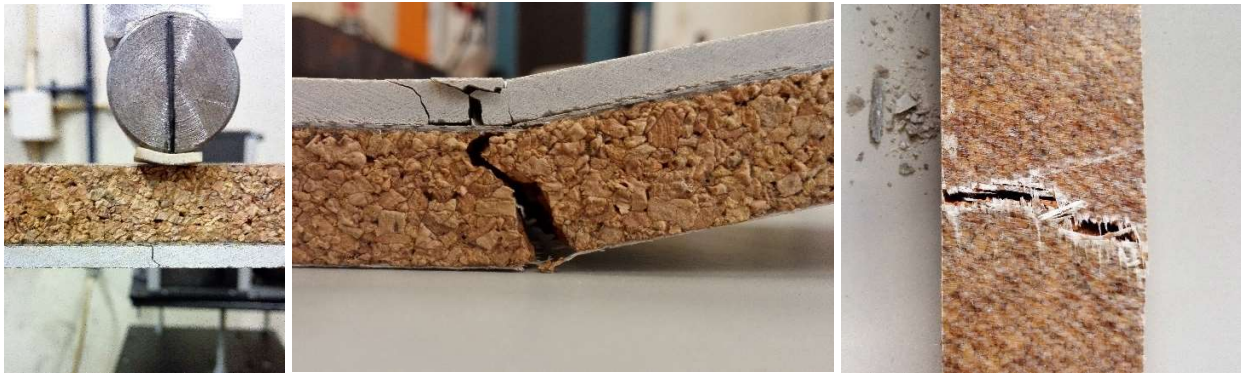
Figure 5.14 Failure modes observed for load percentage 55% (L2C1). Left: fracture of the limestone (the picture was taken in "reversed configuration" applying a tensional load on the stone to open the crack, for it to be easily seen. Center: fracture nucleated on the lower fibers. Right: picture of the fractured fibers.

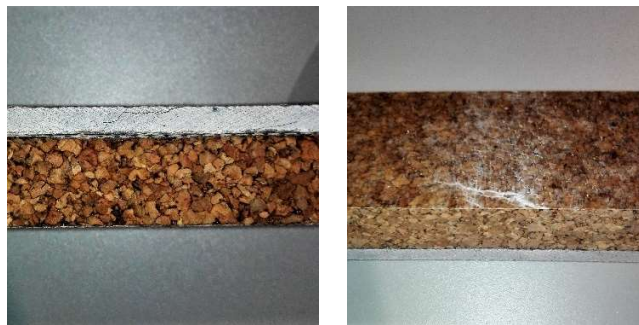
Figure 5.17 Specimen tested at 60% with resting time. Left: crack on the stone. Right: whitening of the resin.
