Seismic Vulnerability Assessment of Lisbon's Downtown

Luís Guilherme Faria da Luz

Instituto Superior Técnico, Universidade de Lisboa

November 2017

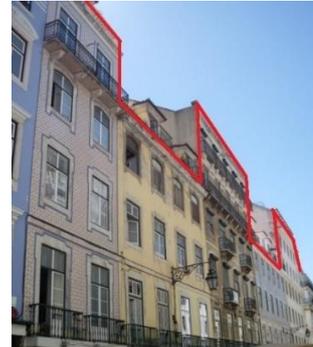
Figure 2.1 – Irregularities in the *pombalino* block due to the increasing number of storeys

The idea of a *pombalino* block constituted by buildings with the same height nowadays is not a reality in Lisbon's downtown. Due to the irregularities in the *pombalino* block (Figure 2.1) buildings will show different dynamic characteristics which can compromise the seismic behaviour of the block.

The direct consequence of adding new floors is the increase of the weight of the structure, resulting in the increasing of the inertial horizontal forces and displacements during the seismic action. This would not represent a problem if the building was properly reinforced, but in most of the situations this does not happen [3].

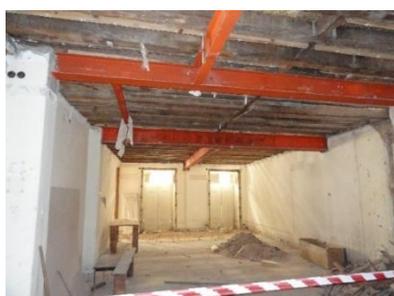
Figure 2.3 – Frontal walls substituted by steel beams [4]

to a different use. This intervention is usually complemented by the introduction of steel/concrete beams supported by columns or transferring loads to adjacent walls (Figure 2.3).

Frontal walls are extremely important on withstanding the horizontal forces and contribute to the energy dissipation capacity of the system. The consequences of interrupting the *Gaiola Pombalina* will be the decrease in stiffness and strength at that level. In addition, the embrace of the façades can be compromised if the removed *frontal* walls were perpendicular to these ones.

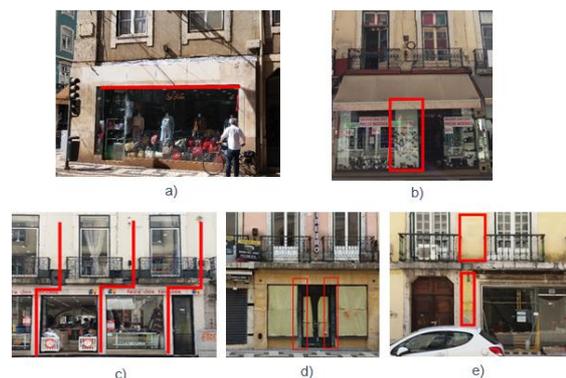
Figure 4.5 – Types of discontinuities for ground floor piers

Figure 4.5 illustrates the types of discontinuities observed for the ground floor piers in Lisbon's downtown.
