Excavation and Peripheral Earth Retaining Solutions

Case Study: Hotel Meliá Lisbon

Madalena Eliseu Felgueiras

July 2021

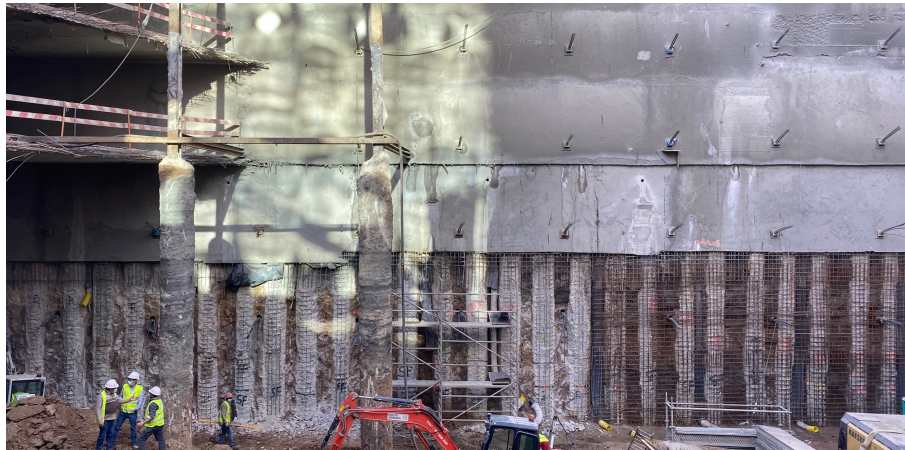
Figure 2 – Alignment D-E (northern area) – Pile curtain with a reinforced concrete wall and anchors

The ground anchors were placed between piles, with different distances between them to fit the earth retaining structure needs. The stability and final rigidity of each wall was reinforced by the structure itself in the final phase (Figure 2).

- Alignment A-A' – Ø 500mm piles, 0.75m apart, with an average length of 15m.
- Alignments B-C/C-D/D-E – Ø 800mm piles, 1.20m apart, with an average length of 27m.

It was necessary to build a reinforced concrete lining wall (shotcrete) at the piles face, increasing the main wall rigidity and continuity. This lining wall was progressively executed as the excavation evolved (“top-down” sequence).

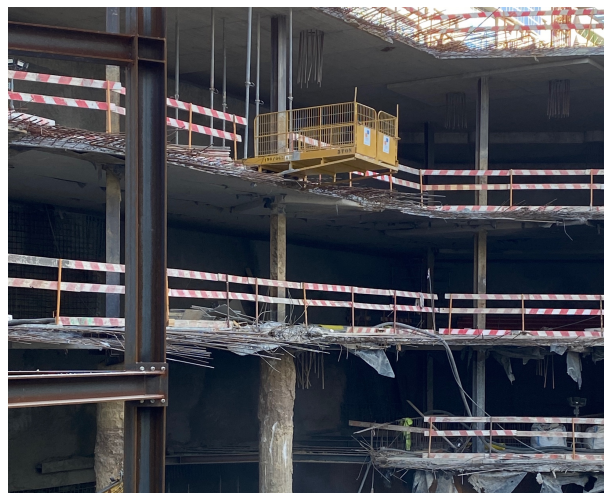
Figure 3 – Alignment B-C – Slab bands with HEB260 metal profiles working as temporary pillars

The geometry of the slab bands was conceived to minimize interference with the execution of the cellars below and to allow the movement of machines and people. Their vertical support, during the excavation phase, was guaranteed by the earth retaining structure walls and HEB260 steel profiles (temporary pillars) (Figure 3).

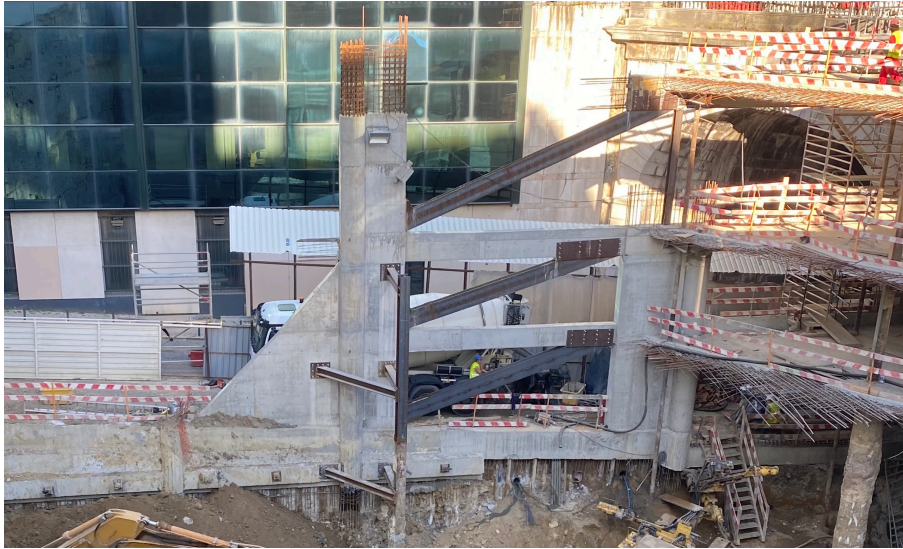
Figure 4 – Alignment A-B – Reaction frame

Given the geometry of the excavation site, and the difference between the ground levels at Rua São Sebastião da Pedreira and Avenida António Augusto de Aguiar – about 10 to 12 meters – the slab strips above floor -3, inclusive, were supported through a reaction frame (Figure 4).

This frame is formed with elements of the permanent structure, composed by columns and wall in reinforced concrete, supported by micropiles, and braced by steel struts" [8]. It functions as a buttress

and will integrate the permanent structure. Its purpose is to transfer the horizontal loads from the slab bands to the foundation of the structure.

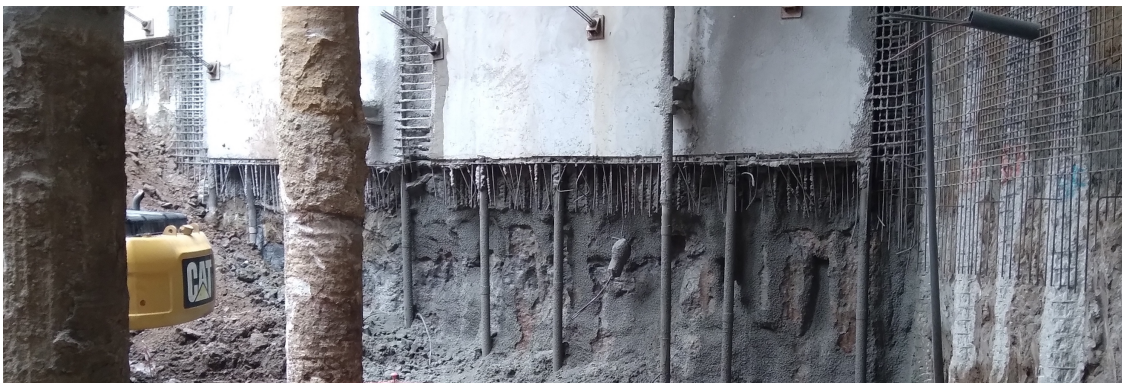
Figure 5 – Alignment A-B – King Post Wal with protection of grout columns

The excavation of king post wall was protected by a curtain of grout columns (\varnothing 250 mm, 0.25m apart), alternately reinforced with HEB 120 steel profiles, built behind and along the wall the wall (allowing greater excavation panels) (Figure 5).
