STABILIZATION OF SÃO PEDRO DE ALCANTARA'S VIEWPOINT WITH MINIMIZATION OF EARTHWORKS

From the project to the execution

April 2018

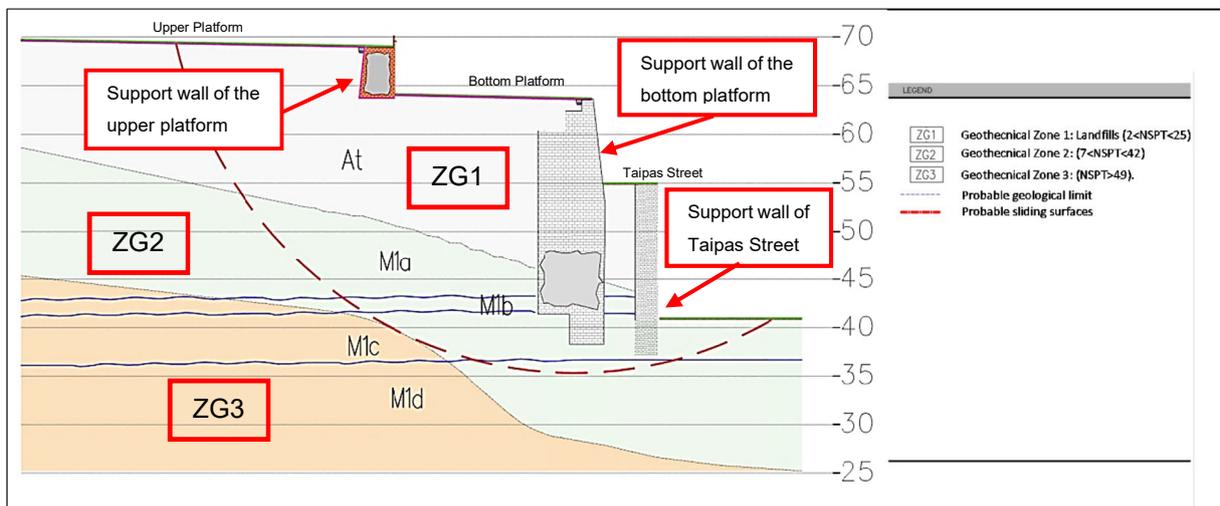
Figure 2: Cross section of the viewpoint and geotechnical zones.

The garden of the MSPA is divided in two levels (see figure 2), one superior, contiguous to the street of São Pedro de Alcântara, and a second platform that is located at a lower level and which is delimited by the lower wall that follows the Taipas street. Already outside the garden but still important to the complex of the viewpoint there is a third wall, which serves as support to the Taipas street. The detailed knowledge of the elements that compose the viewpoint complex, especially regarding the organization and architectural layout, are an essential component for the understanding of the processes and actions inherent to the slope stabilization.

- Characterization of the ground that supports the equipment and its framing in three different geotechnical zones (see fig. 2);
- Displacement of the lower support wall (see fig. 3);
- Possible sliding surface at depths of around 30 meters (see fig. 3).

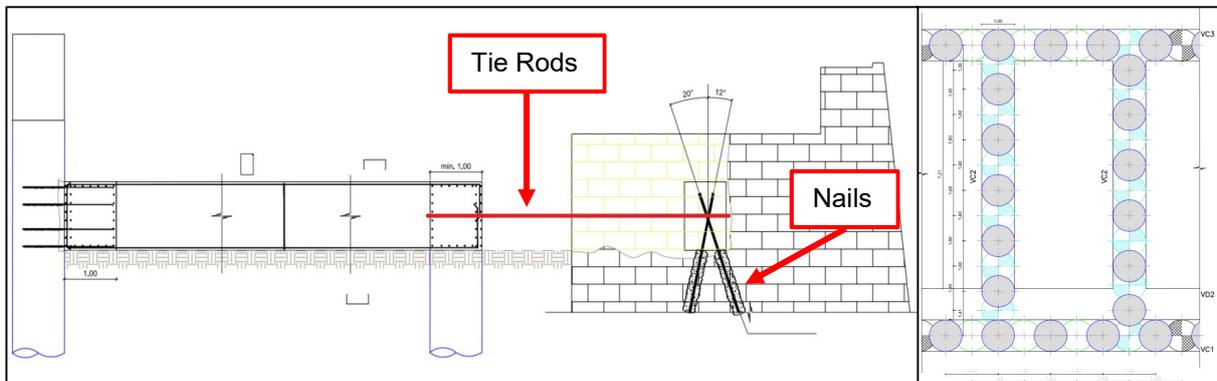
Figure 5: Buttresses cross sections and plan of the piles alignments.

The piles used in the stabilizing structure were bored piles with different lengths. These piles intersect alternately between reinforced concrete piles (secondary piles) and non-reinforced elements (primary piles) to form the secant pile walls. In the right image of figure 5 it is possible to see the way these elements were inserted in plan in the ground.

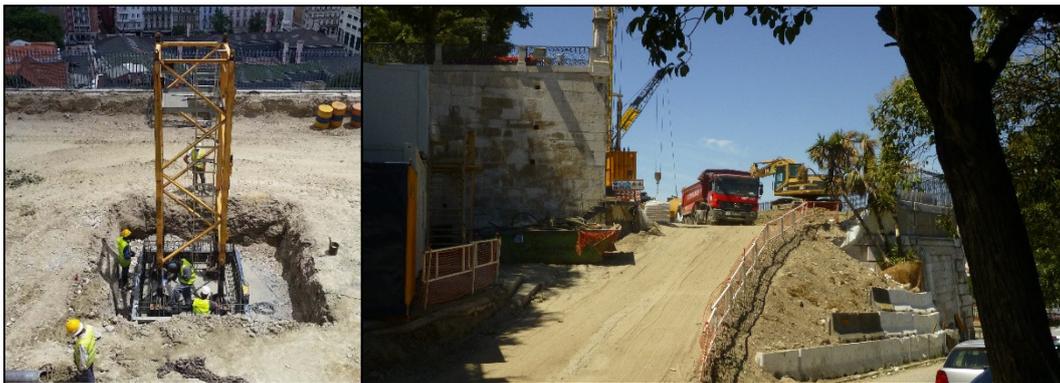
Figure 6: Installation of the crane tower and view from the access ramp to the lower platform

Among the installed equipment in the construction site, the installation of the crane tower (see figure 6) and the execution of an access ramp are the two elements with higher visibility.
