Failure Analysis of the Guide Vanes of the Pico Power Plant Wells Turbine

Mário Vieira

Instituto Superior Técnico, Universidade de Lisboa, Portugal

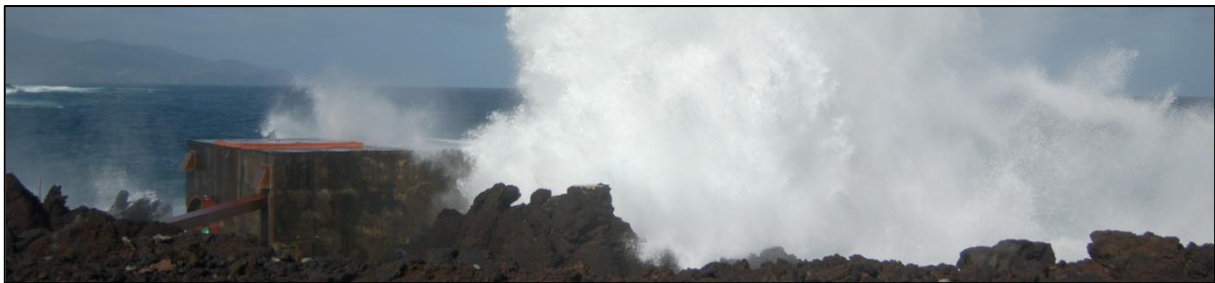
Figure 1 - The Pico Island Power Plant being hit by a massive wave.

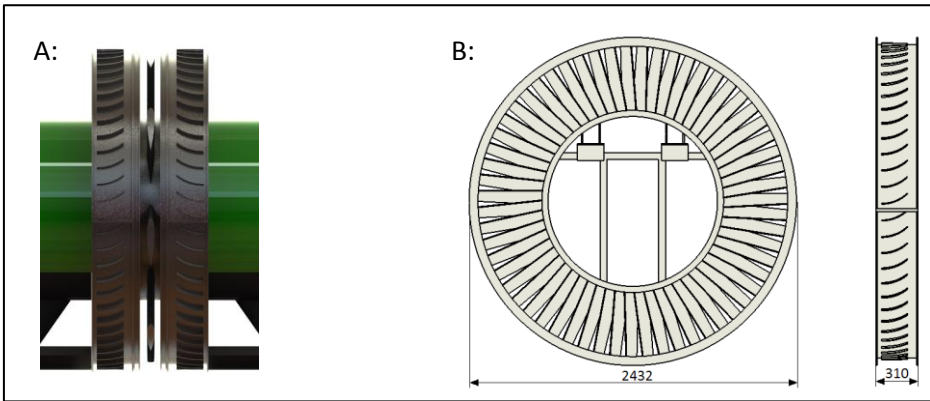
Figure 2 - CAD scheme of both the stators, with the turbine in the middle (A) and general dimensions (in millimeters) of the earth-side stator (B).

The stators under the scope on this project were not the ones installed with the original turbine, since the latter demonstrated, within the first hours of operation, a low rigidity that led to successive repairs and to its final withdrawal in 2005. A second pair of stators was then projected by Kymaner, which was built in AISI 316L steel, an austenitic stainless steel with superior corrosion capabilities and low carbon content for welding purposes. During the manufacturing of the blades' stator, several notches were created and left in them, supposedly due to the laser input in the laser cutting process, leaving all the blades with either two or four notches (Figure 3). So, even though these reinforced stators were built to resist to the harsh conditions they would be subjected to several cracks appeared in the earth-side stators' blades, with the nucleation of these visible cracks being held at the notch locations. There are, in total, one hundred and ninety notches distributed by the fifty-nine blades and, among these, sixty-six resulted in crack nucleation and consequent propagation.

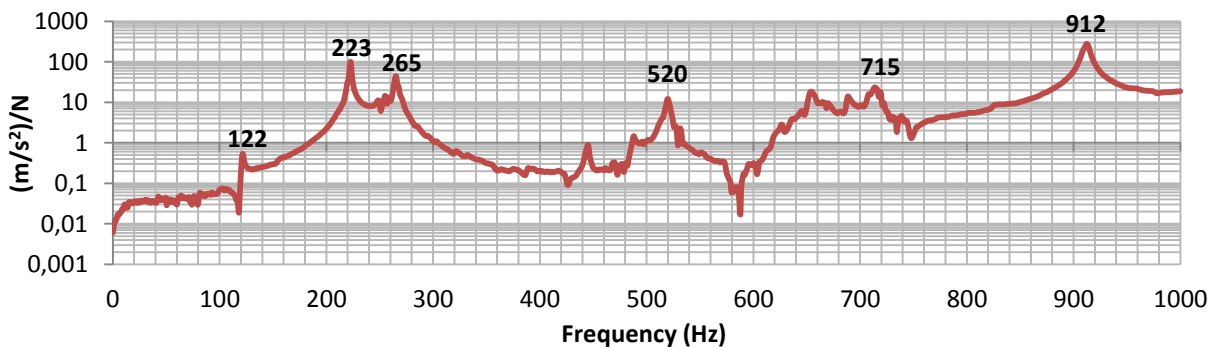
Modal testing revealed the structural curve of different blades, allowing the knowledge of their natural frequencies, as well as the understanding of the effect of cracks on the blade natural frequencies. In Figure 8 it is possible to analyze one of these curves, obtained from a free-crack blade (at least, on the notch regions).

Figure 8 – Transfer function obtained from modal testing of one of the eart-side stator blades.

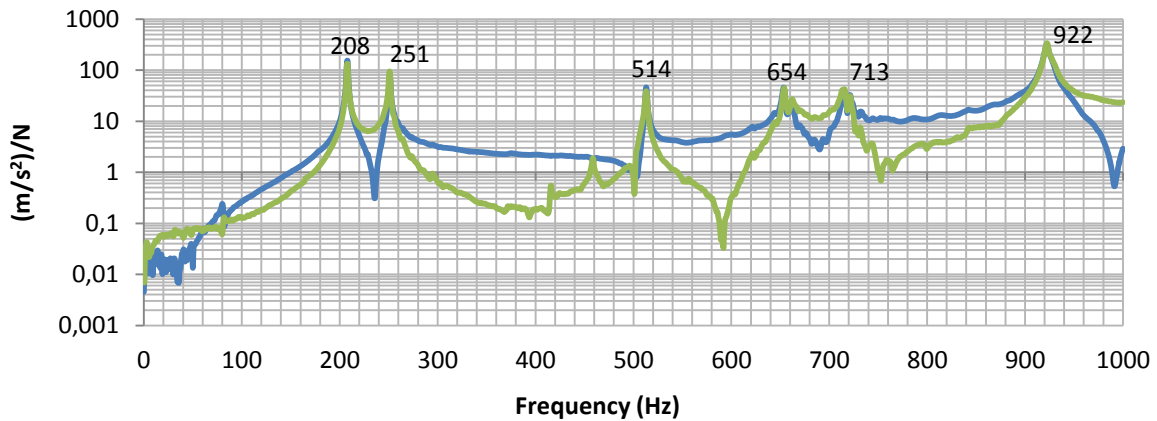
Figure 13 – Modal testing of the mechanically-jointed blade.

The results obtained are quite similar to the ones obtained for the original blade, although some natural frequencies got a bit reduced.

This design was built, installed and tested in real operating conditions and tested for its natural frequencies (Figure 13):
