STUDY ABOUT THE TECHNICAL VIABILITY OF USING COMPOSITE MATERIALS
IN THE REHABILITATION OF HYDRAULIC/AGRICULTURAL HIGHWAY UNDERPASSES.

Miguel Maria Potes Barroso Silva Santos
miguelsilvsantos@tecnico.ulisboa.pt

Instituto Superior Técnico, University of Lisbon, Portugal (2020)

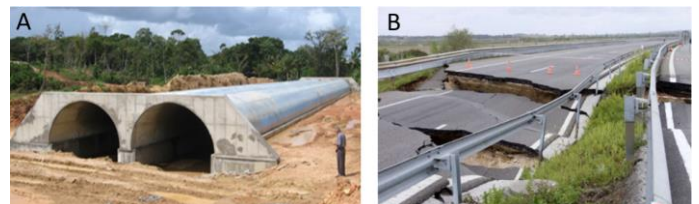
Figure 1 – a) Example of the ARMCO solution; b) Road subsidence in A41 (2016) Portugal [1].

Since the 1980s until the beginning of this XXI century, during the expansion of Portuguese highways, it was necessary to construct many hydraulic and agricultural underpasses; in many of these projects, a construction system called ARMCO solution was adopted. This system consists of using corrugated steel sheets, with an average thickness between 4 and 7 mm, which are screwed together, being assembled *in situ* before landfilling (Figure 1a).

Since 2016, there have been three road subsidences in Portugal due to the loss of mechanical resistance of PH/PA built with the ARMCO solution, caused by the corrosion of those metal pipes. Figure 1b shows the subsidence that occurred in the Portuguese motorway A41, which created traffic interruptions for months. The most serious case to date occurred in 2013,

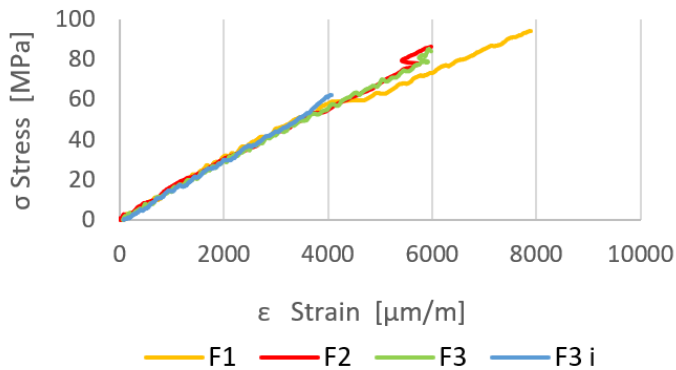
Figure 3 – Flexural tests: stress vs. strain curves.

Figure 3 depicts the stress vs. strain curves, showing a notable similarity between the slope of the various curves/specimens.

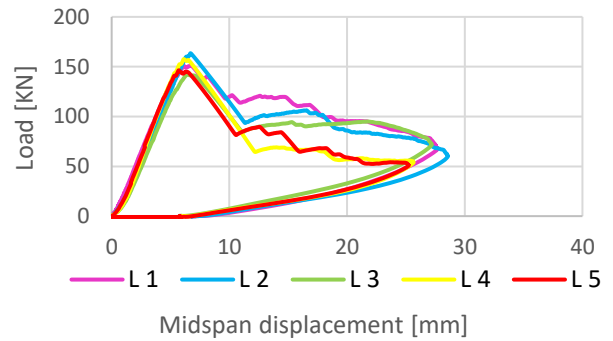
Figure 4 – Interlaminar shear tests: load vs. midspan displacement curves of longitudinal specimens.

The objective of the interlaminar shear test, which was carried out according to ISO 14130 [5], was to determine the shear resistance of the matrix layer between the fibre reinforcement layers. To this end, 5 specimens with dimensions of 600x120x60 mm were subjected to a single load applied at the centre of a 300 mm short span. The relationship between the thickness and the span was set (based on the above-mentioned standard) to cause the rupture by delamination of the layers. Figure 4 shows the load vs. midspan displacement curves in the longitudinal direction – the average interlaminar shear strength

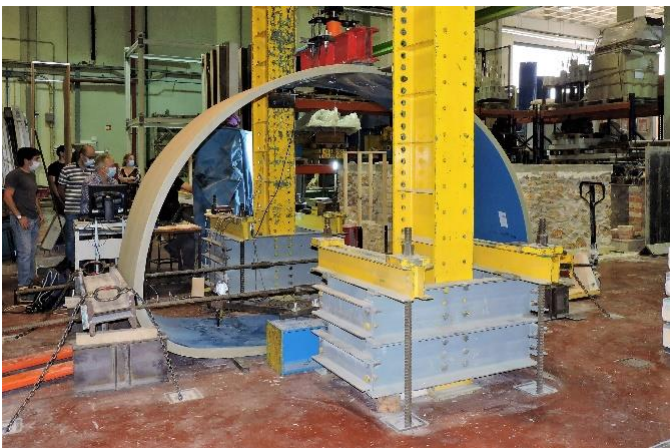
Figure 5 – Full-scale test (PH2).

The full-scale tests were performed on three specimens (PH1, PH2, PH3, Figure 5) with an ovoid-shape, with 1 m of length, a maximum opening of 3540 mm and a height of 2200 mm. The test consisted in applying a transverse load at the top of the GFRP tube – using a hydraulic jack with a 600 kN capacity and with a 250 mm stroke – by means of a steel load distribution beam. The test specimens have typical dimensions of GFRP tubular elements used in PH/PA rehabilitation.

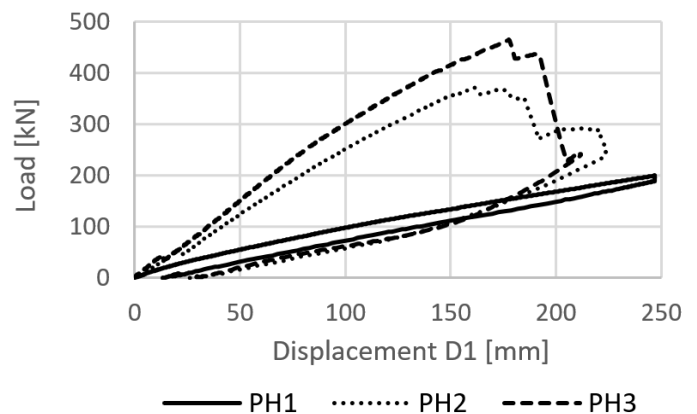
Figure 6 – Full-scale tests: Load vs. Displacement curve.

Figure 6 shows the load vs. vertical displacement at the top (D1) of specimen PH1. It can be verified that the maximum stroke of the hydraulic jack (250 mm) has been reached at a 200 kN load, without causing specimen failure. After an initial phase in which the behavior was non-linear, the structure presented a linear elastic behavior, with a proportional increase of the deformation with the load increase. After the maximum stroke of the jack was attained, the tubular element was unloaded and largely recovered its initial position. At the end of the unloading stage, the residual deformation was about 5%, corresponding to a permanent vertical displacement at the top of the specimen of 13 mm, which should be essentially associated with the aforementioned damage in the support layer. These results prove, once again, the high elasticity of the GFRP material.

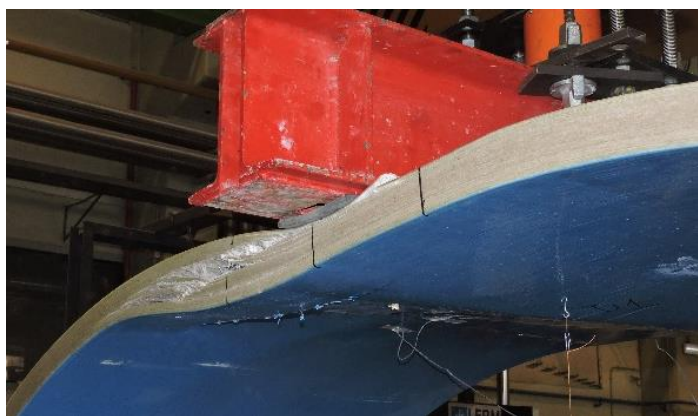
Figure 7 – Full-scale tests: interlaminar shear with delamination of the different layers.

Failure of specimens PH2 and PH3 occurred by compression (crushing) of the fibers on the upper surface of the top section of the tube, which was subjected to bending and compression (as detailed in the numerical study). After failure was triggered, the rupture by compression was followed by interlaminar shear failure, with delamination of the different layers, leading to an inclined crack (Figure 7). At some point, a hinge formed in this central part of the top of the tube. It was also possible to observe a longitudinal tensile crack along the bottom surface of the GFRP tube.

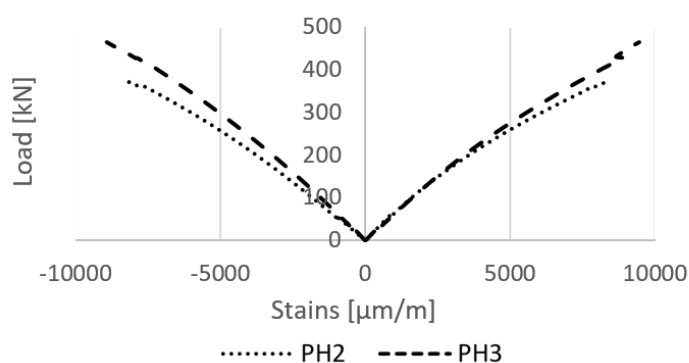
Figure 8 – Full-scale tests of specimens PH2 and PH3: Load vs. strain curves.

Figure 8 shows the load vs. strain curves recorded in two pairs of strain gauges placed in the same zone of test specimens PH2 and PH3. Each pair of strain gauges was placed as follows: one was placed in the outer surface (recording tensile strains) and the other one on the inner surface (recording compressions strains) of the GFRP pipe, at a cross-section distanced 220 mm from the top section.

The maximum strain (at failure) in specimens PH2 and PH3 corresponded to an approximate compressive stress of 140 MPa (considering $E = 14.5$ GPa). Since these strain gauges were placed at a distance of 220 mm from the load application section, it was not possible to determine the maximum tension in that critical section (this was assessed based on the numerical models). For similar loads, the maximum strains recorded in specimen PH1 were considerably smaller than those measured in the other two specimens, due to the absence of lateral restrictions in the test of specimen PH1.

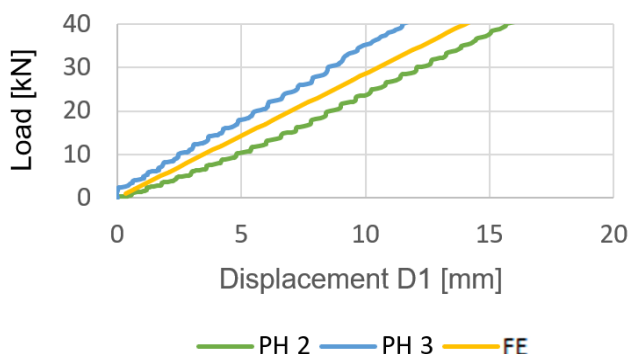
Figure 10 – Initial load vs. strain curves PH2/PH3 and FE.

The stiffness of the structure obtained from the FE model was determined by dividing the 1 kN load by the displacement D1 at the top of the pipe. Figure 10 compares the initial load vs. displacement D1 curves measured in the tests of specimens PH2/PH3 and obtained from the FE model. Figure 10 shows that the stiffness obtained from the FE model is quite similar to the average stiffness from the two tests.

For a 40 kN load, the displacement obtained from the model was 14.2 mm. This displacement compares with an average experimental value of 13.6 mm – values measured in specimens PH2 and PH3 were respectively 15.6 mm and 11.6 mm. Note that the thicknesses of the GFRP pipe measured at the top of specimens PH2 and PH3 were 58 mm and 65 mm, respectively, and that the thickness considered in the FE model (60 mm) is intermediate between these two values. This may partly explain the fact that the numerically obtained stiffness is also intermediate between the stiffness values measured on both specimens.

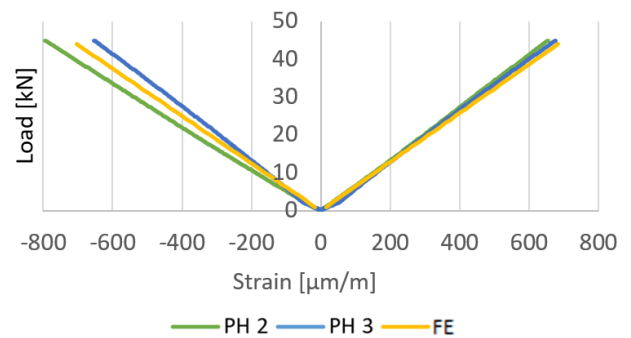
Figure 11 – Load vs. strain curves PH2/PH3 and FE.

Figure 11 compares the evolution of the axial strains with the applied load registered in strain gauges ext1 (compression) and ext2 (tension) of specimens PH2/PH3 with the corresponding strains calculated by the FE model. It is possible to see a good agreement between the numerical and experimental results.

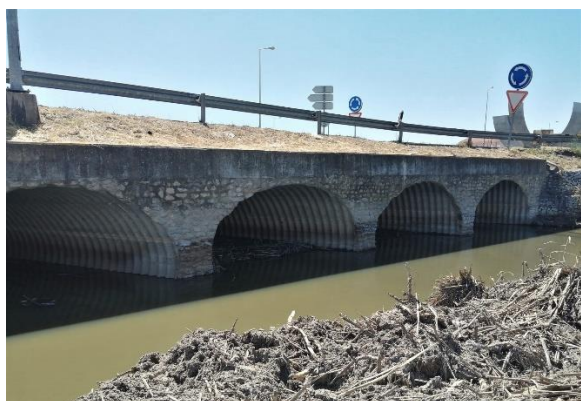
Figure 16a – Initial state of the PH after deforestation work.

The rehabilitation work that was visited in the final part of this dissertation is located at the exit number 3 of the Portuguese motorway A33, Sarilhos Grandes (Figure 16a). Five parallel tubular structures, with an ovoid shape, were built in 1997 using the ARMCO solution. This structure was designed to ensure a flow of approximately $100 \text{ m}^3/\text{s}$, for a return period of 100 years, through the 5 parallel passages, each one being 30 m long. With the ARMCO structure, the maximum flow rate was $150 \text{ m}^3/\text{s}$. This value increased with the GFRP rehabilitation (due to the decrease of the roughness coefficient) to $200 \text{ m}^3/\text{s}$.

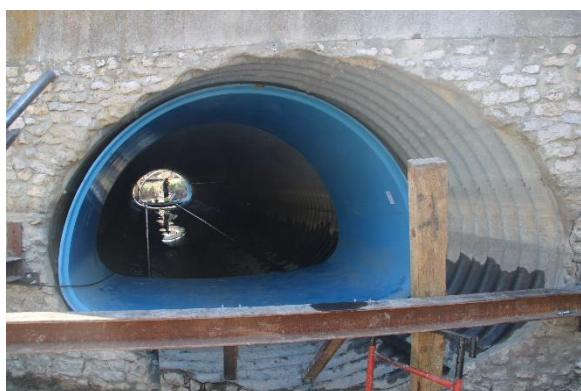
Figure 16b – Installation of the GFRP pipes.

The second step is to place the new pipes inside the degraded ones. For this, a longitudinal rail-like structure must be installed over which the tubes will move (Figure 16b). Then, the tubes are usually pushed to their final position with a mechanical winch. The tubes are connected through joints that depend on the supplier of the tubes. There are essentially two types of connections: (i) one that consists of a male-female connection, in which silicone is placed along the joint before fitting; and (ii) another one that is secured by two pipe flaps. In any case, the connection requires the greatest attention and control to ensure good performance of the joints. If such connections are not successfully executed, then this will likely be a source of pathologies in the future.

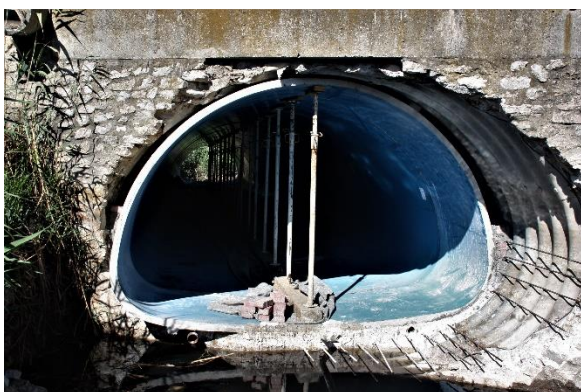
Figure 16c – GFRP pipes shored and buffered, ready to start the first stage of grout injection.

The third step starts by shoring the GFRP pipes to prevent them from moving due to the upward impulses caused by grout injection (to be applied later). After shoring all tubes, both pipe ends are buffered, and the grout injection is started. The grout injection must be done in a phased manner to ensure both homogeneity throughout the passage and uniformity of the lateral impulses. This is the most challenging stage (Figure 16c). Once the new GFRP piping is joined to the old one, some finishes are carried out, such as paintings, finishing details of the PH/PA enter/exit, and assembly of energy sinks upstream and/or downstream, depending on the needs. Figure 16d

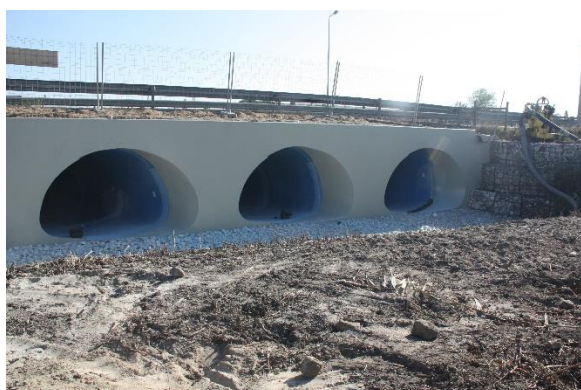
Figure 16d – PH after rehabilitation.

shows the final stage, i.e. the state of the hydraulic passage once the GFRP rehabilitation is completed.
