ENERGY-EFFICIENT RETROFITTING: MOURARIA AS CASE-STUDY

ANALYSIS OF FOUR CONSTRUCTION TYPES

Dissertation Extended Abstract to obtain the Master Degree in Architecture

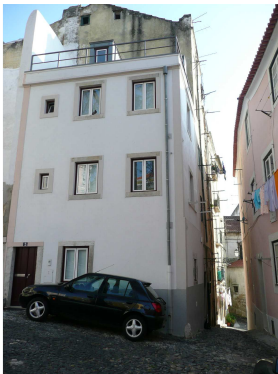
Picture 2 - Largo da Achada, 2 after rehabilitation

The *Largo da Achada n°2* building is one built before the 1755 earthquake that, damaged by the earthquake, was rebuilt using materials of its own downfall. Constructively, the exterior walls of Level 0 are composed of plastered stone masonry, and the upper floors were made of plastered brick masonry. The floor and cover

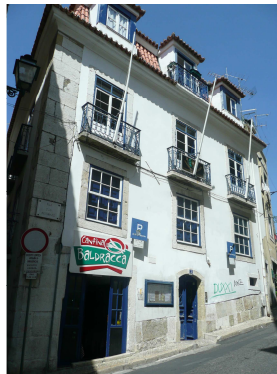
Picture 3 - Rua das Farinha 1-3 nowadays (fonte: autor, 2009)

The origin of this building probably dates back to the sixteenth century, having a considerable architectural value (Marques et al., 1989). Its irreversible state of ruin made it impossible to recover, being then demolished and reconstructed in 1990. This project was designed in full respect to the facades' design, and creating an interior courtyard to improve its living conditions.

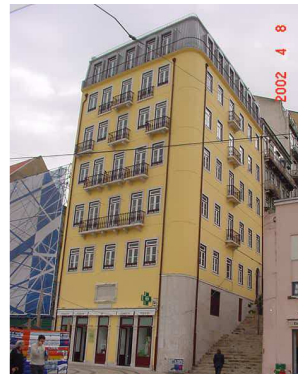
Picture 4 - Rua da Mouraria 8-16 after rehabilitation

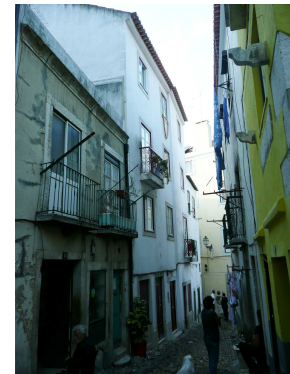
Picture 5 - Rua João do Outeiro 6-14
