INSTITUTO SUPERIOR TÉCNICO
Technical University of Lisbon

EXTENDED ABSTRACT

Rehabilitation of Pombalino buildings
Experimental analysis of frontal walls

Maria João Fonseca Teixeira

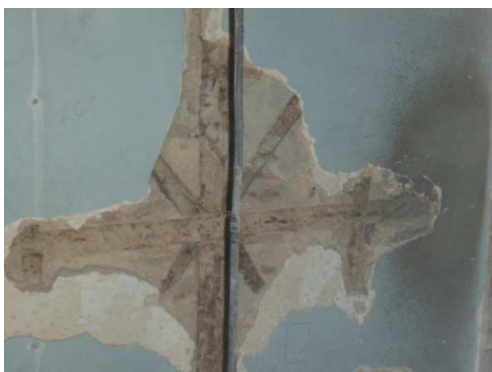
Figure 3 Frontal wall, ‘Santo André’ cross

Inside each building, there is a three-dimensional bracing system called “gaiola pombalina” or ‘Pombalino’ cage. This system is formed by an orthogonal mesh of walls in two directions called “pombalino” frontals, the wooden structure of the pavement and roofing plus a wooden structure which is connected to the exterior stone walls by wooden connectors. This structure can be observed in Figure 2. The structure complexity is responsible for the bracing which is the key to the good seismic behavior of these buildings [APPLETON, 2008]. The “pombalino” frontals are composed by wooden pieces: vertical (plumb lines), horizontal (battens) and diagonal (shores). This intersection creates elements of “Santo André” Cross, which spaces are filled with masonry (Figure 3 and Figure 4).

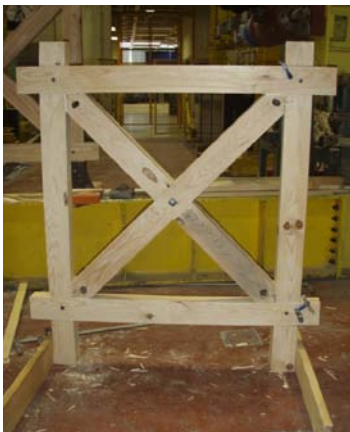
Figure 5 - Wooden cage (GM)

In this context, the purpose was to analyze this structure behavior in an increasing horizontal load test until fracture, conjugated with a constant vertical load that intends to simulate the existing load above this element. Therefore, three modules named GM1, GM2 and GM3 (Figure 5) were tested, consisting of a “Santo André” cross called wooden cage, and three modules PA1, PA2 e PA3 (Figure 6) filled with masonry called masonry walls. This distinction intends to evaluate the contribution of the constituents – wood and masonry – to global behavior and their interaction. Concerning the connections used in these samples they were made using a half-wood method shown in the Figure 7. These connections were reinforced using nails.

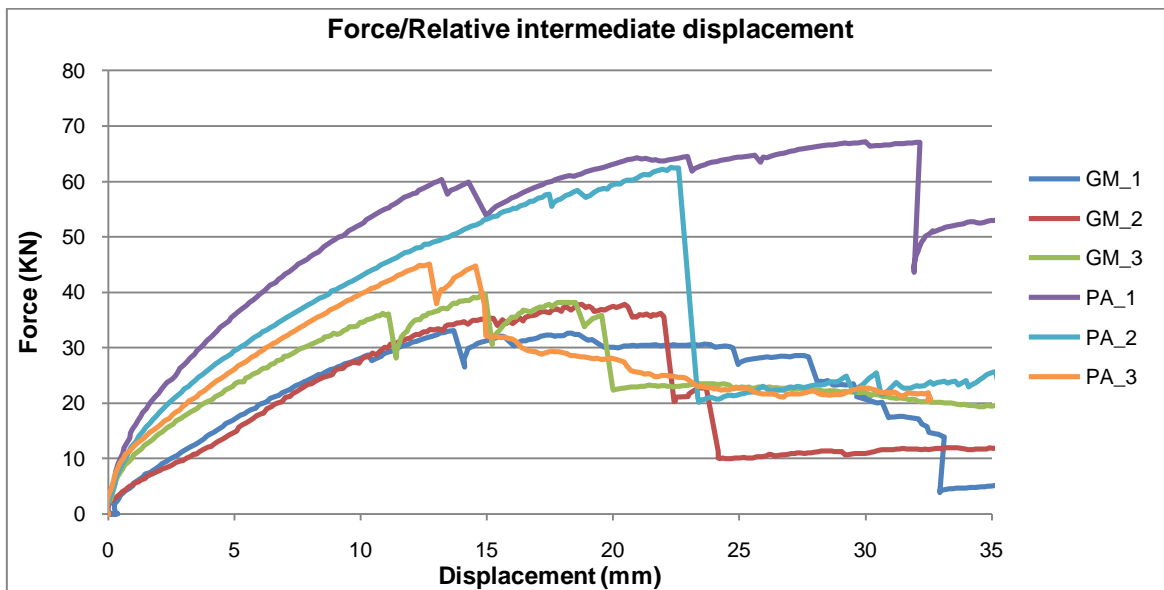
Figure 9 – Force/displacement diagram

In the next figure (Figure 9) is represented the force/ displacement diagram. This displacement is the intermediate (d2) and its value is relative, meaning deducting the support's displacement (d3). This deduction is necessary in order to have a plainer understanding since the superior deformer had a problem.

There is a very similar behavior between GM1 and GM2 in the wooden cages. GM3 showed a higher stiffness, however, had an earlier starting fracture comparing to the others. In other words, GM3 was the first to experience an abrupt fall of the load value, that is to say, reached a lower displacement. GM2 presented a later failure, in other words, reached higher displacement values. This sample's failure occurred in a full section. Considering the failure modes, GM2 presented a more abrupt failure, while the others even regained a little bit stiffness. Regarding the failure forces, GM1 showed the minimum force value, which is the one whose diagonal had a lateral instability rupture developed by the central joint's failure (half-wood section).

The masonry walls had all similar behavior. PA1 presented a higher stiffness while PA3 had the lowest. PA1 and PA2 reached superior forces values, as PA3 suffered a premature failure caused by any local failure, probably in the support. PA2 reached the highest value of force and displacement.

This similarity suggests that the masonry does not have the expected influence concerning this type of loading. However, masonry does have a slightly contribution to the resistance of the whole set and the way it fractures, for instance, avoiding the lateral instability. The presence of masonry was probably more important to vertical loads. Nevertheless, the average effect of the masonry was quite substantial in the stiffness' walls and resistance.

The models that achieved superior failure forces were GM2 and PA2, corresponding to fractures occurred in full sections which were not as fragile as the half-wooden ones. Besides, these models registered the latest (within each group) and most abrupt ruptures and correspond to the same failure mode (plumb line in tensile).

Observing the obtained diagrams in the experimental tests, each module behavior was related with its failure mode. Furthermore, it was found that a higher failure force was associated with rupture profiles in filled sections. On the other hand, the half-wood sections were more fragile. A stiffness decrease in the elements endurance was observed since the beginning of the tests. This feature can be explained by the eventual occurrence rotations of the whole structure during testing, which have not been measured.

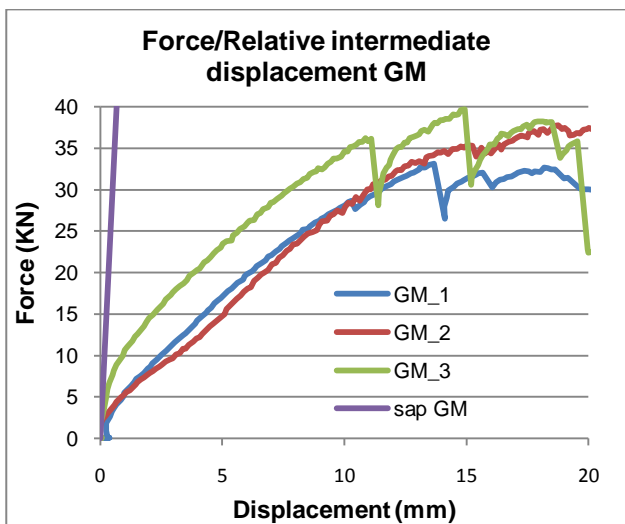
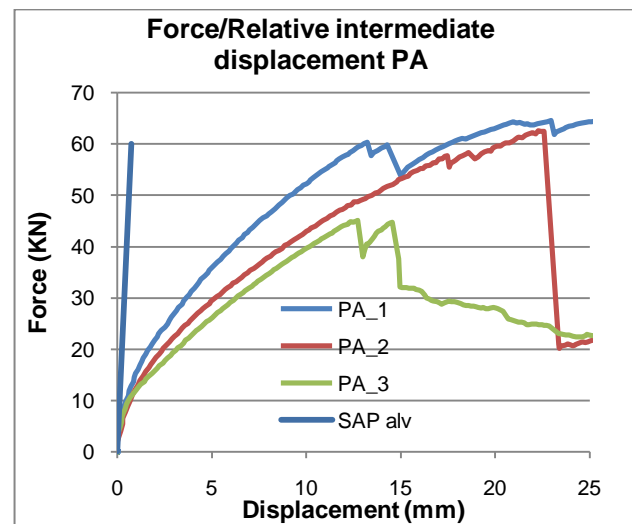
The masonry was considered to be a homogeneous material equivalent with the reduced properties. Thus, shell bi-dimensional elements with a 400 MPa elasticity module were used. The masonry walls were studied in order to select which elements to use in the modulation (triangular or quadrangular) and its refinement, where the displacement value measured was the same. Therefore, it was used a model (model 7) to modulate a masonry wall which consisted in a wooden skeleton of model 4 and where the masonry was defined with quadrangular elements.

The numerical models selected to represent the wooden cage and the masonry wall, present a higher stiffness compared to the models tested. They present only a tangency for an initial period, corresponding to the linear elastic stage. This tangency was only achieved for very low load values.
